SPECIAL OPEN WORK SHOP FOR THE VILLAGE ENERGY TASK FORCE

GOLDEN RAIN FOUNDATION ELECTRICAL INFRASTRUCTURE ASSESSMENT

UNITED LAGUNA HILLS MUTUAL ELECTRICAL INFRASTRUCTURE ASSESSMENT

THIRD LAGUNA HILLS MUTUAL ELECTRICAL INFRASTRUCTURE ASSESSMENT

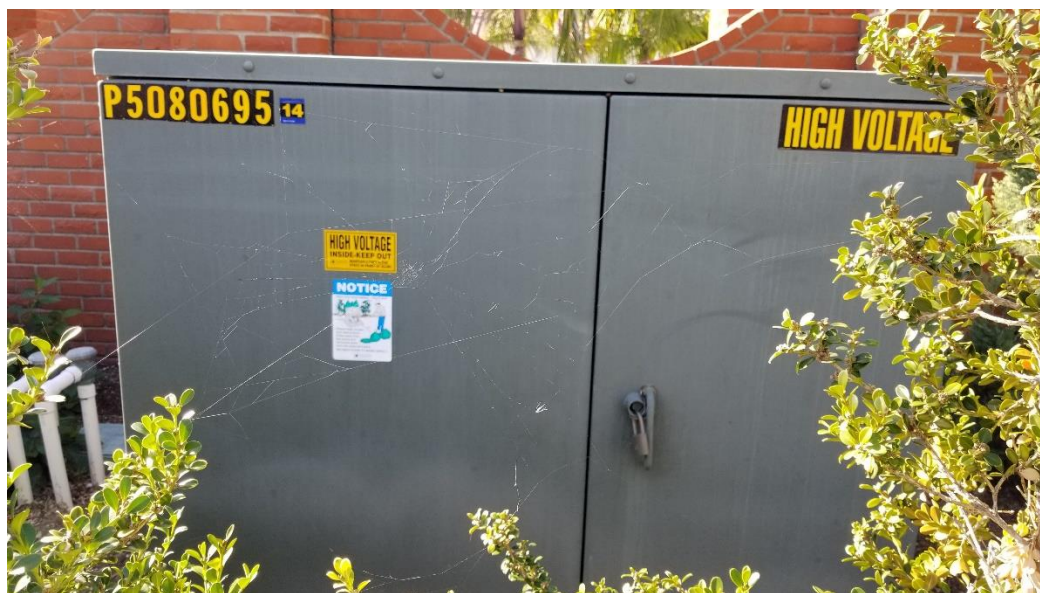
Clubhouse 1 is served with a 225kVA three-phase pad-mounted SCE transformer shown on Figure 5. This transformer is of an older vintage, but overall, the external condition of the transformer was rated 3.0 (Adequate) not rusted, damaged or visibly overloaded, based on the Asset Condition Measurement referenced in Section 3.4. The transformer was last inspected by SCE in 2014. Based on the 182kW (214kVA @ 85% power factor) max demand from Table 3, the transformer is sized adequately for the current load of Clubhouse 1. There is approximately 5% capacity available on this transformer based on nameplate data. Any additional loads will require potential upgrades by SCE. Actual transformer loading analysis is determined by SCE. No action is needed for this equipment.

Figure 5: SCE 225kVA 120V/208V Pad-mounted Transformer Servicing Clubhouse 1

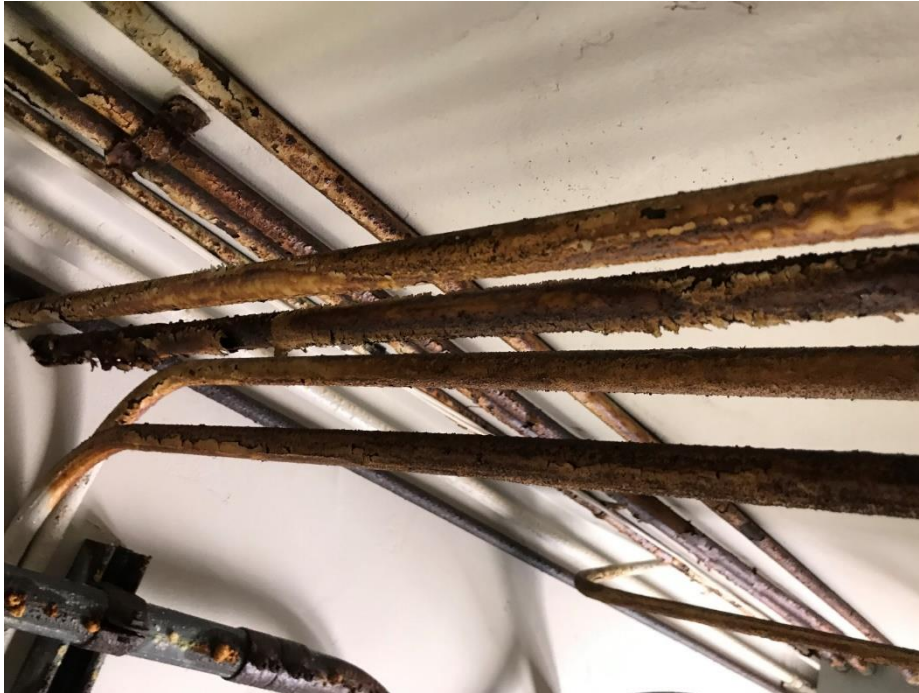
Figure 6: Corroded Piping Found in Clubhouse 1 Main Electrical Room

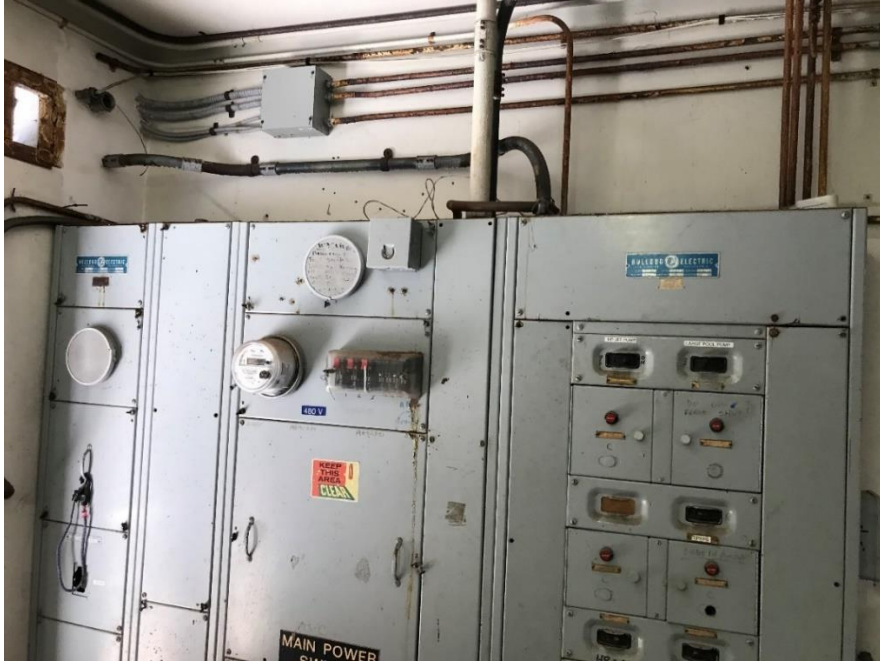
Figure 7: Electrical Switchboard and Meter Found in Clubhouse 1 Main Electrical Room

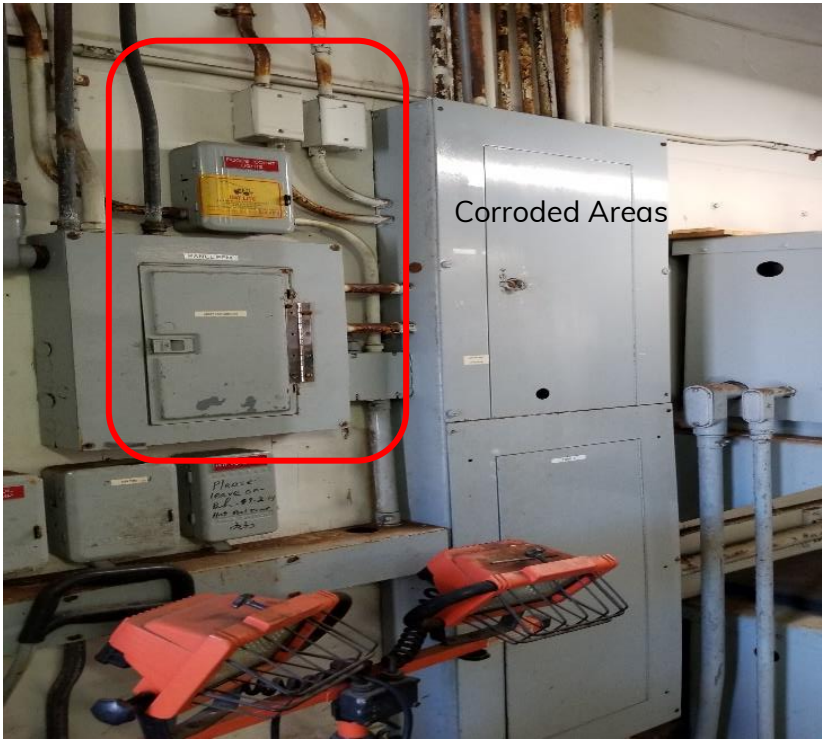
Figure 8: Rusted Electrical Equipment Found in Clubhouse 1 Main Electrical Room

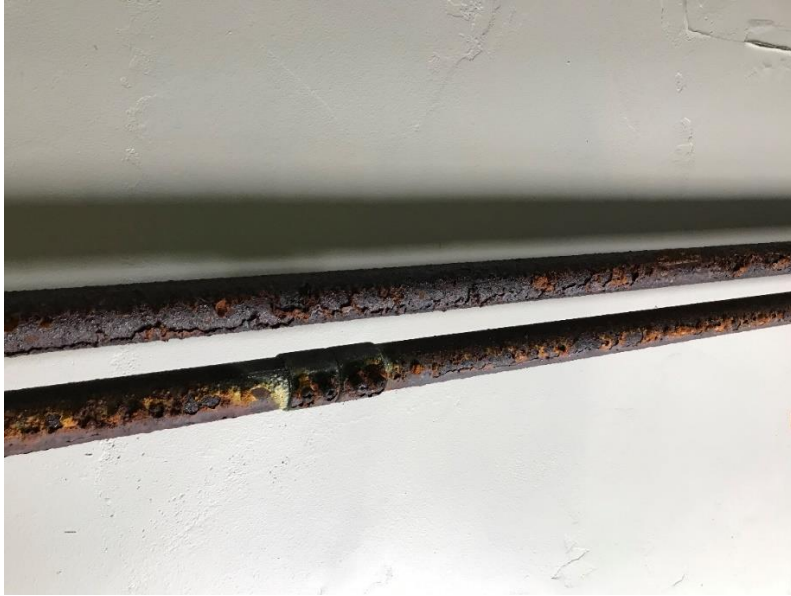
Figure 9: Corroded Conduit Changed Out Four Years Ago Found in Clubhouse 1 Main Electrical Room

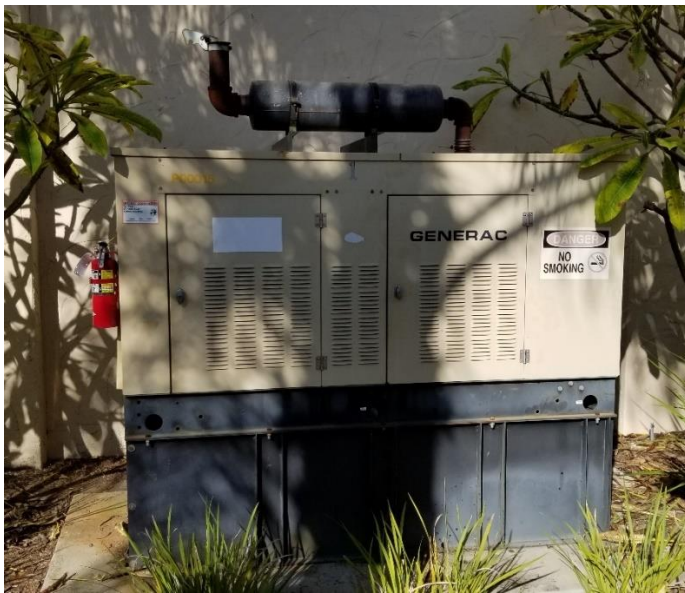
Clubhouse 1 has a 193.7 kVA diesel emergency generator (Figure 10). The generator appears to be in good condition. Maintenance records are current. This generator is rated 4.0 (Good) based on the Asset Condition Measurement referenced in Section 3.4. A generator program analysis was not part of this electric infrastructure assessment report scope.

Figure 10: Diesel Backup Power Generator at Clubhouse 1

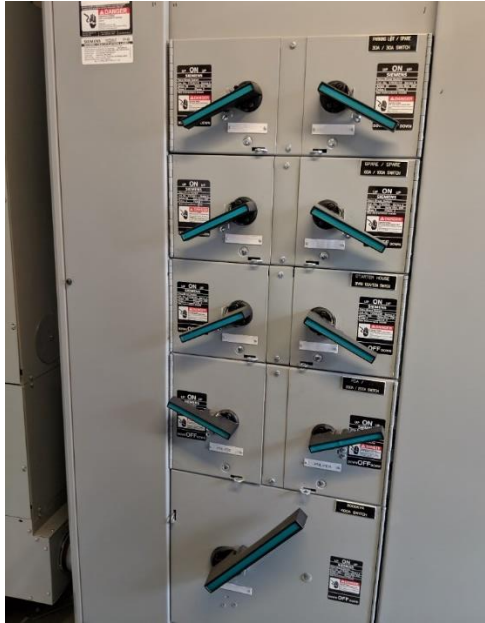
The electrical rooms and panels were newly installed and rated 5.0 (Excellent) based on the Asset Condition Measurement referenced in Section 3.4. The main panel is an 800A, 277/480V panel replaced in 2016. The dry-type transformer is a 300kVA 277/480-120/208V in good condition. The subpanels are also in good condition. Emergency room panels are located in an adjacent room and are in good condition. This electrical room does not require any further action other than an annual inspection.

Figure 12: SCE 800A 277/480V Panel Servicing Clubhouse 2

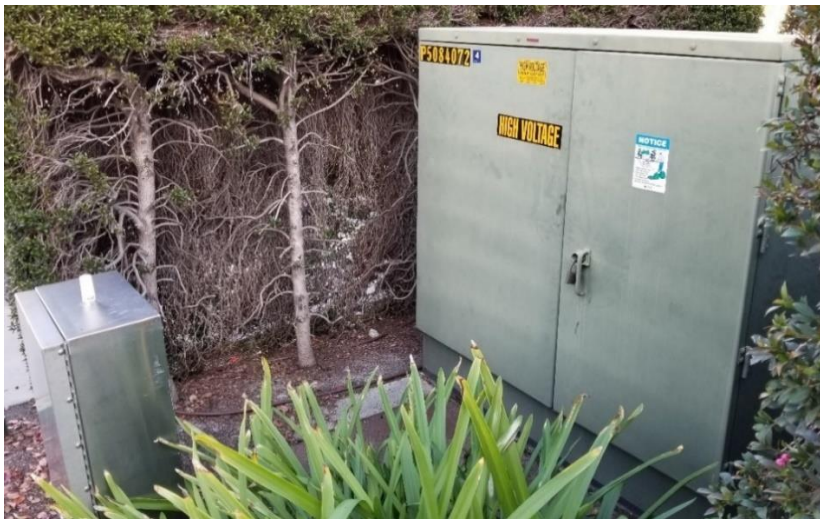
The SCE transformer serving Clubhouse 3 is a newer 500kVA 120/208 pad-mounted unit as shown on Figure 13. The exact date of manufacture and installation was not available on the equipment. The transformer was rated 4.0 (Good) based on the available info. The transformer is more than adequately sized to serve the 144kW (169kVA @ 85% power factor) max load shown in Table 3. There is approximately 195% capacity available on these transformers based on nameplate information. Actual transformer loading analysis is determined by SCE.

Figure 13: SCE 500kVA 120V/208V Pad-mounted Transformer Servicing Clubhouse 3

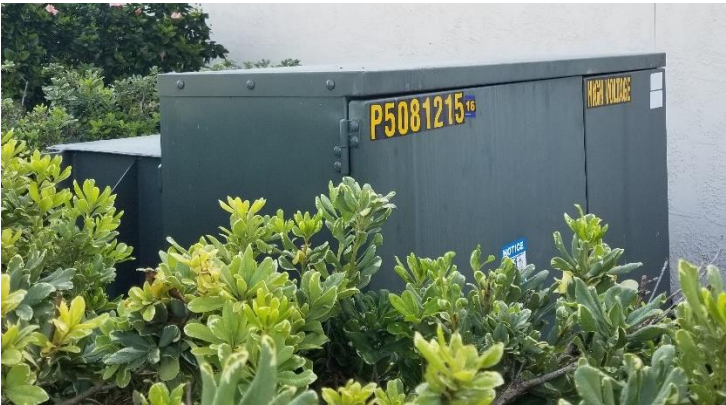
The SCE transformer serving Clubhouse 4 is a newer 300kVA 120/208 pad-mounted unit as shown on Figure 15. The transformer was manufactured in 2011. The transformer was rated 4.0 (Good) based on the Asset Condition Measurement referenced in Section 3.4. The transformer is more than adequately sized to serve the 156kW (184kVA @ 85% power factor) max load shown in Table 3. There is approximately 63% capacity available on these transformers based on nameplate information. Actual transformer loading analysis is determined by SCE.

Figure 15: SCE 300kVA 120V/208V Pad-mounted Transformer Servicing Clubhouse 4

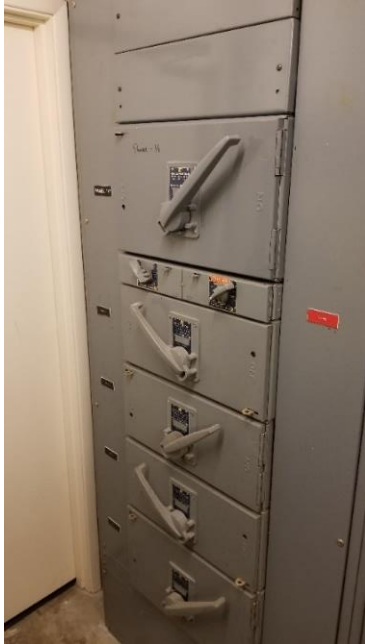
The Clubhouse 4 electrical panels are of an older vintage and generally in adequate condition. The main panel is a 2000A, 120/208V with several subpanels to serve the load. The condition of the switchgear shown on Figure 16 was rated as a 3.67 (Adequate) based on the Asset Condition Measurement referenced in Section 3.4 due to its age.

Figure 16: Main 2000A 120/208V Switchgear Servicing Clubhouse 4

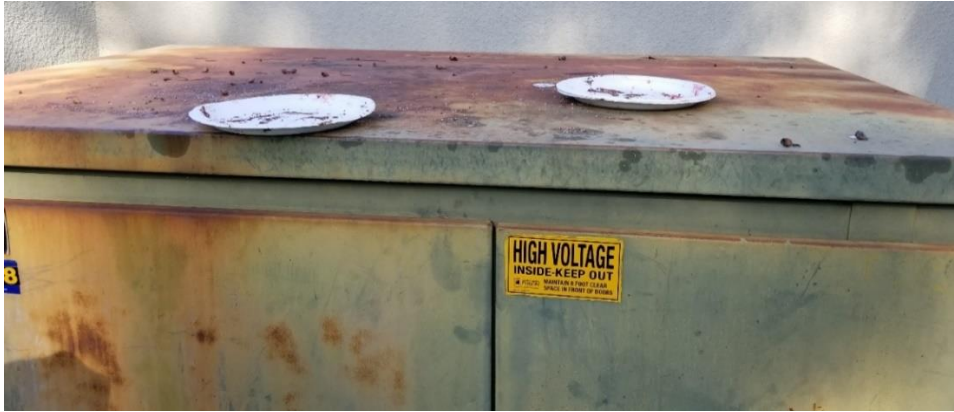
The transformer is more than adequately sized to serve the 166kW (195kVA @ 85% power factor) max load shown in Table 3. There is approximately 54% capacity available on these transformers based on nameplate information. Actual transformer loading analysis is determined by SCE.

Figure 17: SCE 300kVA 120V/208V Pad-mounted Transformer Servicing Clubhouse 5

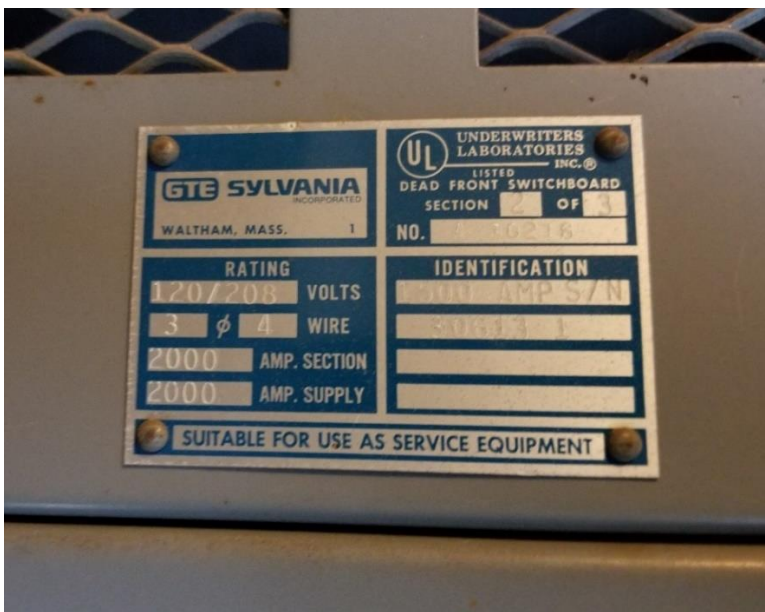
The Clubhouse 5 electrical panels are an older vintage and generally in adequate condition. The panels appear to be at least 40 years old and possibly the original equipment installed to serve the Clubhouse. The rating for the switchgear is marginal at a 2.75 (Marginal) based on the Asset Condition Measurement referenced in Section 3.4. The equipment is adequate for the current load but has passed the midpoint of its useful life. The main panel is a 2000A 120/208V with several subpanels to serve the load. The nameplate is shown on Figure 18. The condition of the panels is adequate for current load. A majority of the subpanels appeared to be newer installations. The equipment was rated at a 3.5 based on the Asset Condition Measurement referenced in Section 3.4.

Figure 18: Main Panel 2000A, 120V/208V Servicing Clubhouse 5

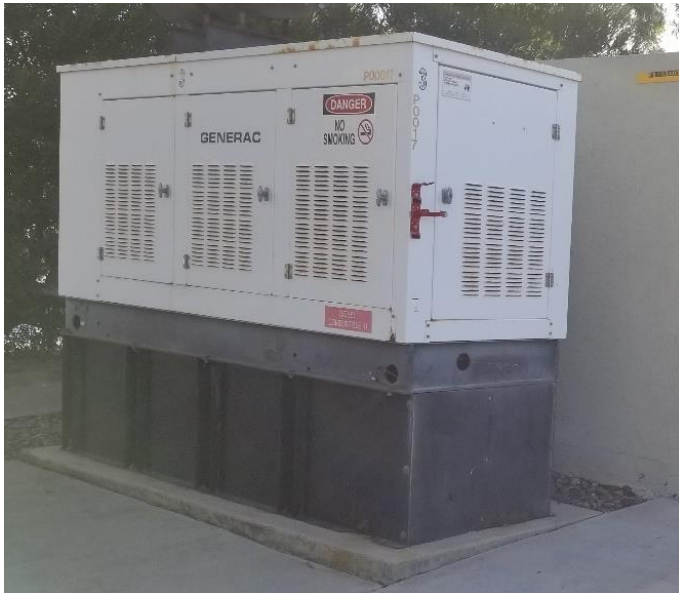
Clubhouse 5 has a 193.7 kVA 277/489V diesel emergency generator. The unit is shown on Figure 19. The generator appears to be in good condition. Maintenance records are up to date and generators are exercised regularly according the LWV maintenance. This generator is rated 4.0 (Good) based on the Asset Condition Measurement referenced in Section 3.4. A generator program analysis was not part of the assessment report.

Figure 19: 194kVA Emergency Generator Servicing Clubhouse 5

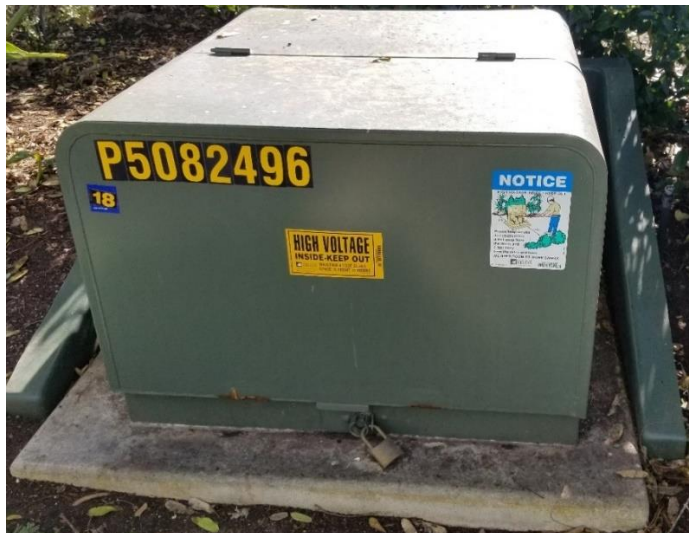
The transformer is more than adequately sized to serve the 35kW (41kVA @ 85% power factor) max load shown in Table 3. There is approximately 83% capacity available on these transformers based on nameplate information. Actual transformer loading analysis is determined by SCE.

Figure 20: SCE 75kVA 120V/240V Pad-mounted Transformer Servicing Clubhouse 6

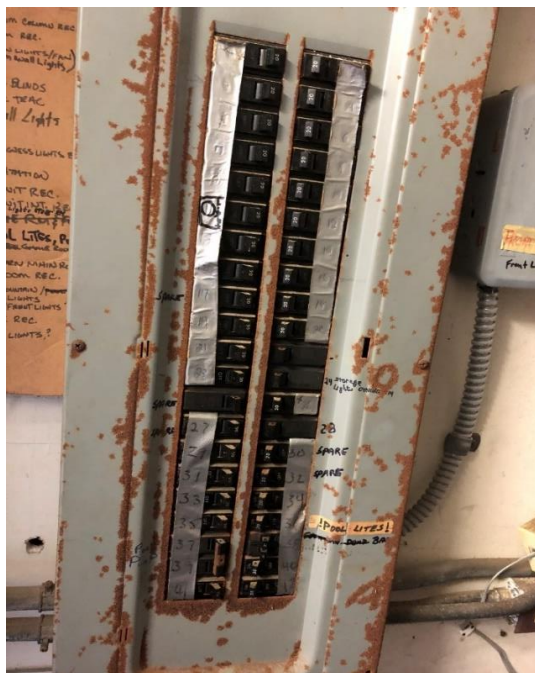
The Clubhouse 6 electrical panels are an older vintage and some in hazardous condition. The panels are corroded and in need of repair or replacement. Similar to Clubhouse 1, they appear to have been exposed to pool chemicals that caused the corrosion. The equipment appears to be at least 40 years old and possibly the original equipment installed to serve the Clubhouse. The main panel is a 400A 120/240V with several subpanels and timers to serve the load. All of the subpanels and timers are corroded (Figure 21 and Figure 22). The overall Asset Condition Measurement rating for this equipment is 1.75 (Poor) based on the Asset Condition Measurement referenced in Section 3.4.

Figure 21: Rusted Breaker Panel Servicing Clubhouse 6

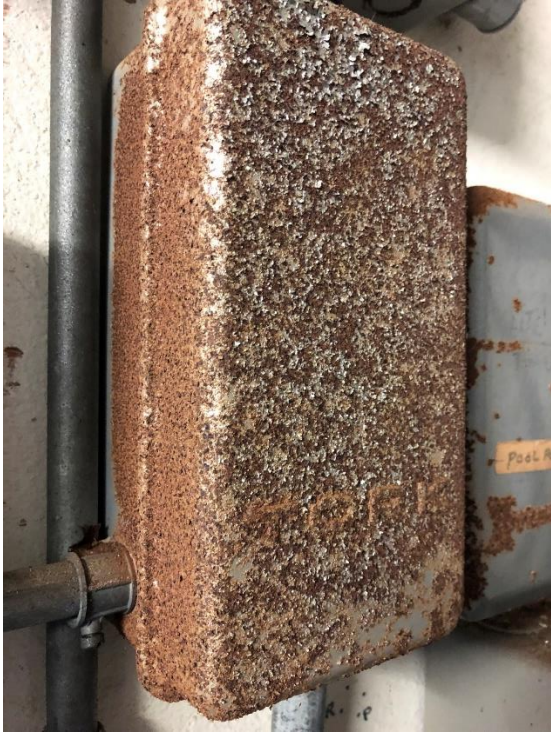
Figure 22: Rusted Junction Box Servicing Clubhouse 6

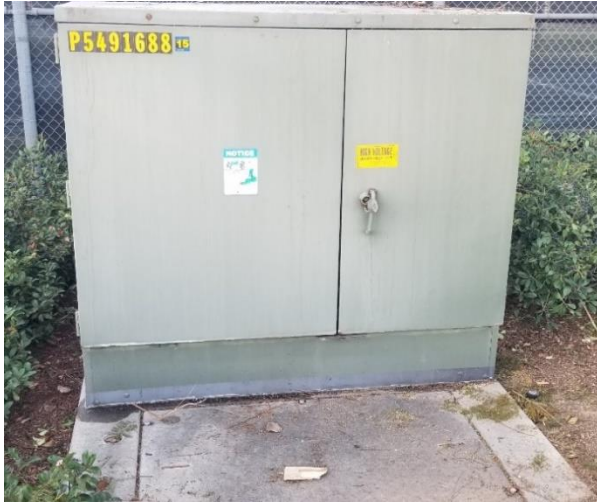
The SCE transformer serving Clubhouse 7 is a newer 300kVA 277/480 pad-mounted unit as shown on Figure 23. The transformer was manufactured in 2005. The transformer was rated 4.0 (Good) based on the Asset Condition Measurement referenced in Section 3.4. The transformer is more than adequately sized to serve the 142kW (167kVA @ 85% power factor) max load shown in Table 3. There is approximately 80% capacity available on these transformers based on nameplate information. Actual transformer loading analysis is determined by SCE.

Figure 23: SCE 300kVA 277/480V Pad-mounted Transformer Servicing Clubhouse 7

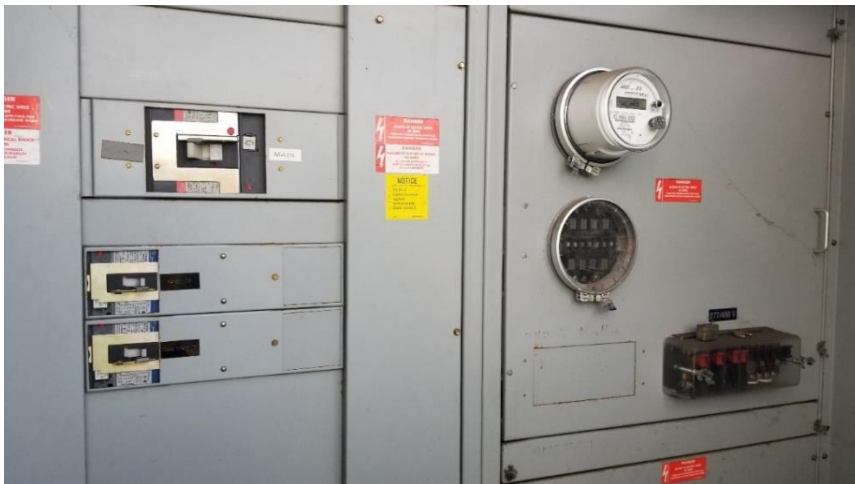
The Clubhouse 7 electrical panels are an older vintage and generally in good condition. The main panel (Figure 24) is a 2000A, 120/208V with several subpanels to serve the load. The equipment is rated at a 3.0 (Adequate) based on the Asset Condition Measurement referenced in Section 3.4.

Figure 24: 400A 277/480V Main Panel Servicing Clubhouse 7

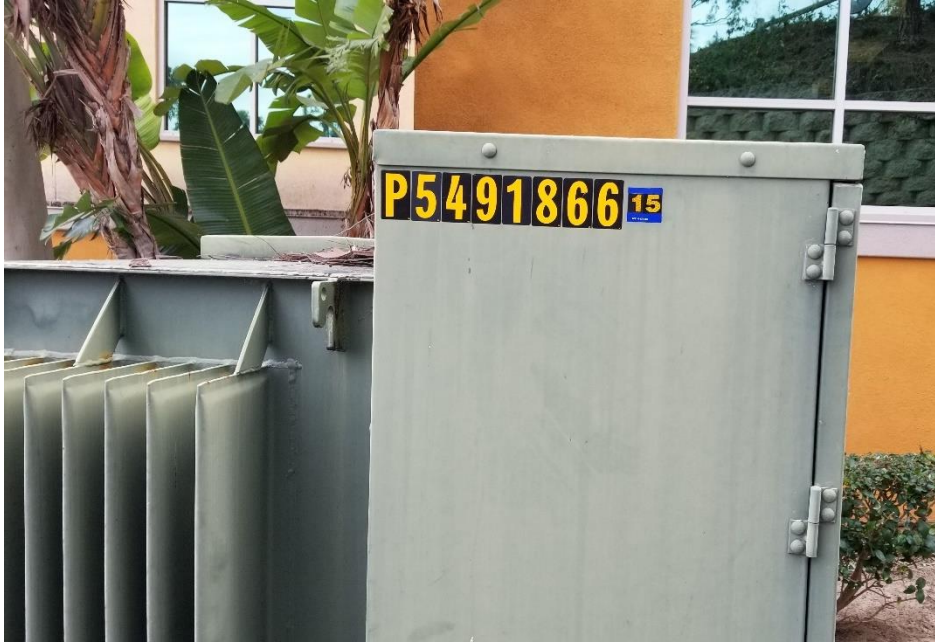
The SCE transformer serving the Community Center shown in Figure 25 is 1500kVA 277/480V and in good condition. The transformer was rated 4.0 (Good) based on the Asset Condition Measurement referenced in Section 3.4. The transformer is more than adequately sized to serve the 417kW (490kVA @ 85% power factor) max load shown in Table 3. The transformer is sized approximately three times as large for the load it serves. There is approximately 206% capacity available on these transformers based on nameplate information. Actual transformer loading analysis is determined by SCE.

Figure 25: SCE 1500kVA 277/480V Pad-mounted Transformer Servicing the Community Center

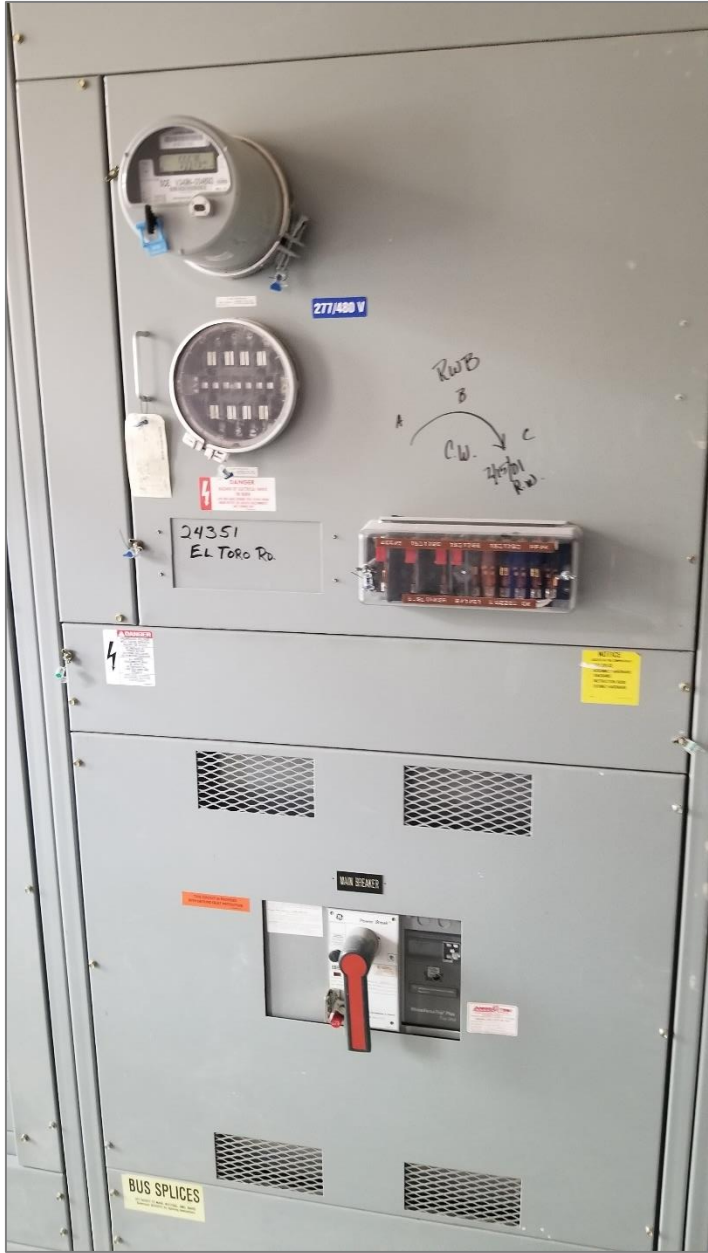
The electrical equipment in the Community Center is a 2000A 277/480V section and is in good condition with a rating of 4.0 (Good) based on the Asset Condition Measurement referenced in Section 3.4. There are three 600A subpanels, one for each of the floors of the building and two circuits for the two elevators.

Figure 26: 2000A, 277/480V Main Switch Serving the Community Center

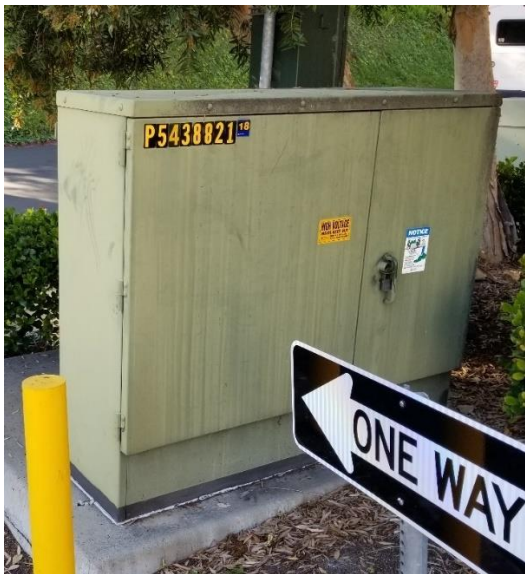
The SCE transformer serving the Library is an older 75kVA, 120/208V pad-mounted unit as shown on Figure 27. The size was not available on the unit in the field, however, the size information was provided in Table 3. The transformer was rated 3.00 (Adequate) based on the Asset Condition Measurement referenced in Section 3.4. The transformer is more than adequately sized to serve the 40kW (47kVA @ 85% power factor) max load shown in Table 3. There is approximately 60% capacity available on these transformers based on nameplate information. Actual transformer loading analysis is determined by SCE. The equipment was rated as 3.5 (adequate condition) based on the Asset Condition Measurement referenced in Section 3.4.

Figure 27: SCE 75kVA 120/2080V Pad-mounted Transformer Servicing the Library

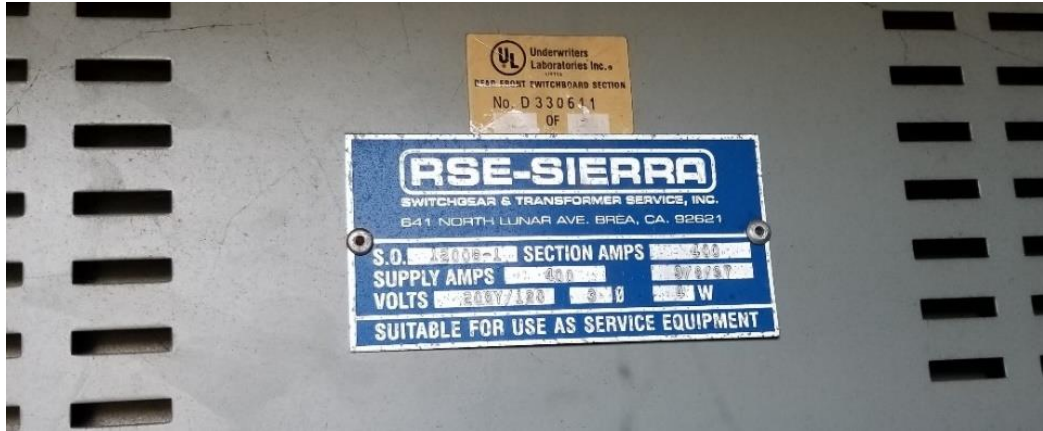
The 400A 120/208V Main panel (Figure 28) is located outside of the Library. It is an older style panel and rated at a 3.0 (Adequate) based on the Asset Condition Measurement referenced in Section 3.4. All the breakers for the Library are located inside this panel enclosure.

Figure 28: 400A 120/208V Main Panel Servicing the Library

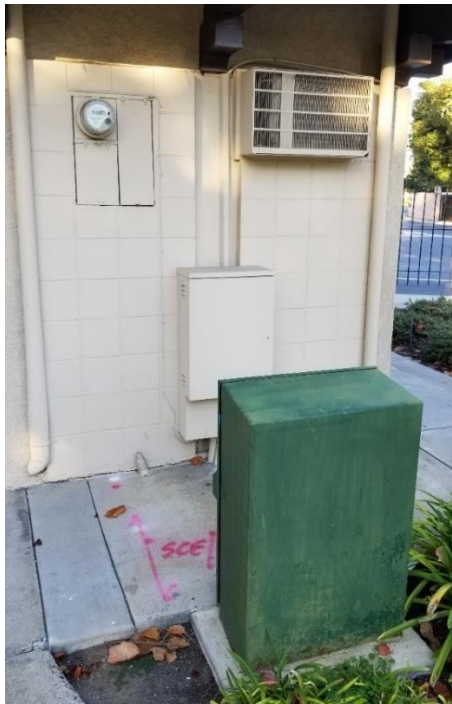
The 60A 120/240V Main panel (Figure 29) is located outside of the Gatehouse. It is an older style panel and in adequate condition. All the breakers for the Gatehouse are located inside this panel. The equipment is rated as 3.0 (Adequate) based on the Asset Condition Measurement referenced in Section 3.4.

Figure 29: 60A 120/240V Main Panel Servicing Gatehouse 2
