**REGULAR MEETING  
GOLDEN RAIN FOUNDATION LANDSCAPE COMMITTEE**

**SUBJECT: Aliso Creek Update**

### **2021 ANNUAL PERFORMANCE MONITORING REPORT FOR HABITAT RESTORATION AT THE ALISO CREEK TRAIL REPAIR PROJECT**

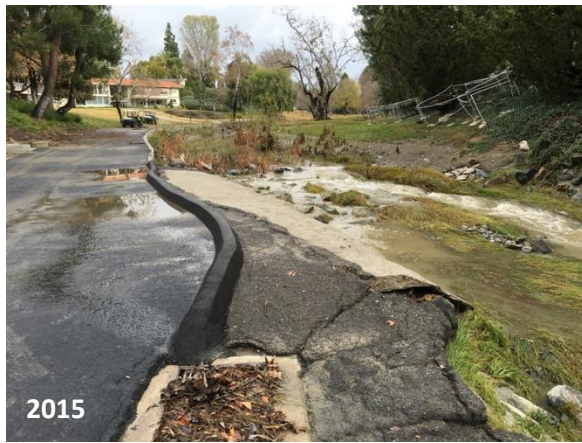
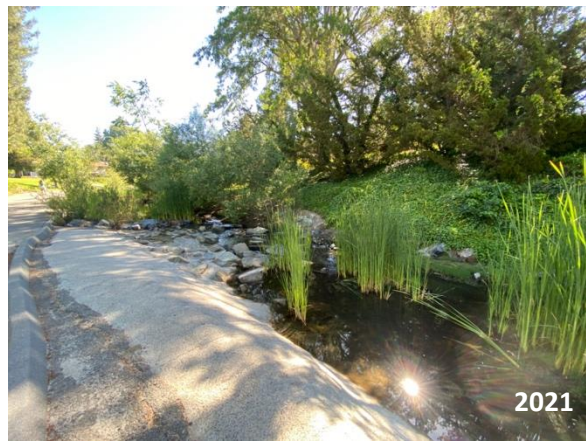
### Photo 1.

Photo Station 1. Photo depicts the north side of the Creek facing northeast (upstream). Photograph on left taken January 2015. Photograph on right taken April 2021.

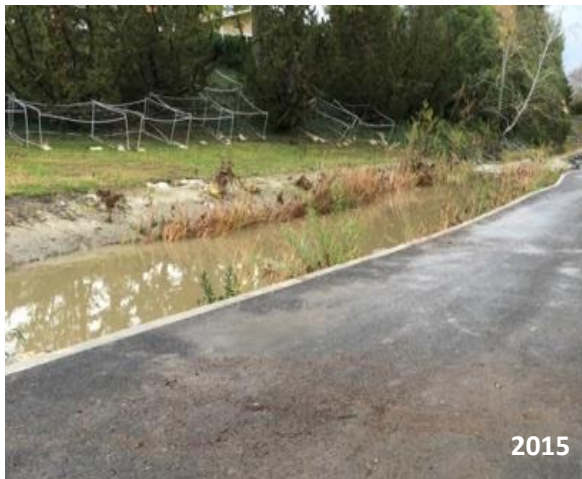
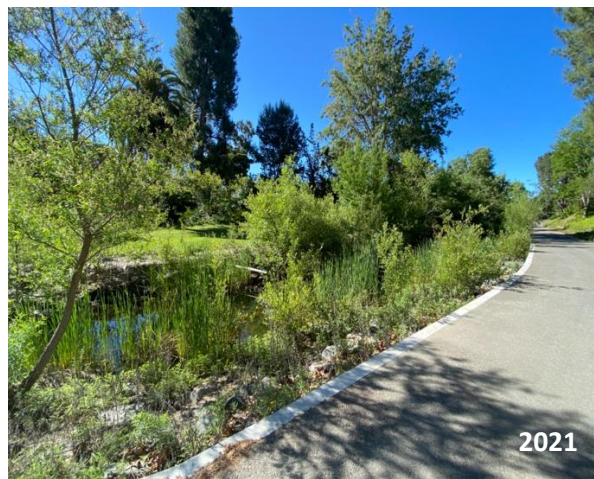
### Photo 2.

Photo Station 2a. Photographs depicts the north side of the Creek facing southwest (downstream). Photograph on left taken January 2015. Photograph on right taken April 2021.

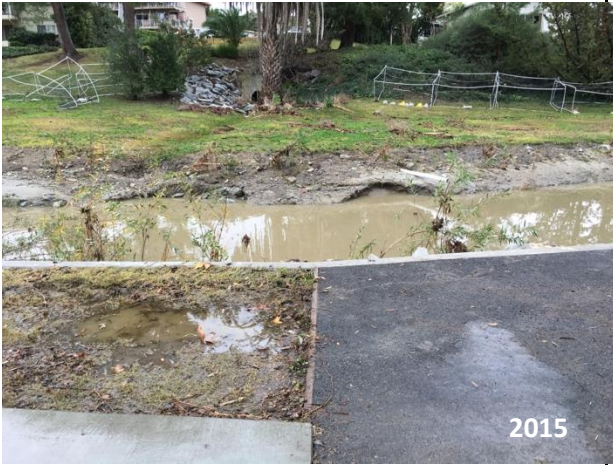
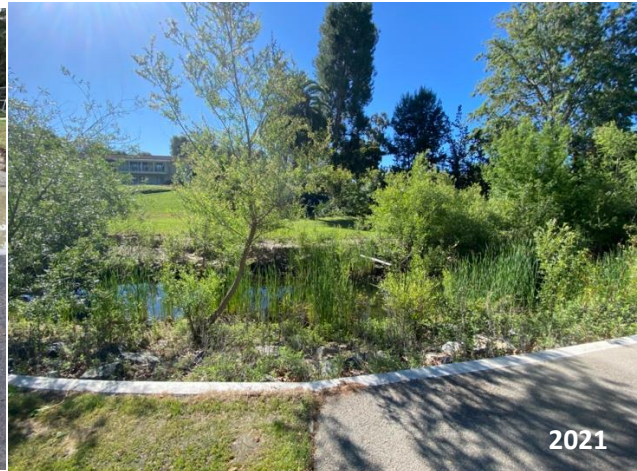
**Photo 3.**

Photo Station 2b. Photographs depicts the north side of the Creek facing southeast, across the creek. Photograph on left taken January 2015. Photograph on right taken April 2021.

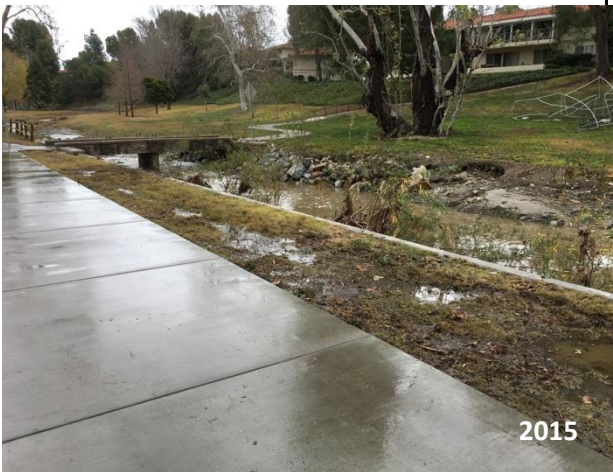
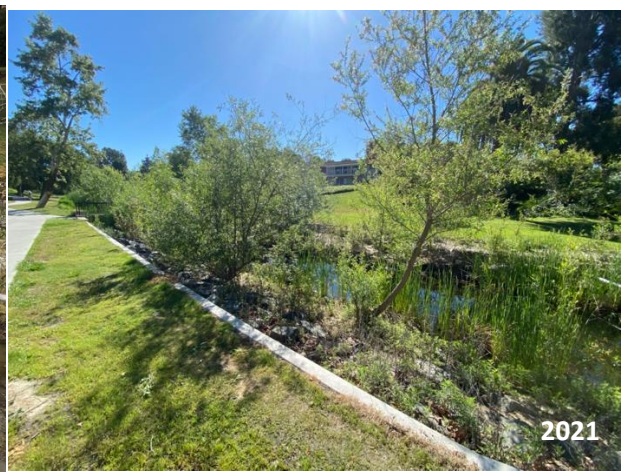
**Photo 4.**

Photo Station 2c. Photographs depicts the north side of the Creek facing northeast (upstream) towards bridge. Photograph on left taken January 2015. Photograph on right taken April 2021.

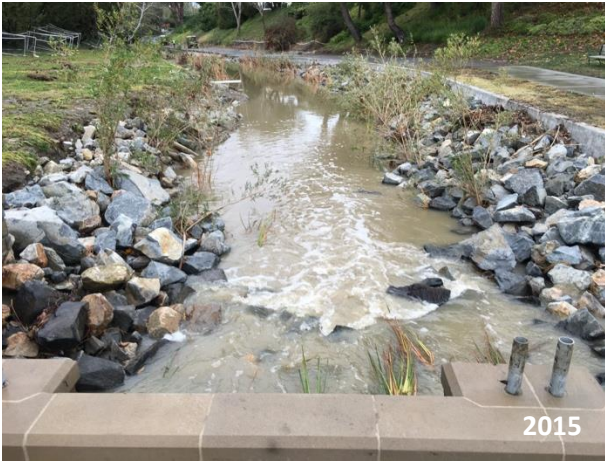
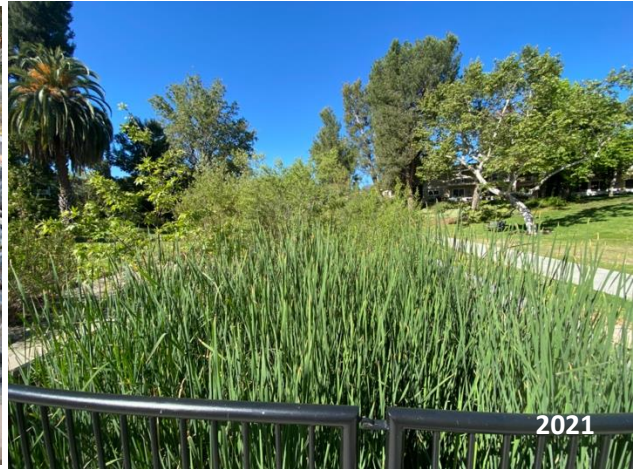
**Photo 5.**

Photo Station 3. Photographs taken on the bridge facing southwest (downstream). Photograph on left taken January 2015. Photograph on right taken April 2021.

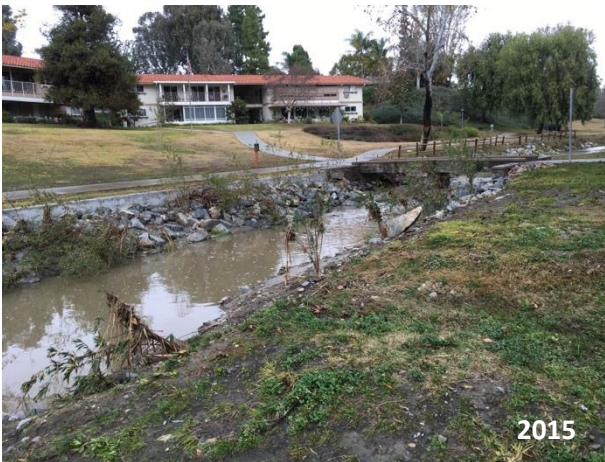
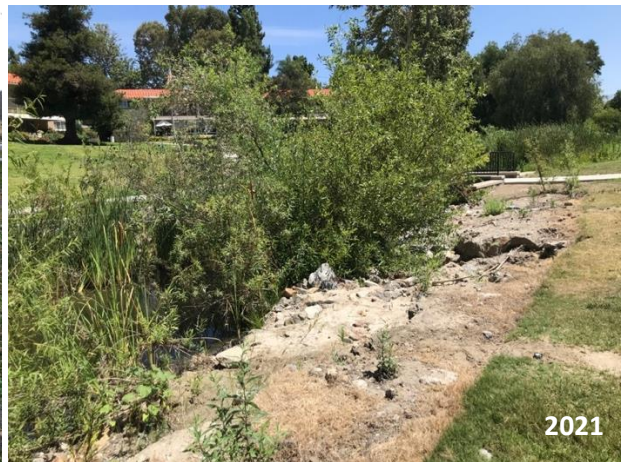
**Photo 6.**

Photo Station 4a (across the creek from Photo Station 2). Photographs depicts the south side of the Creek facing northeast (upstream). Photograph on left taken January 2015. Photograph on right taken April 2021.

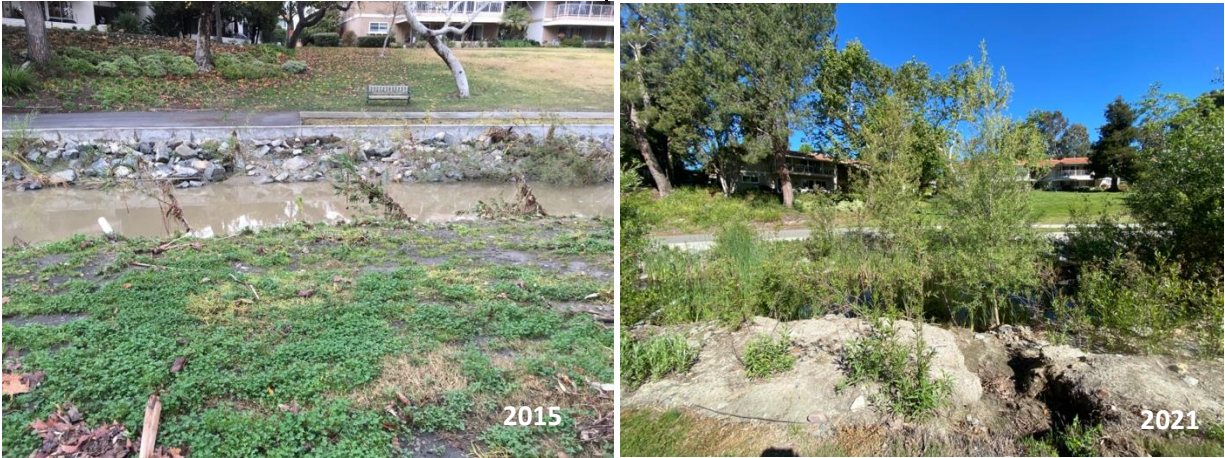
**Photo 7.**

Photo Station 4b (across the creek from Photo Station 2). Photographs depicts the south side of the Creek facing north, across the stream. Photograph on left taken January 2015. Photograph on right taken April 2021.

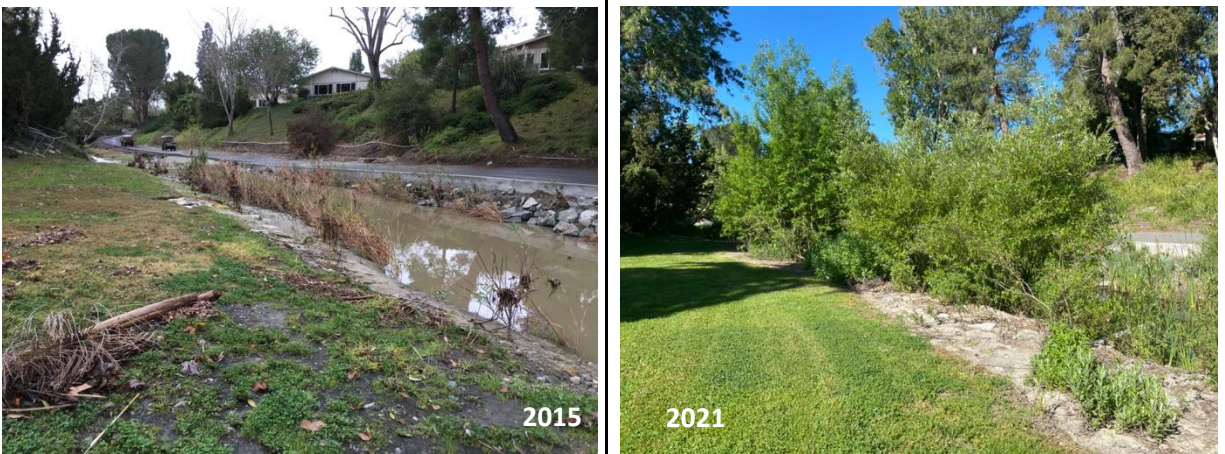
**Photo 8.**

Photo Station 4c (across the creek from Photo Station 2). Photographs depicts the south side of the Creek facing southwest (downstream). Photograph on left taken January 2015. Photograph on right taken April 2021.

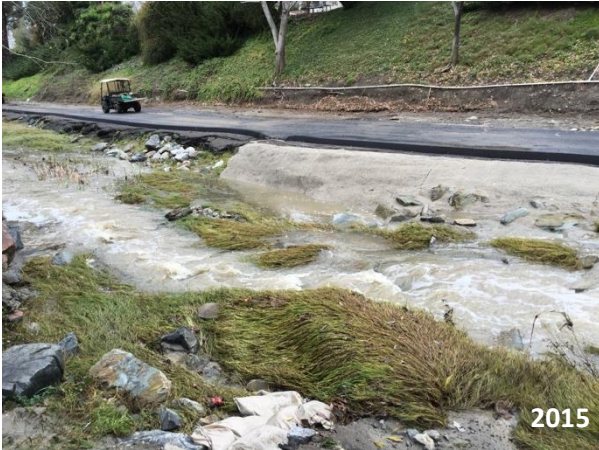
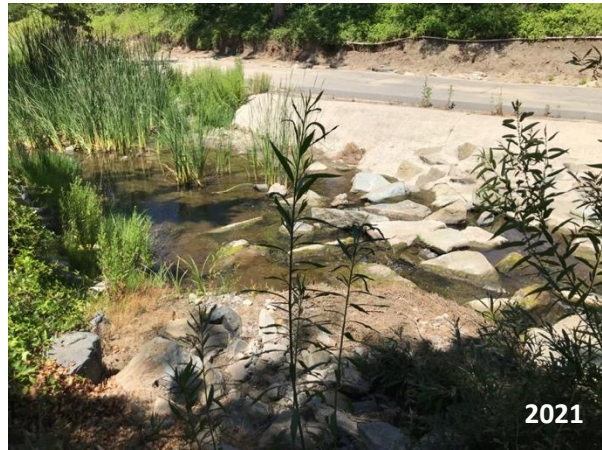
**Photo 9.**

Photo Station 5a. Photo depicts the westernmost edge of the restoration site facing south west (across and slightly down stream). Photograph on left taken January 2015. Photograph on right taken April 2021.

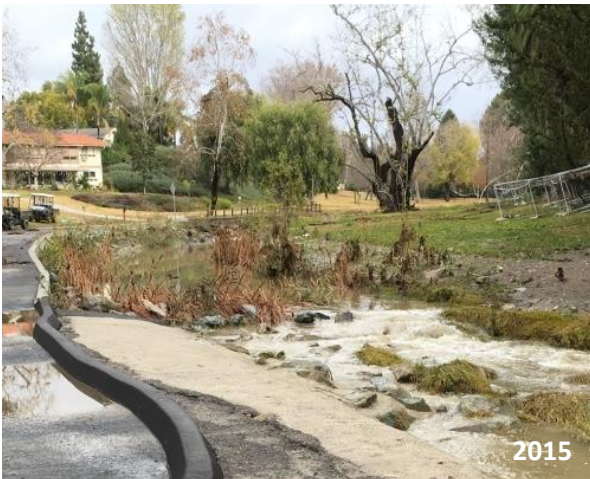
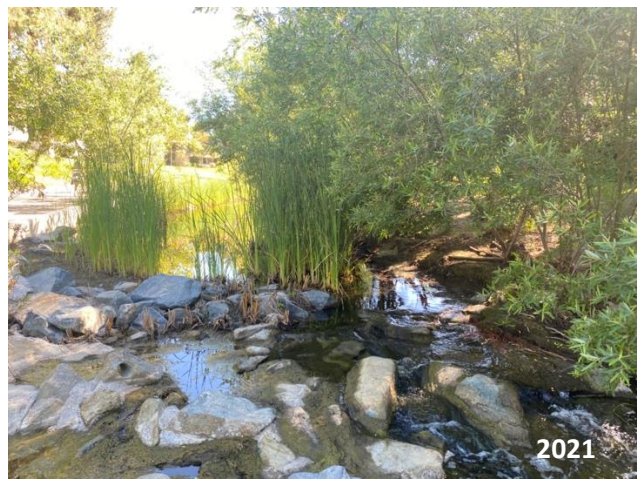
**Photo 10.**

Photo Station 5b. Photo depicts the westernmost edge of the restoration site. Photograph faces north side of creek, upstream and across the creek. Photograph on left taken January 2015. Photograph on right taken April 2021.

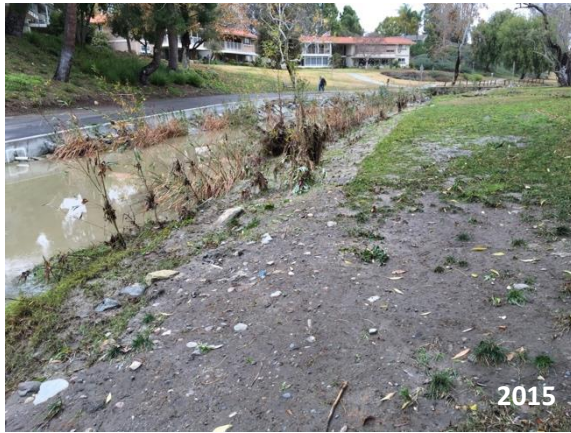
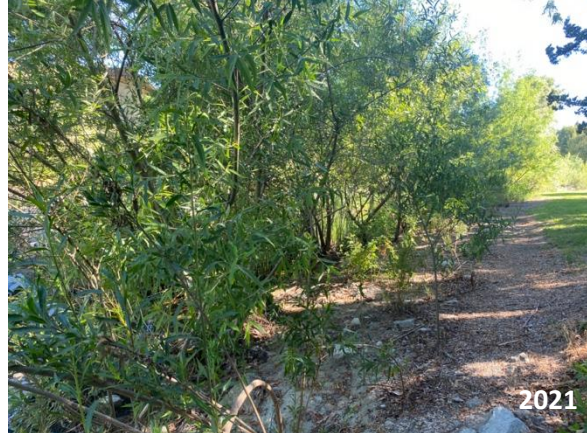
**Photo 11.**

Photo Station 5c. Photo depicts the south side of the Creek at the westernmost edge of the restoration site facing northeast (upstream). Photograph on left taken January 2015. Photograph on right taken April 2021.

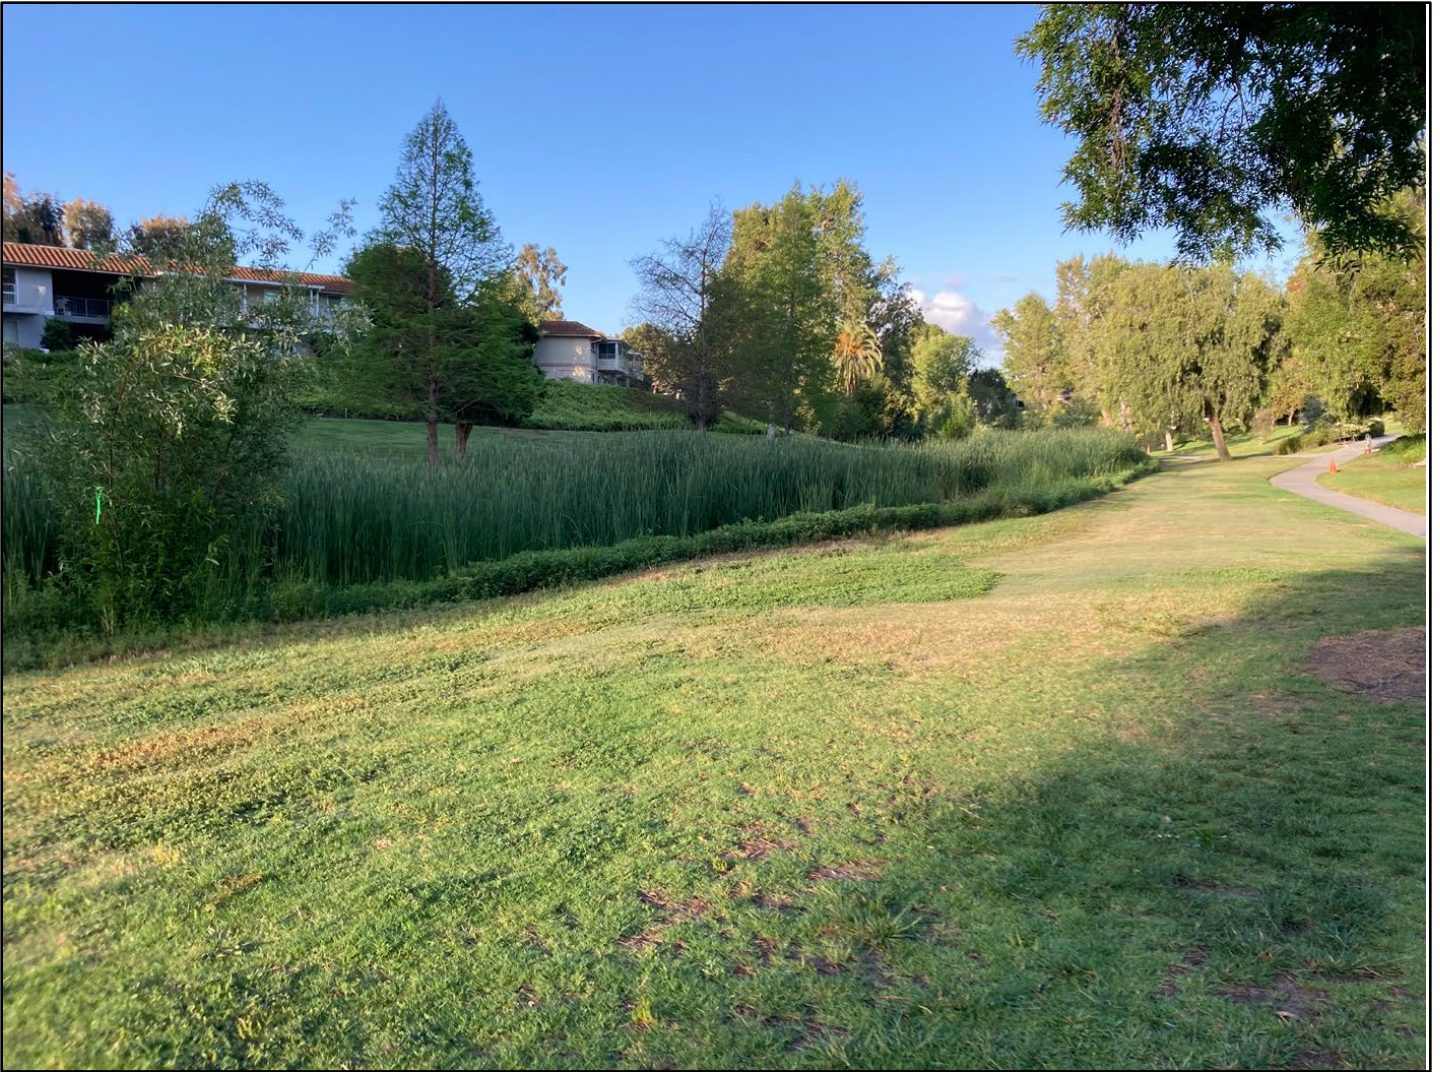
Cattails in the Creek (before)

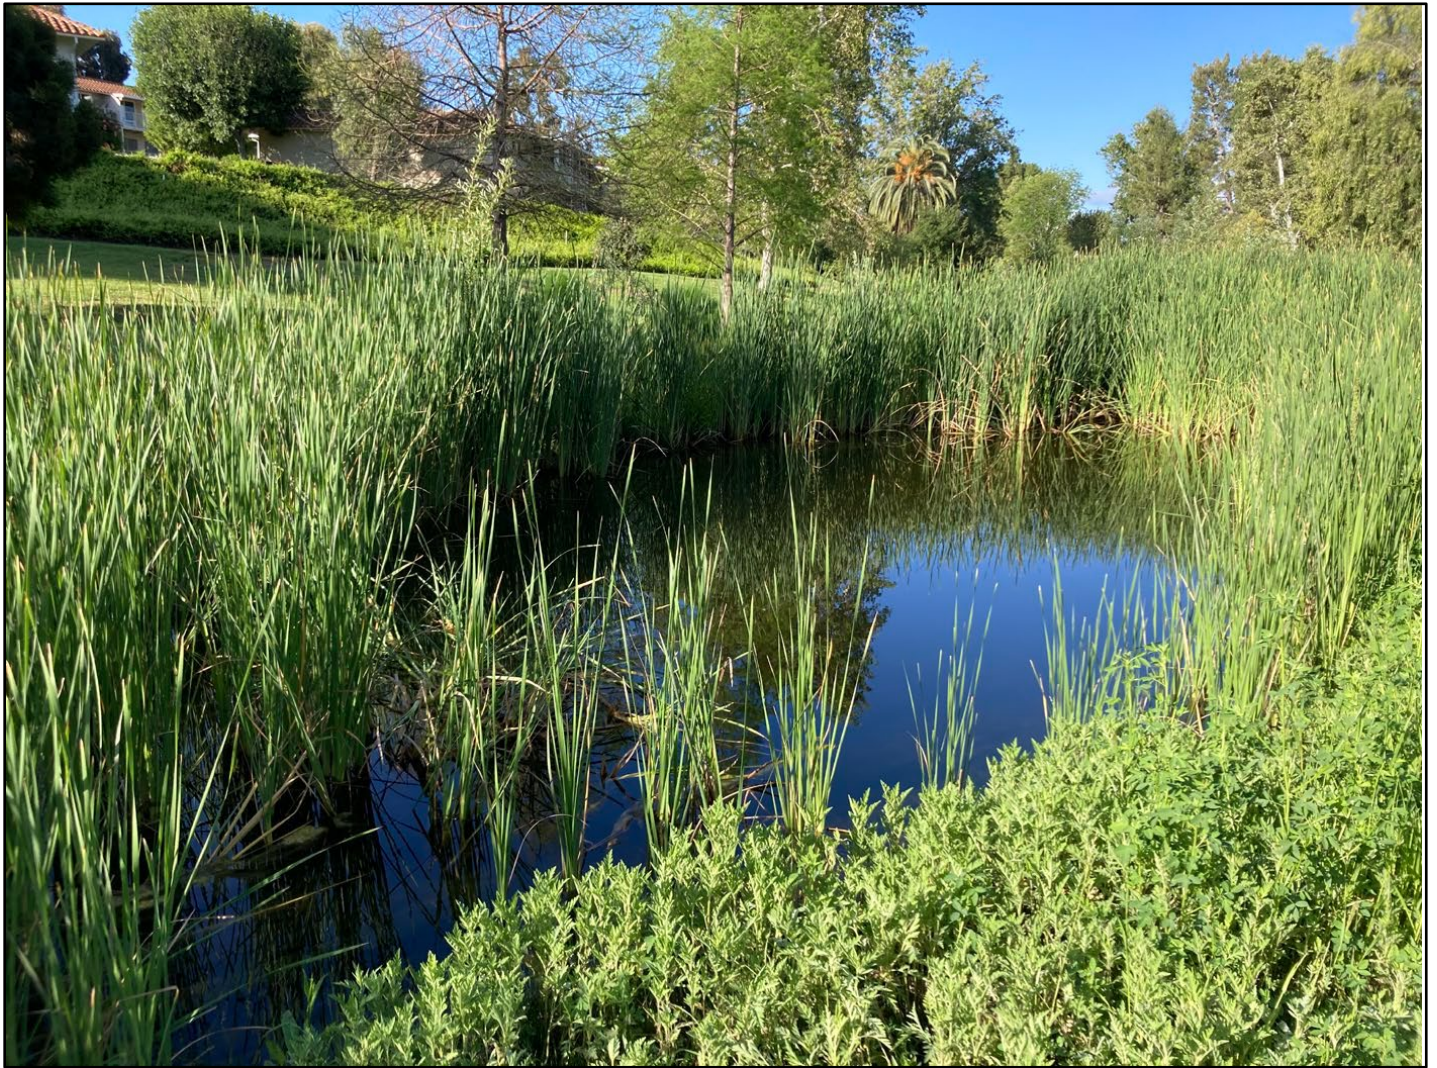
Cattails in the Creek (pond where Western Pond Turtle was originally found)

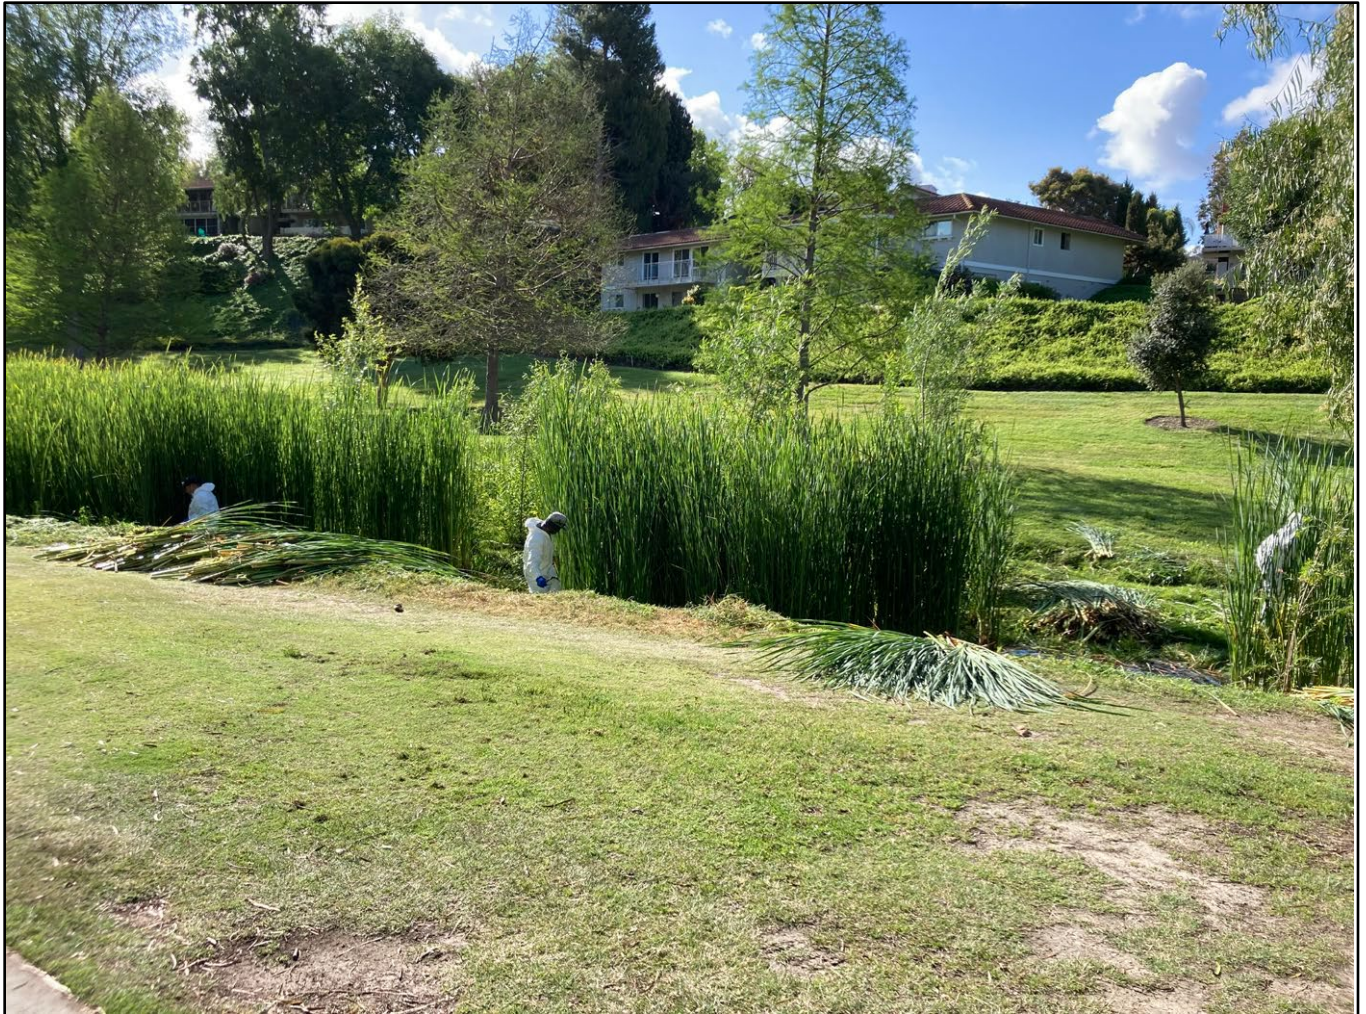
Cattails in the Creek (during crews cutting cattails)

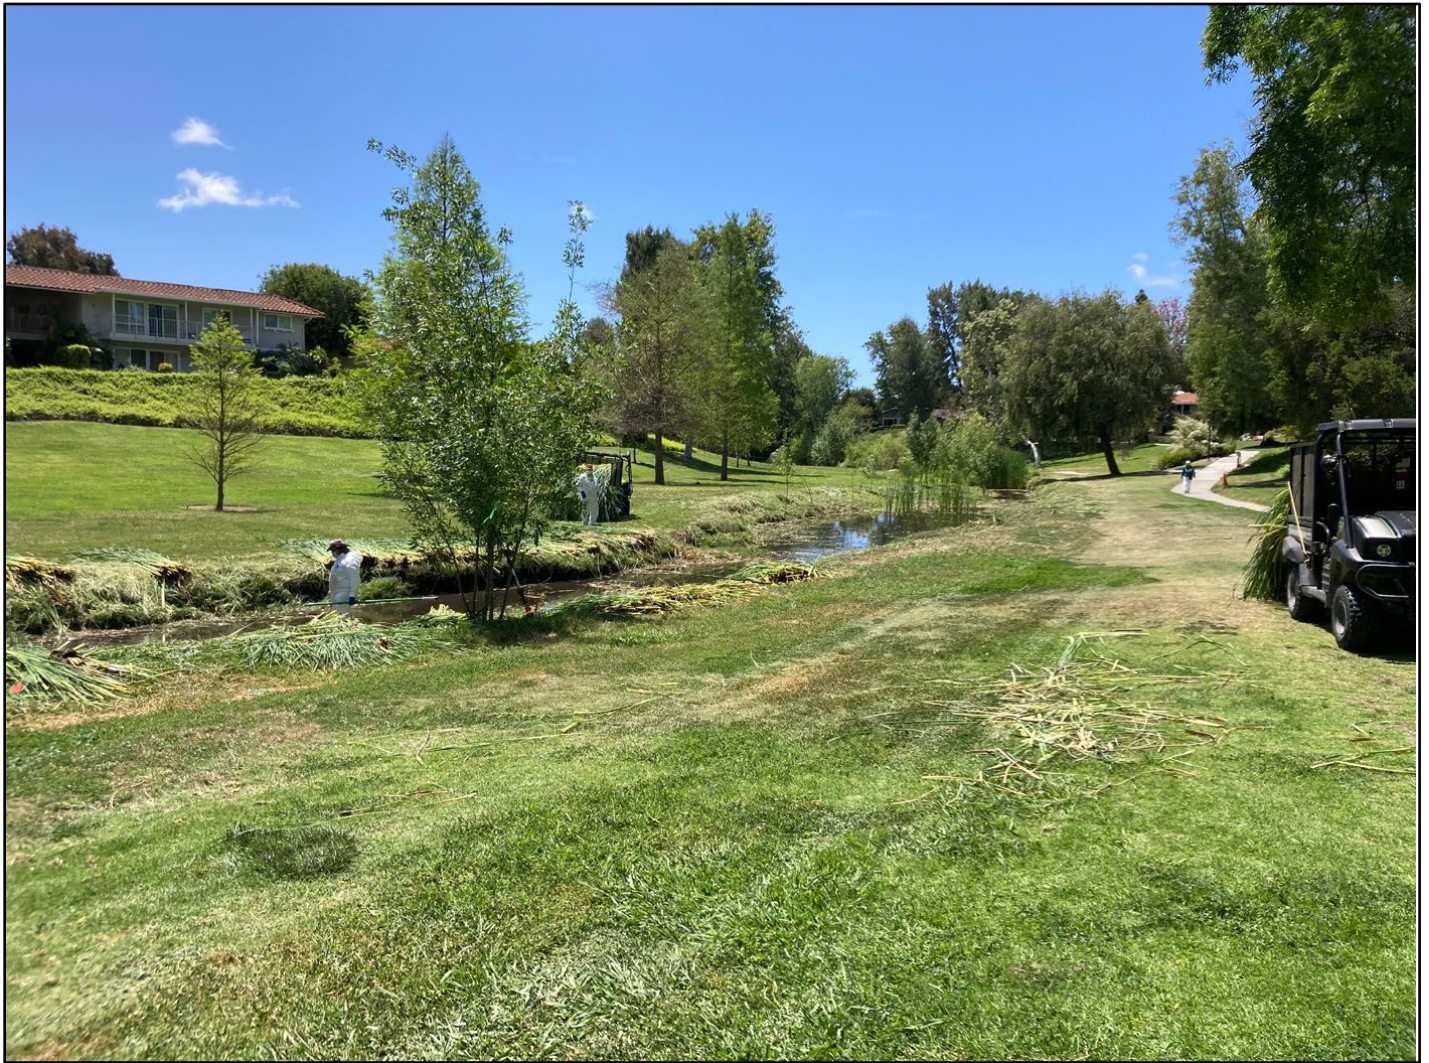
Cattails in the Creek (after)
