REGULAR MEETING OF THE THIRD LAGUNA HILLS MUTUAL MAINTENANCE AND CONSTRUCTION COMMITTEE

**Monday, November 1, 2021 at 1:30 PM
24351 El Toro Road – Board Room & Virtual with Zoom**

10. Alternatives to Mitigate Nuisance Seepage at Brazo and Calzado in Gate 11

Petra Geosciences, Inc. (Petra) is submitting herewith our geotechnical evaluation report regarding the water seepage conditions that have been noted at the toe-of-slope at the south end of Brazo and on the east side of Calzado within the Laguna Woods Village community. Our services were performed in accordance with the scope of services outlined in our Proposal No. 20-307P and our amendment No. 1, dated August 19, 2020 and March 5, 2021, respectively. This report presents the results of Petra's field investigation and laboratory testing, and provides our findings, conclusions and recommendations with respect to the nuisance seepage conditions with the subject site areas.

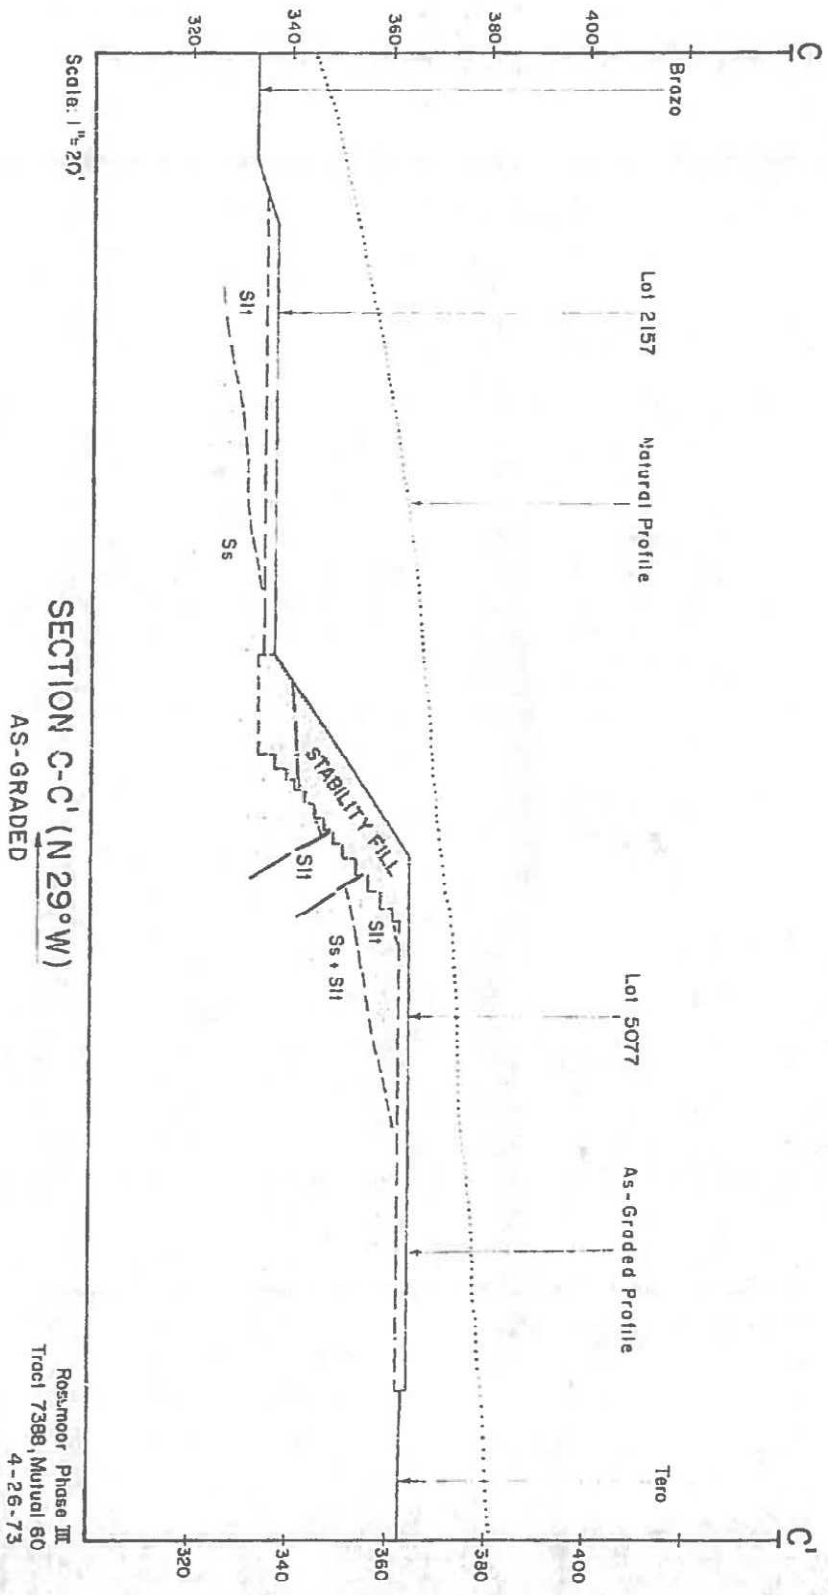
PETRA GEOSCIENCES	DATE: Sep., 2021	Figure 2
	J.N.: 20-307

Review of records at the County of Orange found many of the available map documents for the subject tract grading un-readable at the detail necessary for review. However, based on our interpretation of these documents it is our understanding that F. Beach Leighton & Associates (Leighton) performed observation and testing during rough grading of Tract 7388 from 1971 through 1973 (Leighton, 1973). Grading operations generally consisted of cutting the ridge areas and filling the canyon areas to design grades for development of single family residences. Groundwater seeps were encountered during grading within the canyons underlying the subject site areas (see Figure 2) . Prior to placement of compacted fill, the report

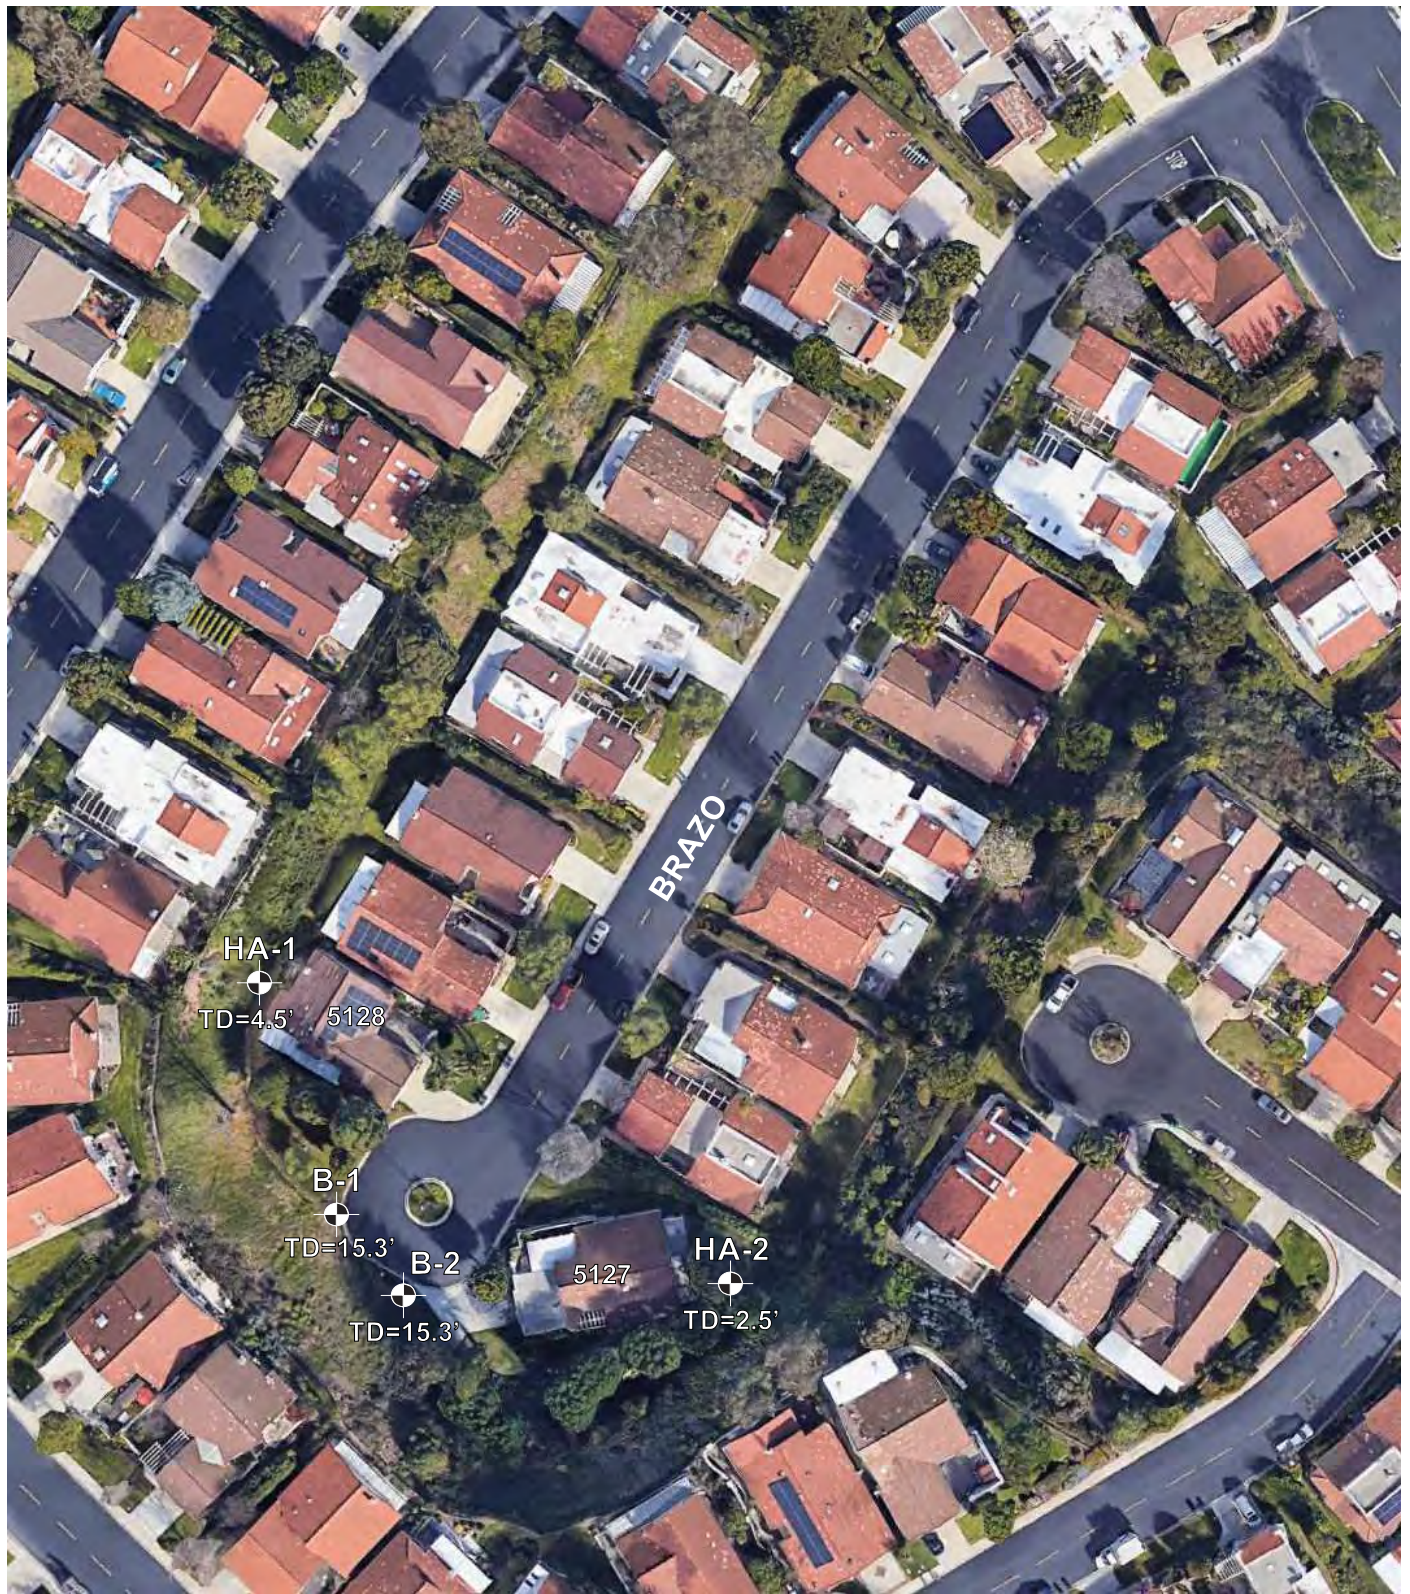
PETRA
GEOSCIENCES
DATE: Sep., 2021
J.N.: 20-307
Figure 3

Following rough grading of the subject tract Leighton (Leighton, 1973), reported the site was underlain by compacted fill that was in turn underlain by interbedded siltstone and sandstone bedrock of the Sespe Formation and alluvium where it was tested and approved if it was left in place. All cut slopes were excavated at a slope ratio of 1.5:1 (horizontal to vertical) and found to be geologically stable with the exception of the slope located at the rear (south) of the residence at 5127 Brazo (see Figure 3, Section C-C'). This slope was removed and replaced with a stability fill.

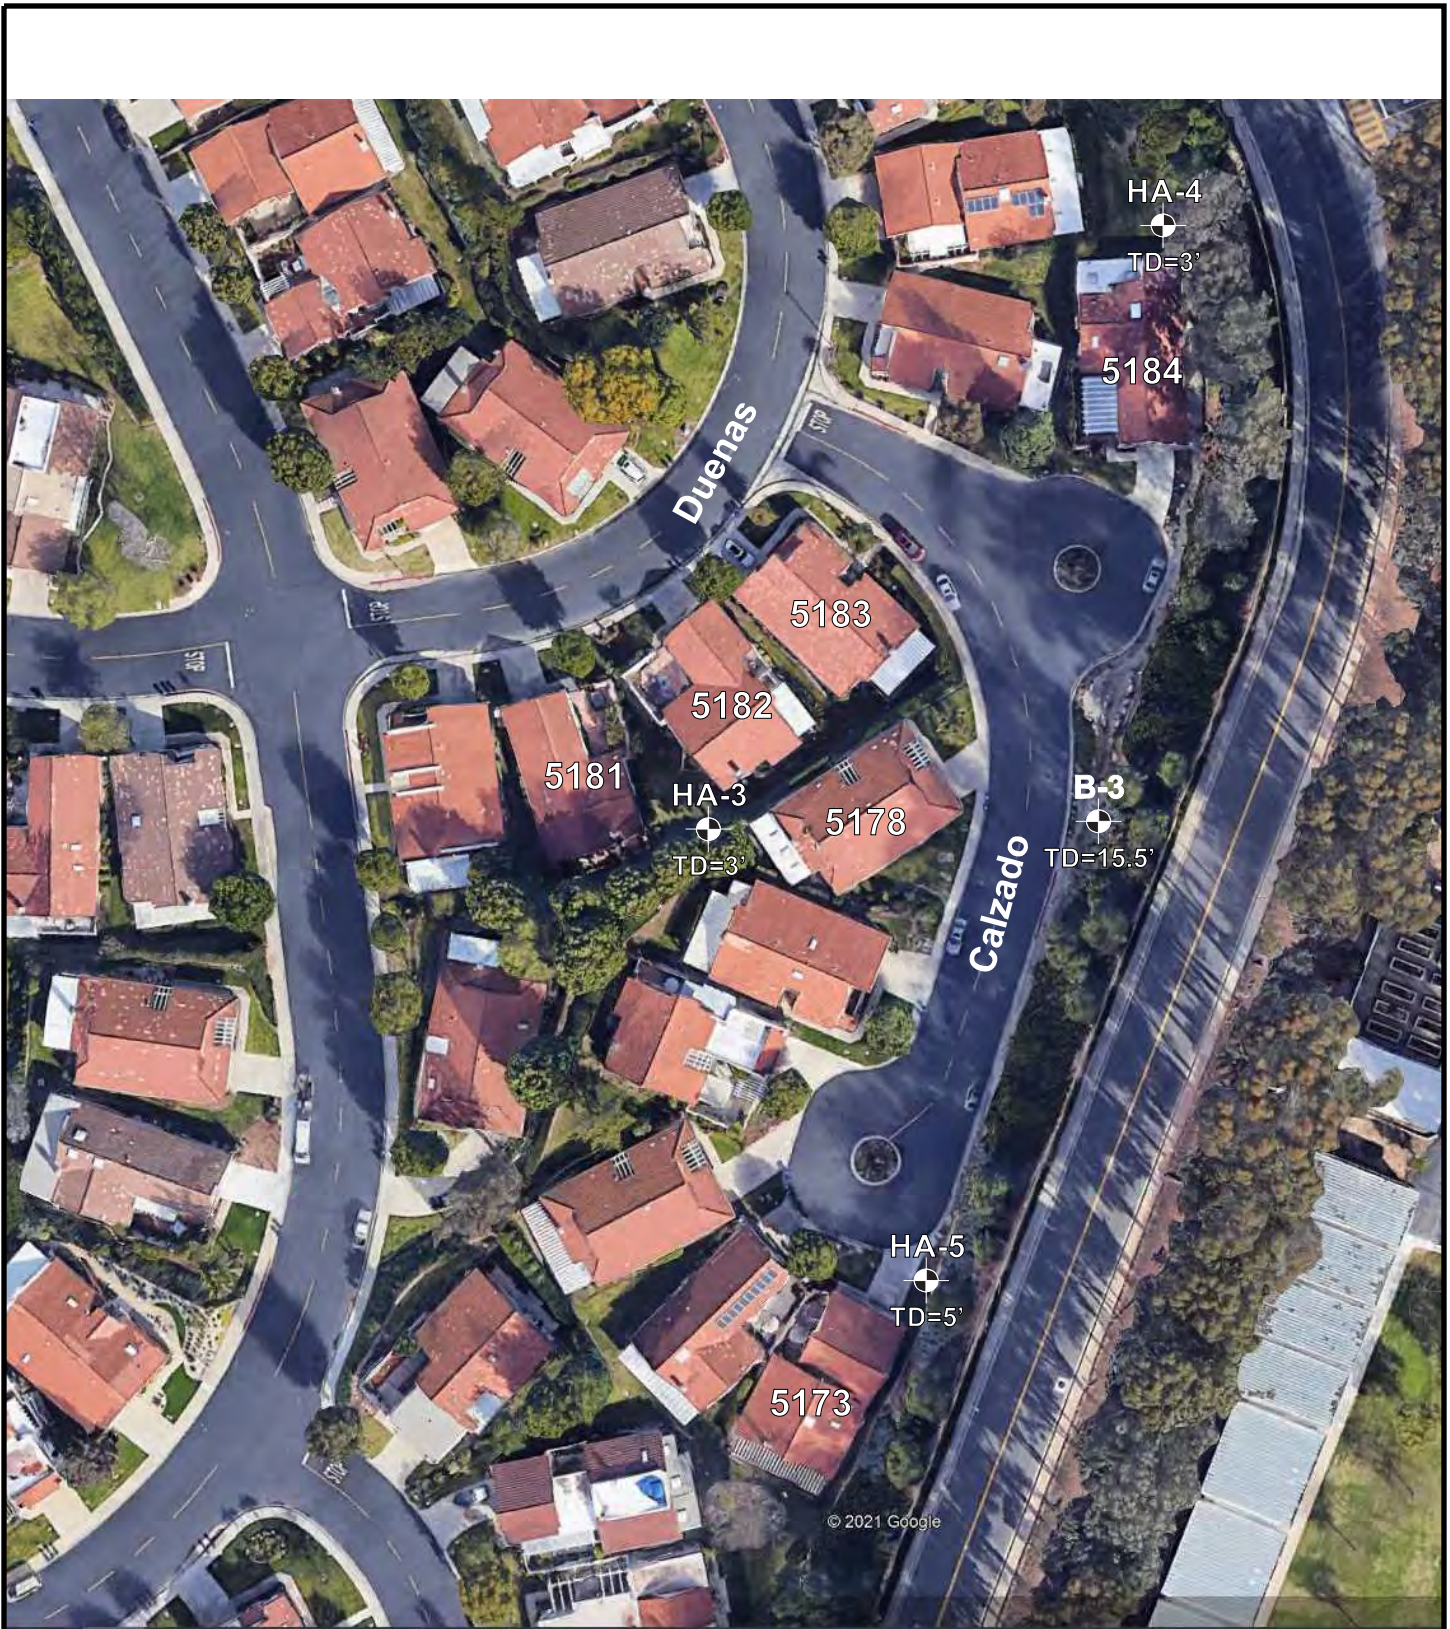
Figure 4

On May 25 & 27, 2021, a subsurface investigation was performed within the subject site areas of Brazo (Site 1) and Calzado (Site 2) to evaluate subsurface soil and groundwater conditions. Our subsurface investigation included the drilling of three exploratory hollow stem borings to a depth of approximately 15 feet below the ground surface utilizing a standard truck-mounted hollow-stem auger drilling rig. A temporary monitoring well was placed within the borings (identified herein as B-1 through B-3) for further monitoring. Additionally, five hand auger borings were also advanced within the areas not accessible by large equipment. The hand auger borings (identified herein as HA-1 through HA-5) were advanced to depths ranging from 2 to 5 feet in depth. Boring locations are shown on the attached Boring Locations Maps (Figures 4 & 5).

After drilling was complete and the drill augers were removed from the borings, water was immediately observed seeping into boring B-1. Immediately after drilling B-1, water was measured 14 feet below the ground surface. After one hour had elapsed, water had reached the surface and was running off into the street. Borings B-2 and B-3 both encountered heavy seepage during drilling. After drilling had been completed and the augers were removed from both borings B-2 and B-3, water had already risen to the surface and was running off into the surrounding landscaping. Within borings B-1 & B-2, it was observed that the water appeared to be infiltrating into the borings along the fill/bedrock contact. Water infiltration within B-3 was so vigorous and immediate that determining where the water was coming from was deemed inconclusive. Water was also encountered within HA-1 and HA-5. All the other hand auger borings were relatively dry at the time the borings were advanced to their total depths. See Appendix A for detailed boring logs.
