**REGULAR MEETING OF THE  
THIRD LAGUNA HILLS MUTUAL  
WATER CONSERVATION SUB-COMMITTEE**

**Monday, October 14, 2019 – 1:00 P.M.  
Laguna Woods Village Community Center Sycamore Room  
24351 El Toro Road**

Landscape Irrigation Survey Provided By:

Agenda Item #8

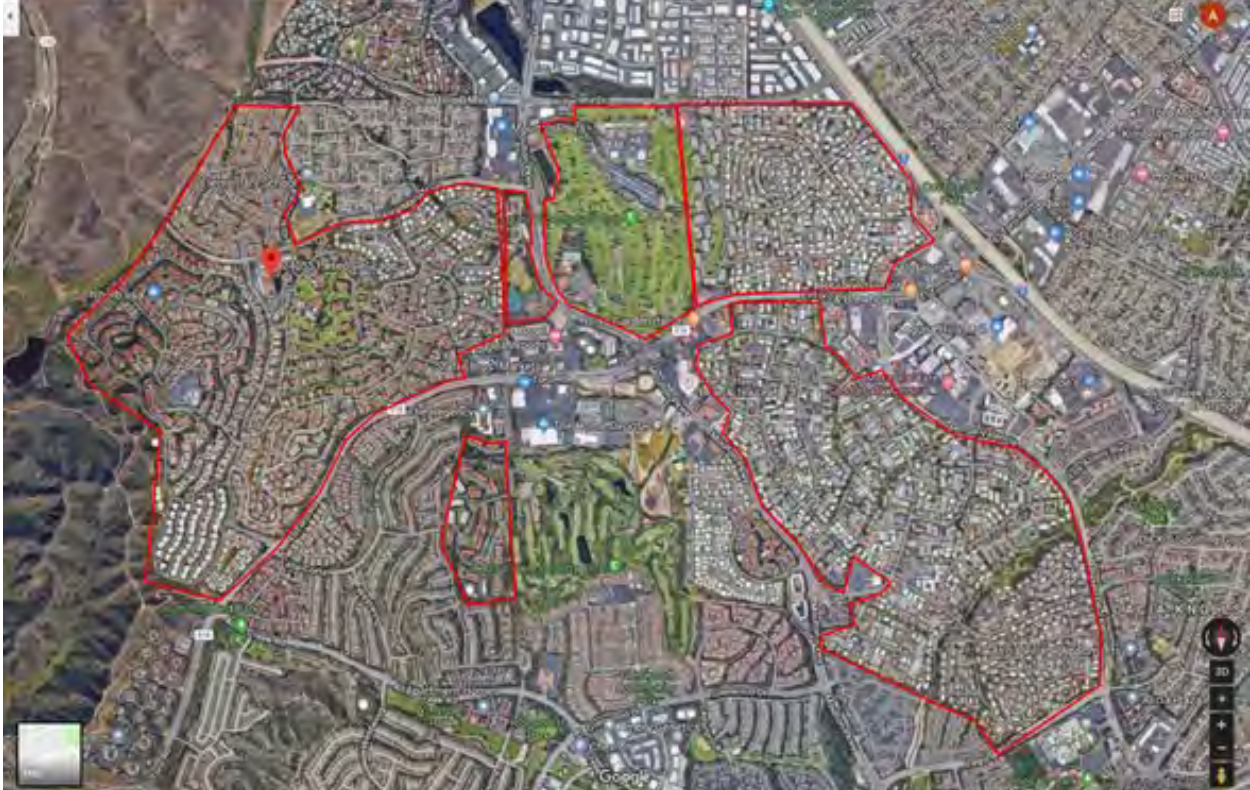
*Aerial Photograph of Laguna Woods Village. Source: Google Earth.*

The representative site surveyed is irrigated with six conventional irrigation controllers that do not currently use soil or moisture sensors. The soil type at this facility is predominantly clay-loam with high water retention, and moderate to low water-infiltration characteristics. The Laguna Woods Village landscape is made up of lawn, planter, and tree areas. The landscaped areas vary between high microclimates with full sun to medium microclimates with partial sun and shade throughout the day for areas next to trees. There are gentle, medium, and steep slopes throughout portions of the landscape but most of the site is comprised of flat landscaped areas.

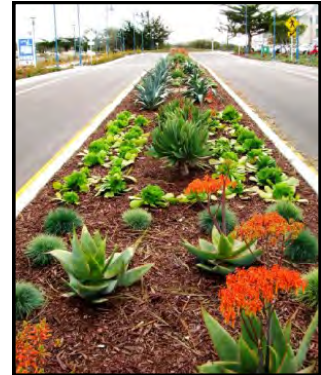
*Example of low water use plants in a median area.*

The surveyor estimated 32,000 square feet of unused grass areas in the HOA that could be replaced with low water use plants. When installed in conjunction with a rotary nozzle irrigation system, these plants will use less water than the existing turf area.

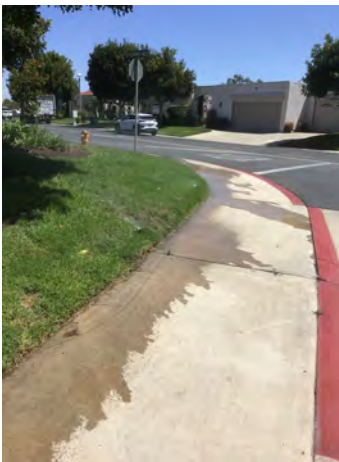
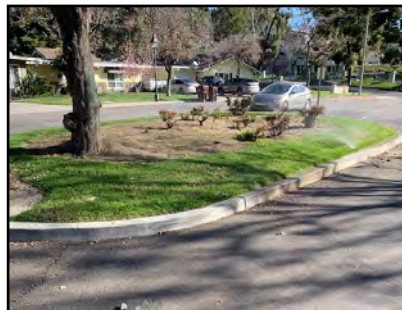
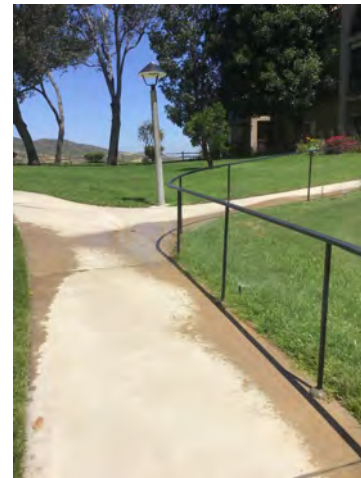
*Parkways and small turfgrass patches are prone to overspray from sprayhead nozzles; these are ideal areas to replace with low water-use plants.*

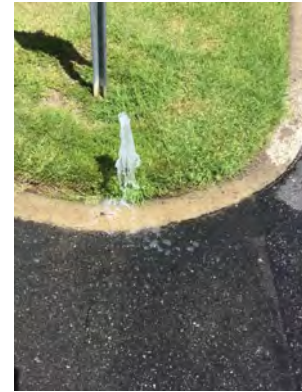
Broken sprinkler head

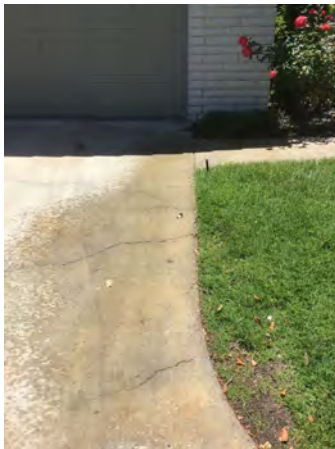
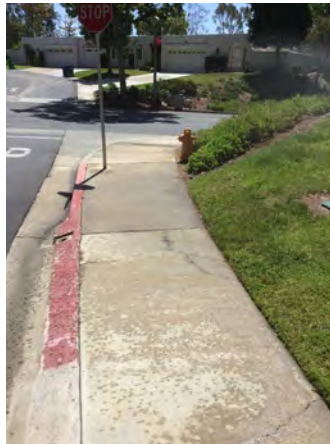
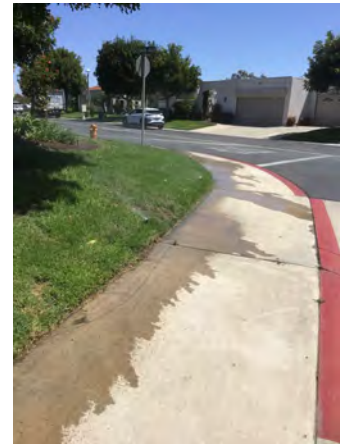
The WaterWise inspection team was able to locate 50 irrigation problems at this site, including clogged (11), blocked (1), arc-misaligned (4), overspraying (33), & tipped (1) sprinkler heads.

Wet sidewalk areas from overspraying sprayheads

Problems found during the inspection were immediately fixed by crew. We recommend fixing all irrigation issues within a times manner in order to avoid water waste.

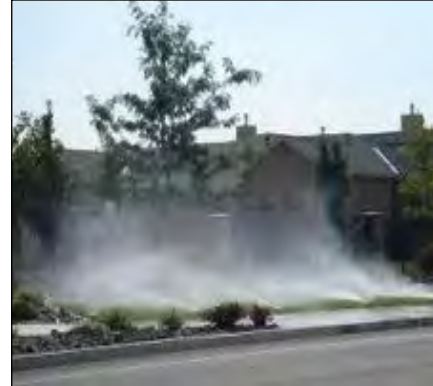
During the inspection, WaterWise identified a total of 822 spray-type sprinkler nozzles irrigating turf and planter areas. We recommend replacing 253 spray nozzles in the turf areas (which could also be replaced with low water-use plants) with more efficient rotary spray nozzles.

*Example of  
Sprayhead Bodies Misting*

Rotary nozzles deliver increased efficiency over standard spray head installations by lowering the standard precipitation rate to a half inch per hour, or less. These nozzles are designed to use less water and reduce run off. On slopes and clay-like soils, a lower application rate allows water to soak into the landscape instead of creating runoff and misting. Matched precipitation rates per zone results in better distribution uniformity and properly scheduled runtimes.

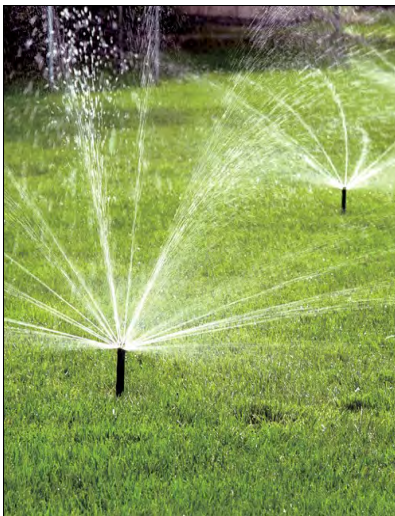
*Rotary Nozzles for Sprayhead Bodies*

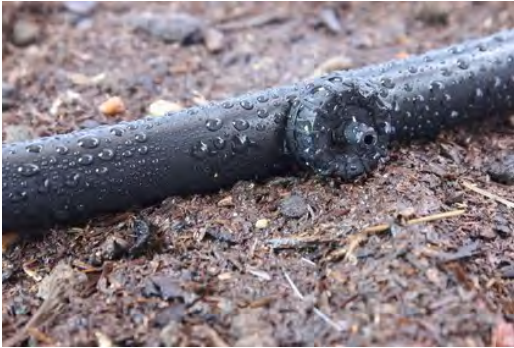
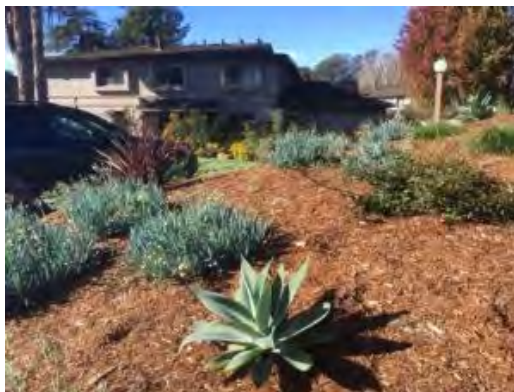
*Drip irrigation is excellent for low water-use areas*

Drip irrigation is a very efficient system that targets precise areas of landscape in order to avoid runoff, misting, drifting, and other problems related to sprinkler heads and overhead irrigation. Proper installation of a drip system requires careful design and proper devices such as filters, pressure regulators and air relief valves.

The surveyor noted that a number of stations would greatly benefit from drip irrigation. Other irregular-shaped, narrow, or tree-dense areas are excellent areas for drip irrigation. Sprayheads can inefficiently water trees and shrubs; sprayhead throws may water mulch and dirt areas and not effectively reach the root zones.

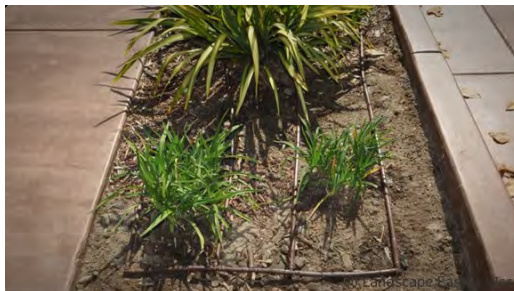
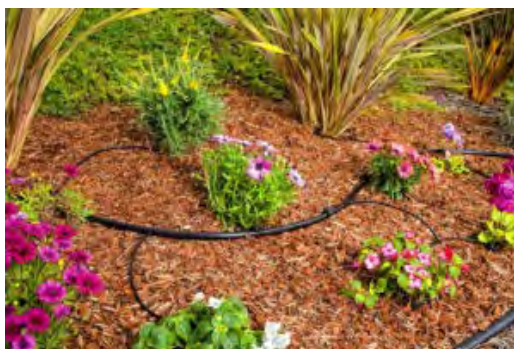
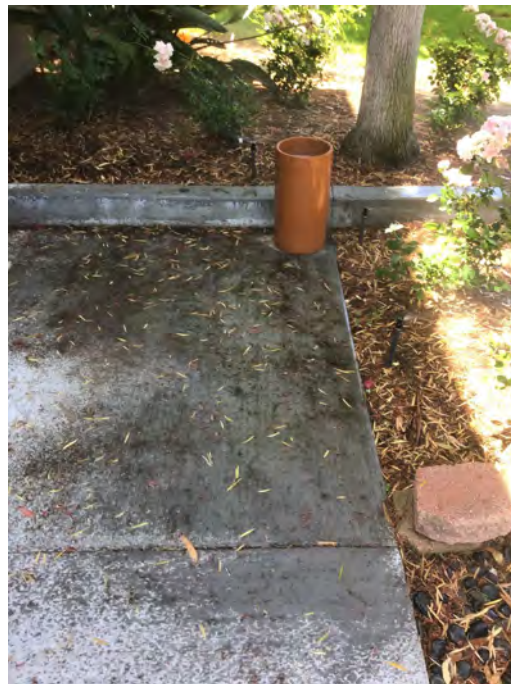
*Example of a narrow area within Laguna Woods Village that would benefit from drip irrigation*

\*Cost to redesign with Drip Irrigation is estimated at \$0.24 per square foot; labor and installation cost is not included.

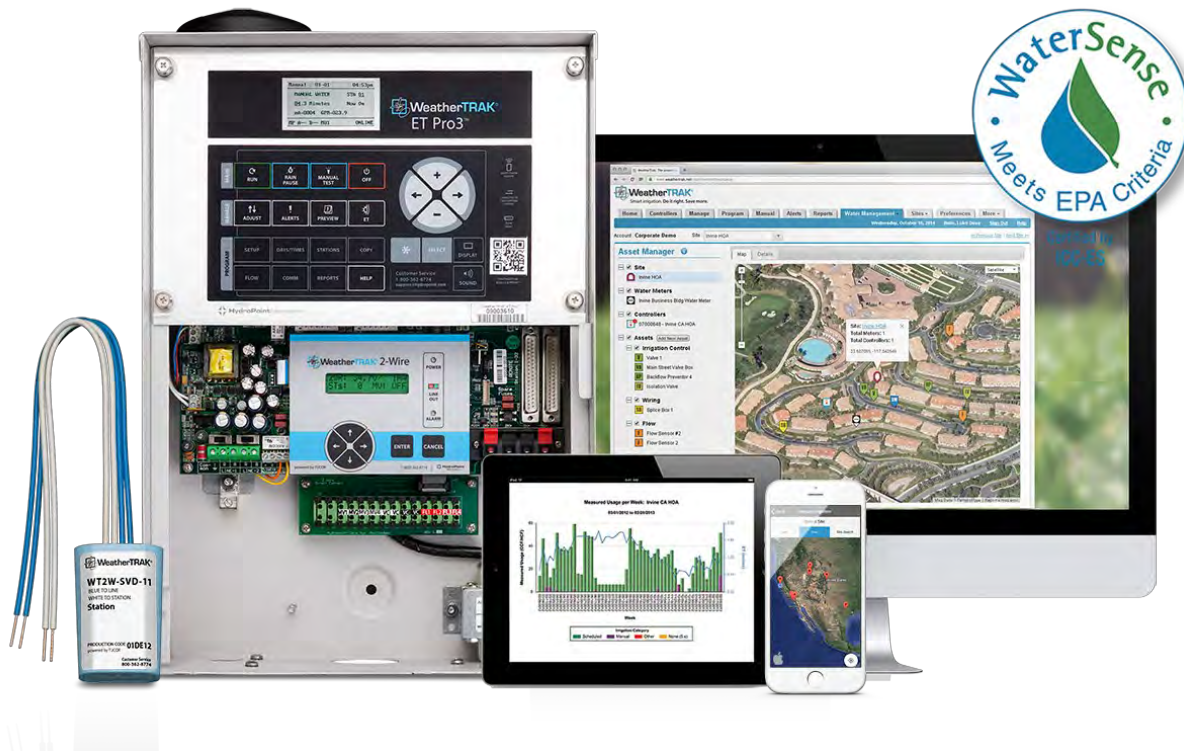
Weather Based Irrigation  
Controller (Smart Controller) and Central Control System Software

The irrigation system surveyed (as a representation of the larger site) has six conventional irrigation controllers which could be upgraded with new smart controllers which can be managed through a central control system. We recommend utilizing the weather-based functions & central control software for increased water savings.

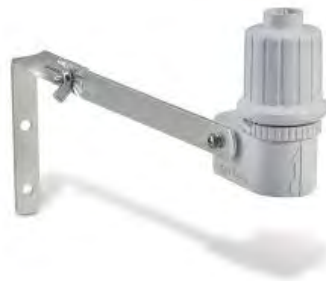
*Rain Sensor*

We recommend adding rain sensors to the existing conventional or new controllers irrigation controllers.

Rain Sensors can be purchased at most irrigation supply distributors. Rain sensors are estimated to cost approximately \$40 per unit.

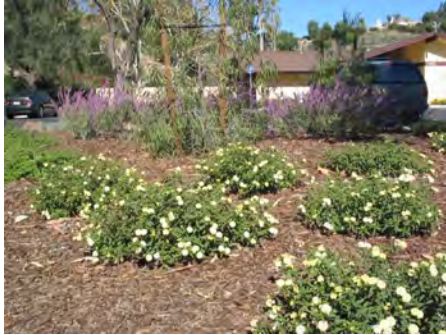
### Apply Mulch to Planters

Applying mulch, especially organic mulch, over planters with bare soil has many benefits. A cover of mulch helps retain moisture in the soil by reducing evaporation, helps to keep the temperature of the soil cool in summer, and helps to suppress weed growth. In some cases, mulch may also help to reduce runoff from planters located on sloping terrain.

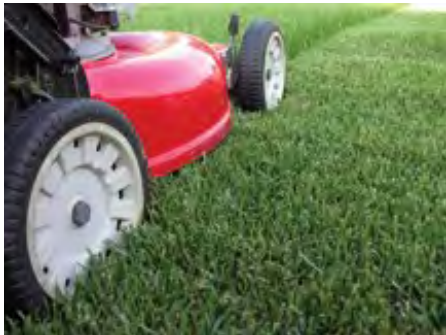
### Proper Mower Height

Lawn that is mowed too low will need more water. Raising the mowing height, on the other hand, will shade the soil surface and decrease the amount of evaporation. Use the 1/3 rule: mow often enough so that no more than one third of the turfgrass shoot (stem and blade) is removed at any one time. The table below provides the recommended mowing heights of commonly used lawns in California (provided by UC Cooperative Extension).

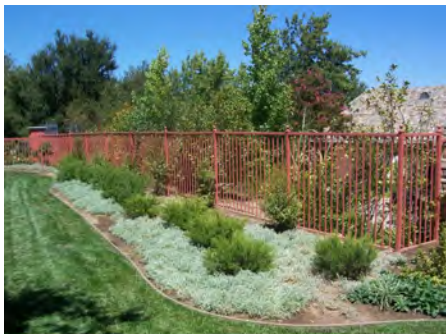
### Hydrozones

Hydrozoning is a design process that involves creating zones in the landscape that are irrigated independently. Each of these zones has plant materials with similar water and exposure needs. If hydrozones are not set and a landscape area has a mixture of plants with varying water needs, it will be difficult to water that zone properly because some plants will be under-irrigated, while others may be over-irrigated.

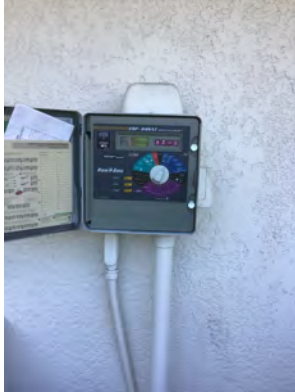
#### Controller One

Controller One at this site is a RainBird ESP-24SAT conventional irrigation controller. This controller is a 24 station model. At the time of the survey there were 24 active and 24 programmed irrigation stations. 10 of these stations were energized and inspected, as a representative survey of the areas. The controller is in good condition and is working properly. This controller is located at 3212 Via Carizo.

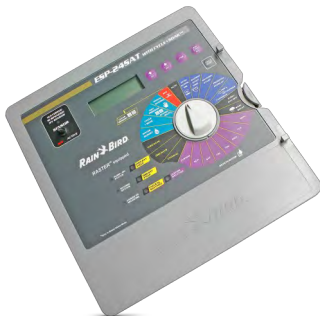
#### Controller Two

Controller Two at this site is a RainBird ESP-24SAT conventional irrigation controller. This controller is a 24 station model. At the time of the survey there were 18 active and 18 programmed irrigation stations. 10 of these stations were energized and inspected, as a representative survey of the areas. The controller is in good condition and is working properly. This controller is located at 3500 Bahia Blanca.

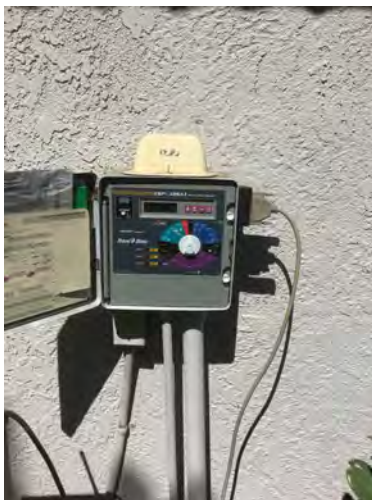
#### Controller Three

Controller Three at this site is a RainBird ESP-34SAT conventional irrigation controller. This controller is a 32 station model. At the time of the survey there were 28 active and 28 programmed irrigation stations. 10 of these stations were energized and inspected, as a representative survey of the areas. The controller is in good condition and is working properly. This controller is located at 4013 Calle Sonora.

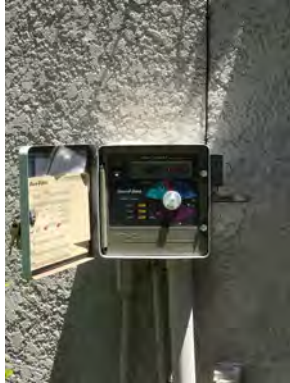
#### Controller Four

Controller Four at this site is a RainBird ESP-32SAT conventional irrigation controller. This controller is a 32 station model. At the time of the survey there were 32 active and 32 programmed irrigation stations. 10 of these stations were energized and inspected, as a representative survey of the areas. The controller is in good condition and is working properly. This controller is located at 5279 Pina.

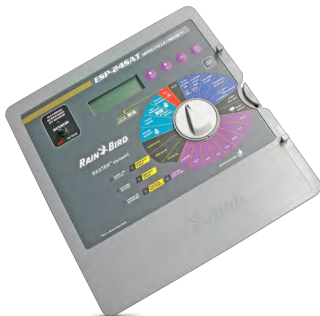
#### Controller Five

Controller Five at this site is a RainBird ESP-24SAT conventional irrigation controller. This controller is a 24 station model. At the time of the survey there were 24 active and 24 programmed irrigation stations. 10 of these stations were energized and inspected, as a representative survey of the areas. The controller is in good condition and is working properly. This controller is located at 5004 Duverney.

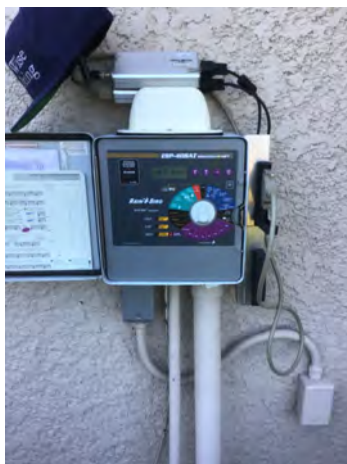
#### Controller Six

Controller Six at this site is a RainBird ESP-404SAT conventional irrigation controller. This controller is a 40 station model. At the time of the survey there were 40 active and 40 programmed irrigation stations. 10 of these stations were energized and inspected, as a representative survey of the areas. The controller is in good condition and is working properly. This controller is located at 3420 Calle Azul.

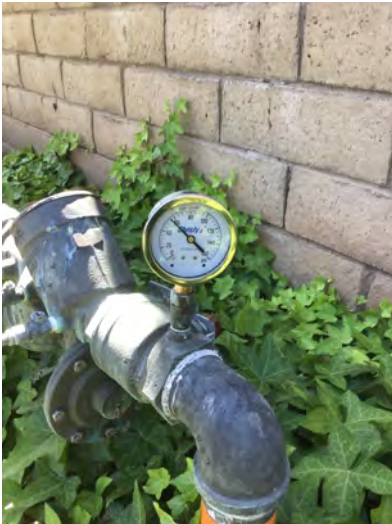
This is a 2" backflow preventer for a landscape irrigation system located within the Laguna Woods Village community. It is a Zurn Wilkins Reduced Pressure Principle Assembly or Reduced Pressure Zone (RPZ) type. The RPZ is installed 12" above ground level. The RPZ provides anti-siphon and anti-backpressure vacuuming and ideal for multi-zone irrigation systems. A pressure test measured the irrigation line for this system at 57.5 psi.

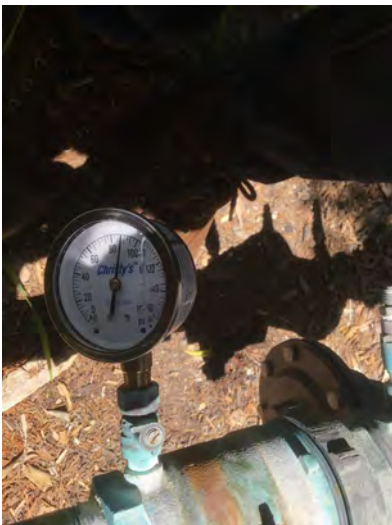
A pressure test measured the irrigation line for this system at 87.5 psi.

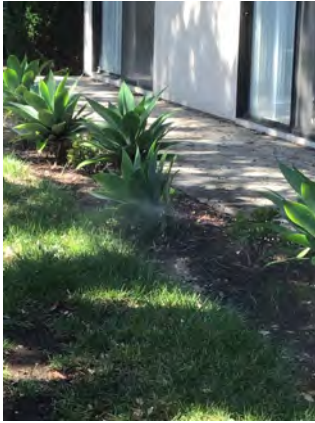
**Problem:** One sprinkler heads was found to have it's watering throw blocked by turfgrass and/or plants which greatly affects distribution uniformity.

**Solution:** We recommend adequate de-thatching and mowing around sprinkler heads to help provide clearance for sprinkler throws.

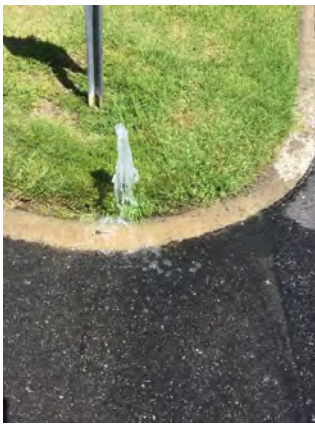
**Problem:** There were broken and leaking sprinklers throughout the survey. Broken/leaking sprinklers/pipes can be attributed to damage, tree roots, high pressure, and wearing of parts.

**Solution:** Broken and leaking sprinklers/pipes need to be repaired immediately as they are wasting significant amounts of water and causing pressure loss in the system. **These issues were repaired immediately during the inspection and not added to total.**

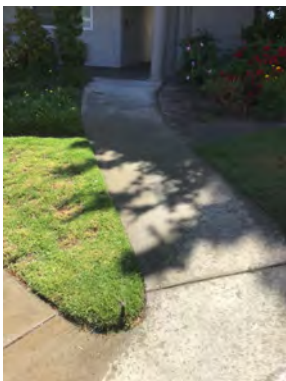
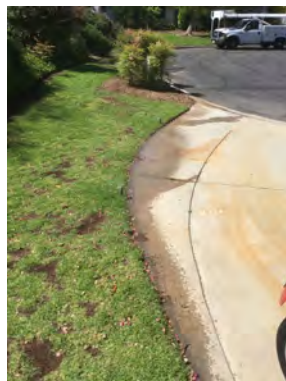
**Problem:** There were 33 sprinkler heads (4 arc-misaligned) that oversprayed on to impermeable surfaces. Overspray can cause improper water distribution onto hardscaped areas such as walls, sidewalks, patios, and driveways.

**Solution:** We recommend adjusting the **arc/radius** of the sprinkler head in order for water to be distributed onto the proper landscaped areas.
