Laguna Woods Village Clubhouse 1

EXECUTIVE SUMMARY

FACILITY CONDITION ASSESSMENT
Laguna Woods Village

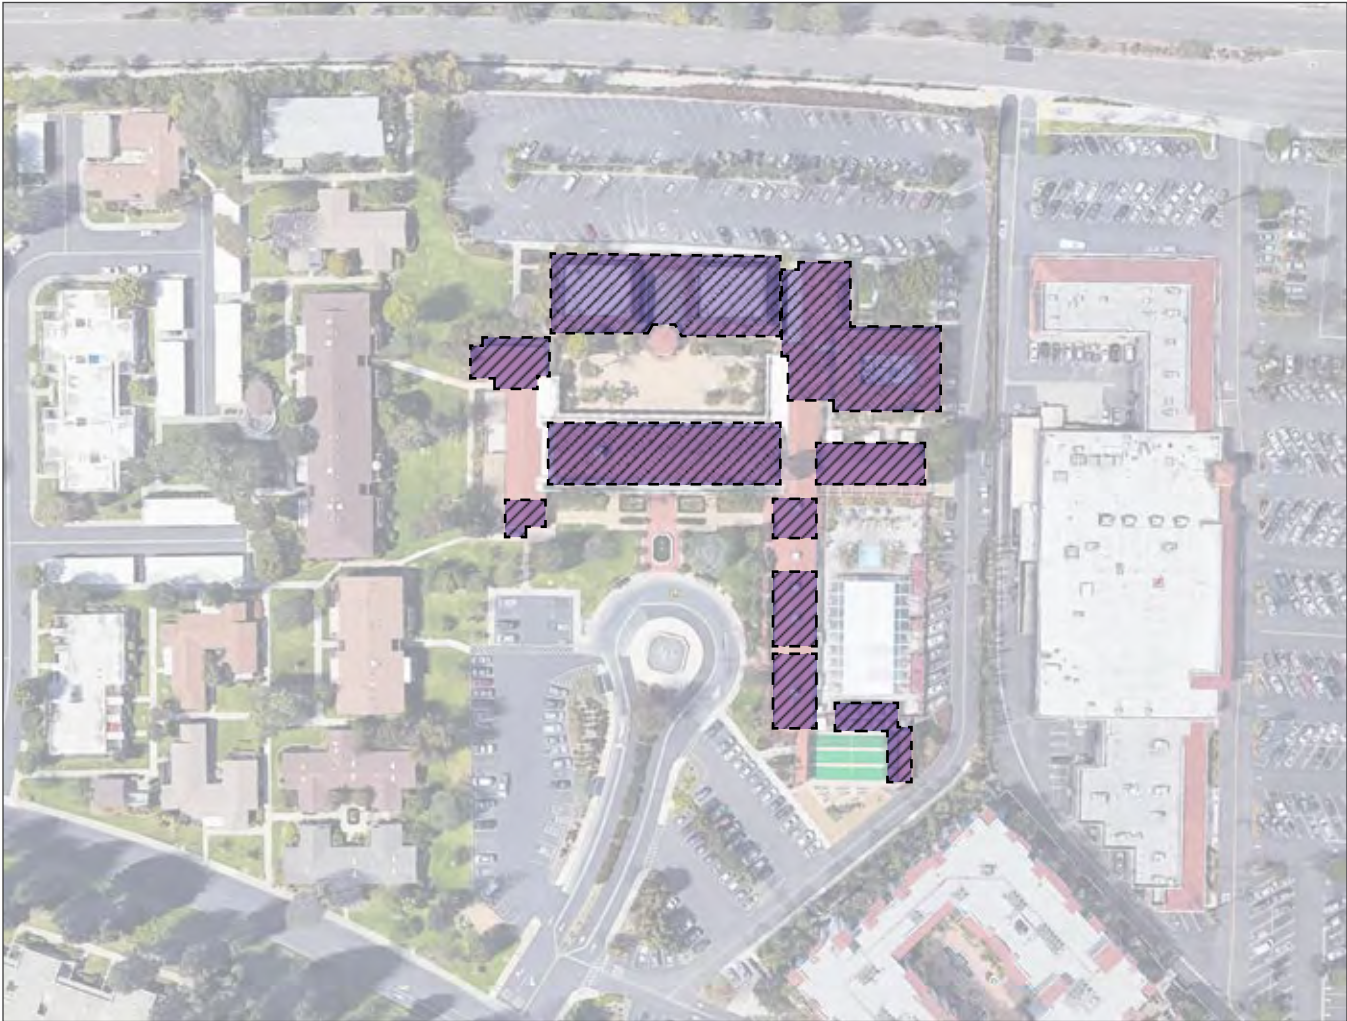
Option 1 — Proposed Renovations

RENOVATION / MODERNIZATION

Having been constructed during the 1960s most of the Clubhouse1 buildings will need some level of seismic retrofit. For example, the Main Lounge will need a significant seismic retrofit that includes adding plywood sheathing at the roof, anchor bolts to the framed walls, and improving shear wall nailing on the existing plywood. The two Shuffleboard Buildings will need extensive retrofitting that will include replacing beams, strengthening steel columns, upgrading shear walls and concrete foundation work. The other buildings will need minimal retrofit – please refer to the Structural Assessment section for additional information and recommendations.

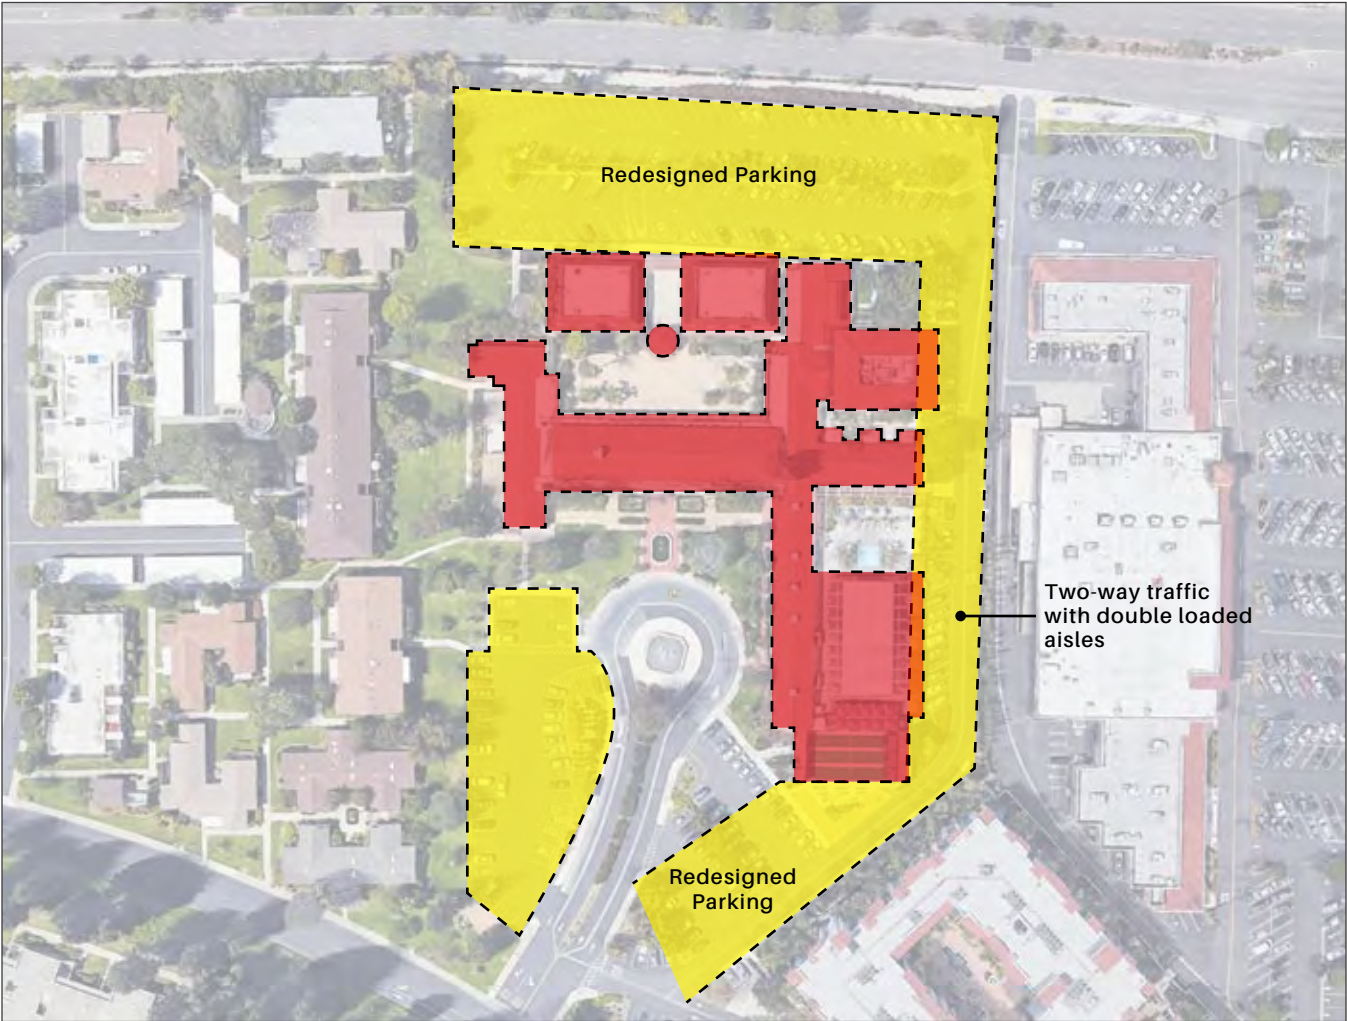
Option 3 — Proposed Demolition and Site Improvements

SITE IMPROVEMENTS / ENHANCEMENTS

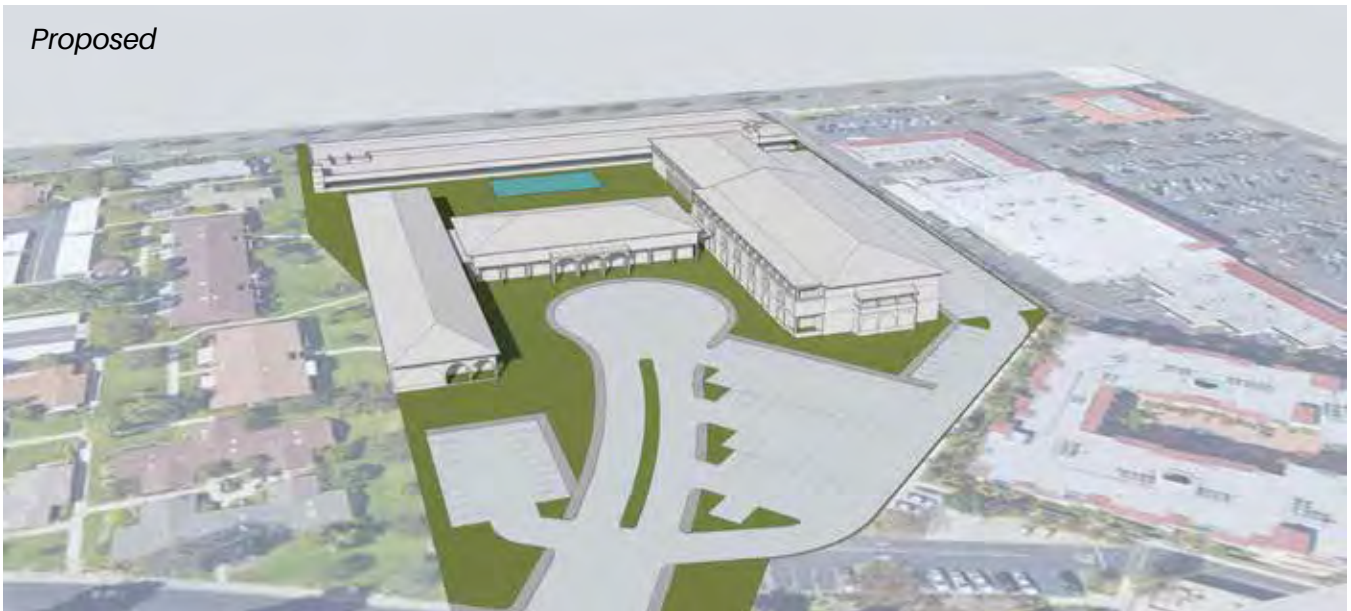
Proposed

The proposed concept formalizes the entry court which will continue to be used for shuttle buses as well as passenger dropoff/pickup. With a reimagined fountain and landscaping the entry court will provide the new focal point of Clubhouse 1. To maintain the scale of the existing residences to the west of the complex only single story facilities are located along this edge. The 3-story Community Center and full height Gymnasium and Fitness center form the eastern edge of the complex where the commercial and multi-level residences populate this portion of the site. The new Great Room connects the two flanking facilities and functions as the new "Front Door" of Clubhouse 1.

Much of the existing surface parking has been maintained with an expanded eastern driveway with double sided parking. The majority of the parking remains at the north end of the site where a two level parking structure accommodates peak periods of activities and provides staff parking for both Clubhouse 1 and the new Community Center.

The Lawn Bowling and Bocce area is located on the west side of the entry drive adjacent to the west wing of the complex. As an outdoor activity area this facility will remain as an unstructured space for barbecuing and socializing.

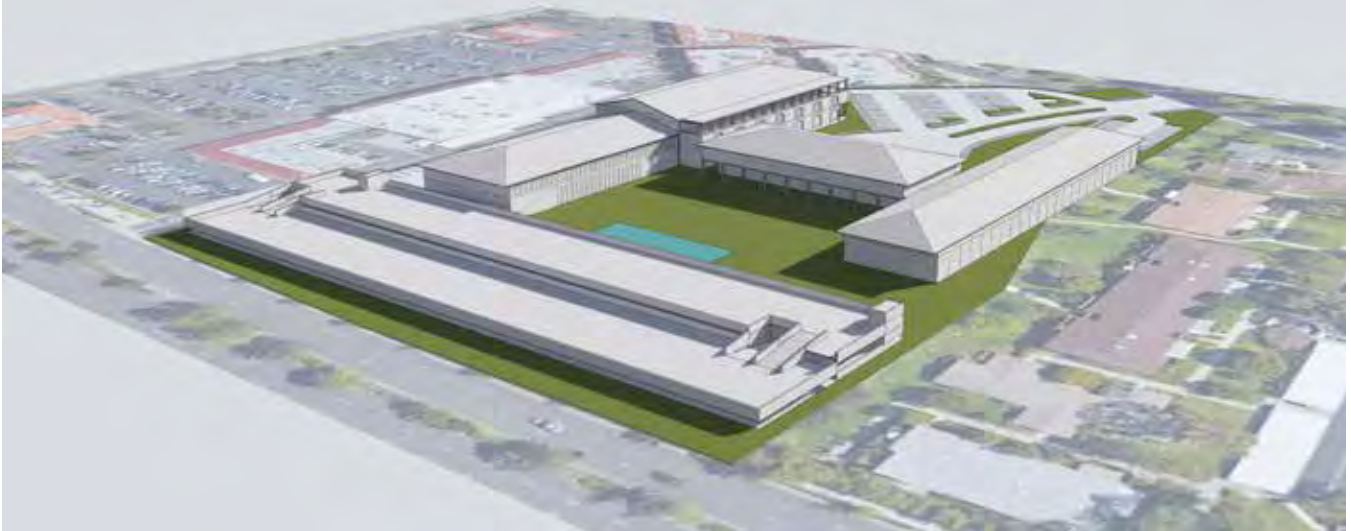
Proposed

With the increased parking requirements and the limited real estate the introduction of structured parking is one solution that addresses these constraints. In the proposed design a two level split parking structure is shown that utilizes the natural grade fall from the south of the site where the entry drive is to the north of the site where the existing parking is located. This strategy minimizes the impact of the overall structure and softens the view from El Toro Road.

Central to the events and venues that will be hosted by this facility the main courtyard will be augmented by the covered veranda of the new Great Room. The pool and deck area will be secured from the courtyard and will serve as a backdrop for evening functions and activities. Adjacent to the pool area, the Gymnasium and fitness center integrate athletics and recreation as well as to promote both programs.
