# REGULAR MEETING OF THE GOLDEN RAIN FOUNDATION BUILDING E SPACE PLANNING AD HOC ADVISORY COMMITTEE\*

# Building E History & Background

# Maintenance Facility Building E

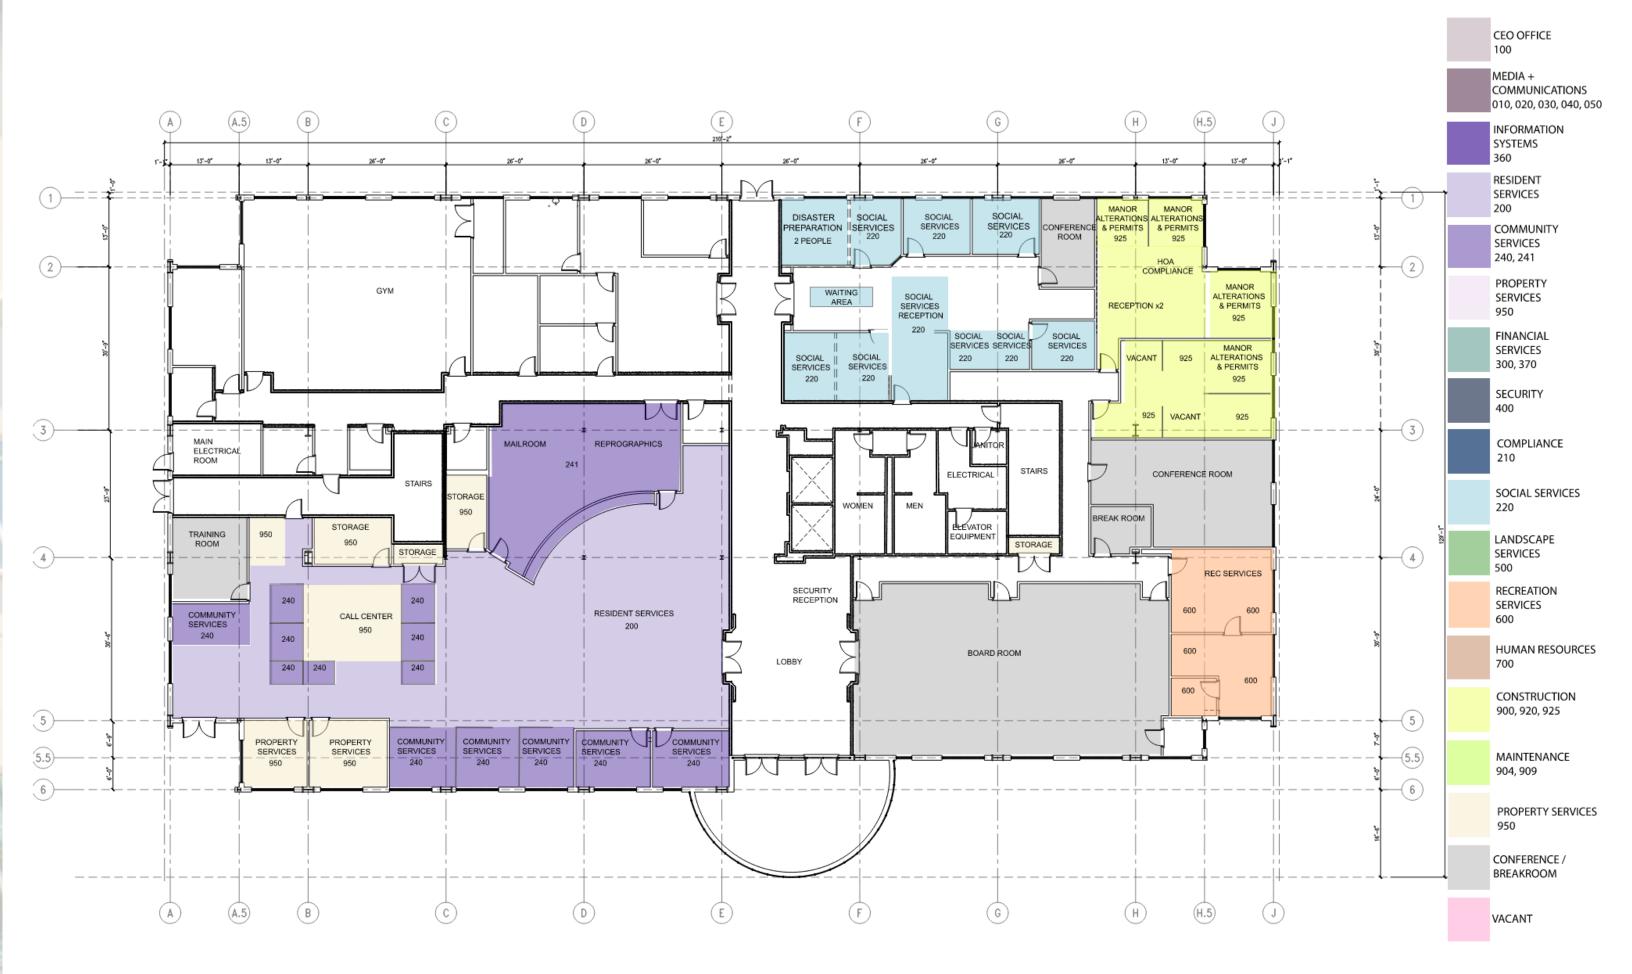
**Existing Community Center - 1st Floor**

There are several departments that have opportunities for space utilization optimization. The Manor Alternations and Permits department is currently separated between the ground and second floors of the Community Center. The department started in a single room and later grew into the adjacent room. The layout of the employee workstations and resident reception desk is not ideal. Locating the department on the same floor and providing a more efficient layout would be preferred.

The Property Services Call Center is currently located behind the Resident Services area. There are roughly 20 Call Center employees tightly packed and co-habitating with the Community Services department. Currently there is very little vacant office space for department growth. The noise created by the call center employees is distracting to other departments. Re-locating the call center to a more private location would benefit both departments.

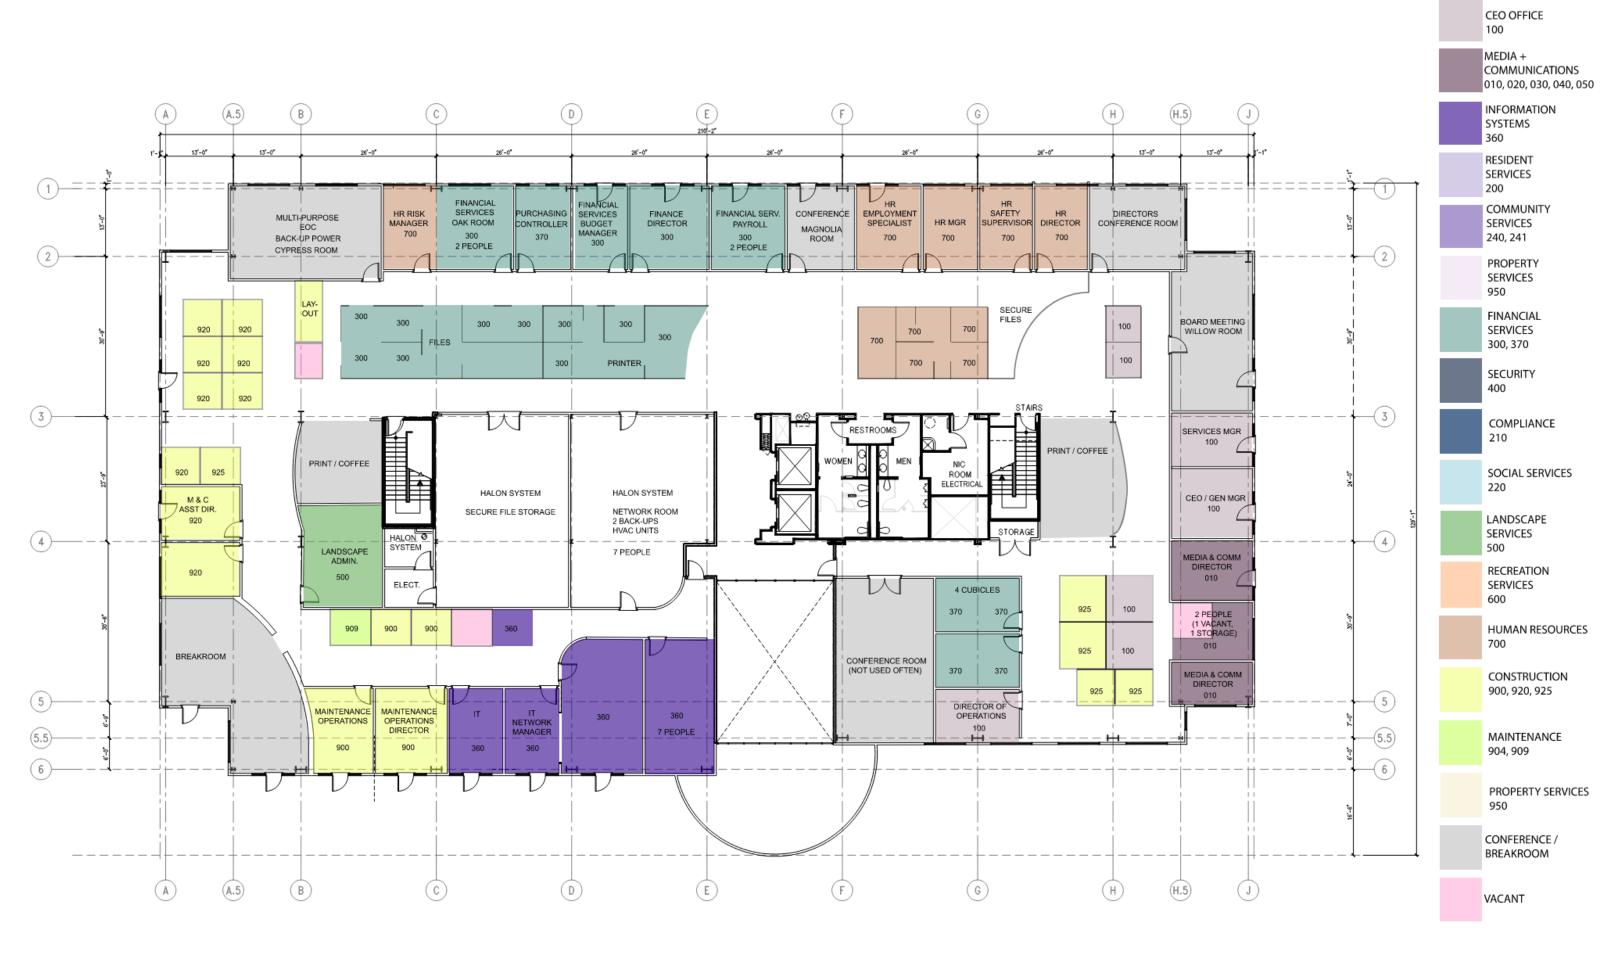
Existing Community Center - 2nd Floor

The Human Resources department has a series of classified documents that need to be secure. Currently these documents are being stored in lateral file cabinets with keyed locks on the open office floor. Prior to the of the day these cabinets must all be locked, and then unlocked at the start of the next day. A secure file room for these documents is preferred.

Currently a portion of the Media Department is split between the second floor and the third floor, adjacent to the TV studio. Locating the department on the same floor and providing a more efficient workstation layout would be preferred.

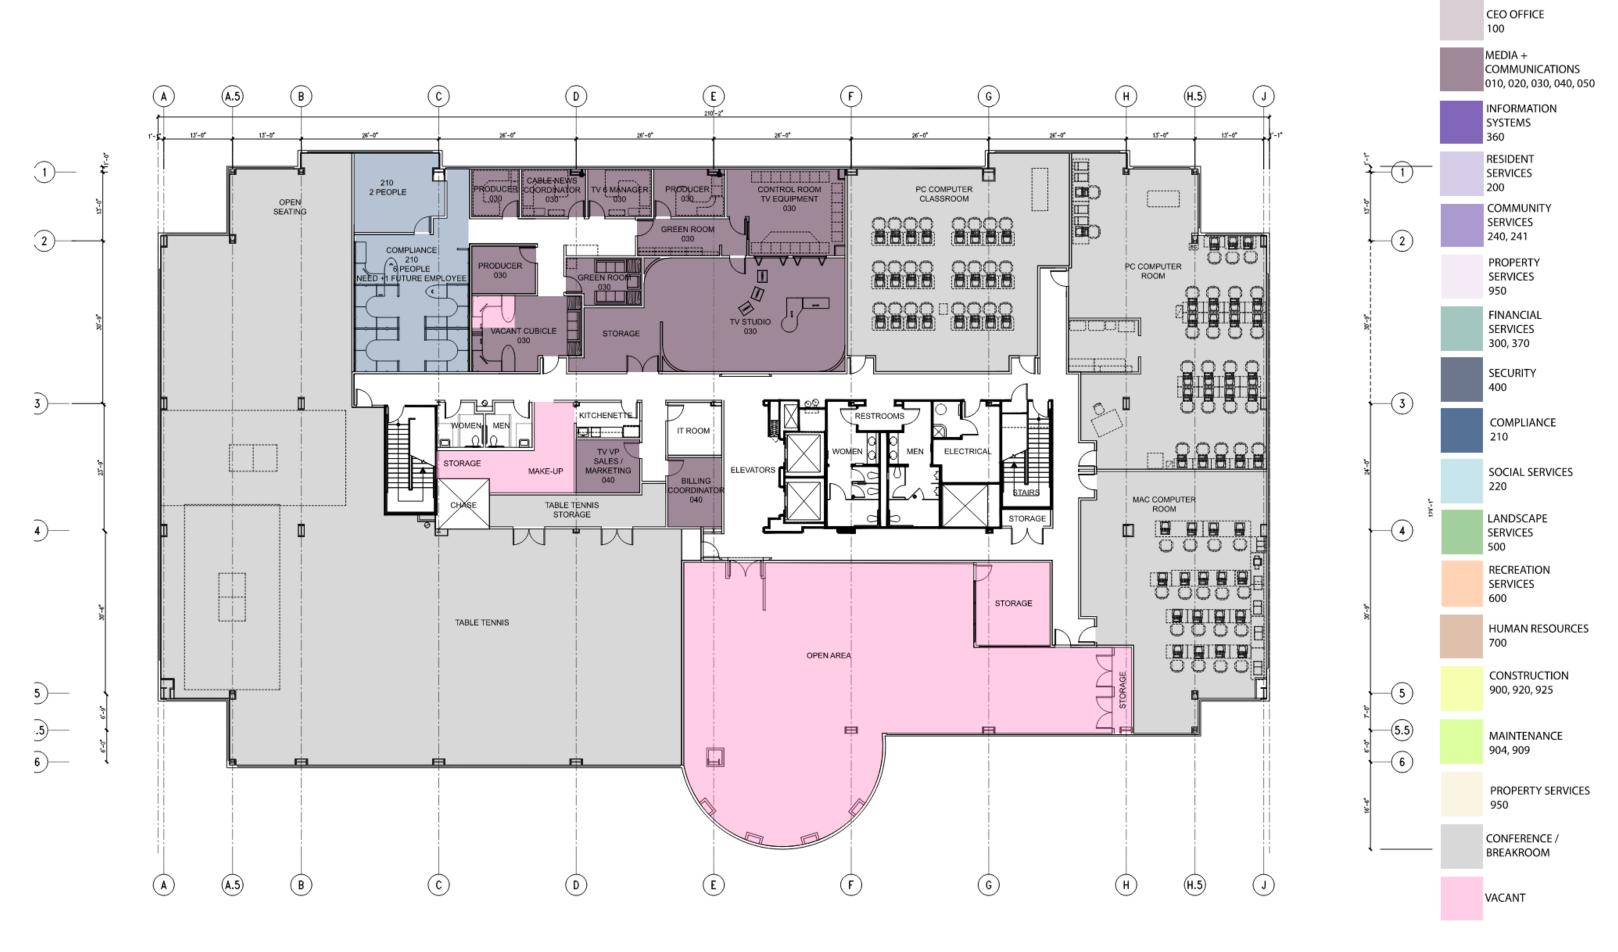
**Existing Community Center - 3rd Floor**

The Table Tennis room is a large, open space that contains roughly 15 tables and a small area with open seating. While Table Tennis is a popular resident activity, the space is oversized for its use. This room is for recreation use only; all Table Tennis tournaments are currently held at Clubhouse 5. For every tournament, the tables in the Community Center are removed and transported to Clubhouse 5 and then transported back to the Community Center after the completion of the tournament. Moving these tables from the third floor, through the elevator, is not ideal. There are also complaints by employees that residents are using the single occupant restrooms to wash themselves after playing Table Tennis. Water is ponding on the floor, creating potential slip hazards. The Community Center is an office building located in a commercial strip-mall; the third floor of this building is not an appropriate location for an activity like table tennis. Finding a new, more appropriate, location for Table Tennis will make a large portion of the floor available for other departments.

Prior to its new location on the ground floor, the Fitness Center was located on the third floor. The roughly 3,000 SF space is still currently vacant. This space can be repurposed for other departments.

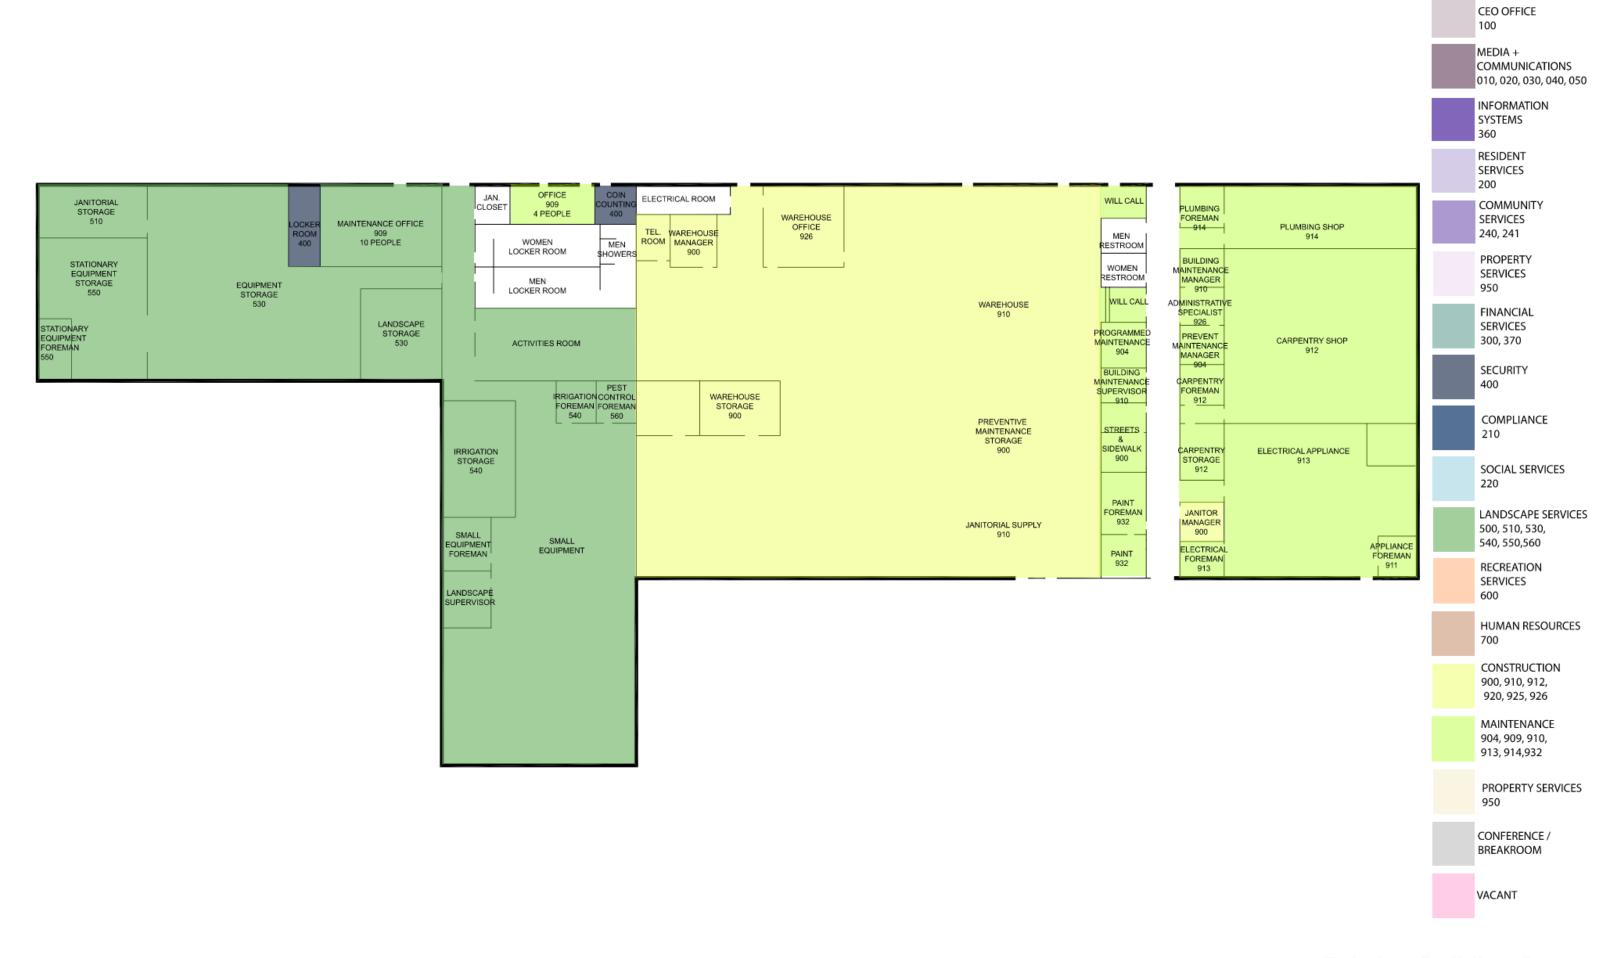
# **MAINTENANCE BUILDING E**

Built – 1976 Building Type – One Story Wood Framed Building with exterior stucco finish Building Size – 5,500 SF Current Uses – Office Space Annual Maintenance Costs – Replacement Cost -

Building E is scheduled to be demolished. All departments within this building will be relocated as part of this study.

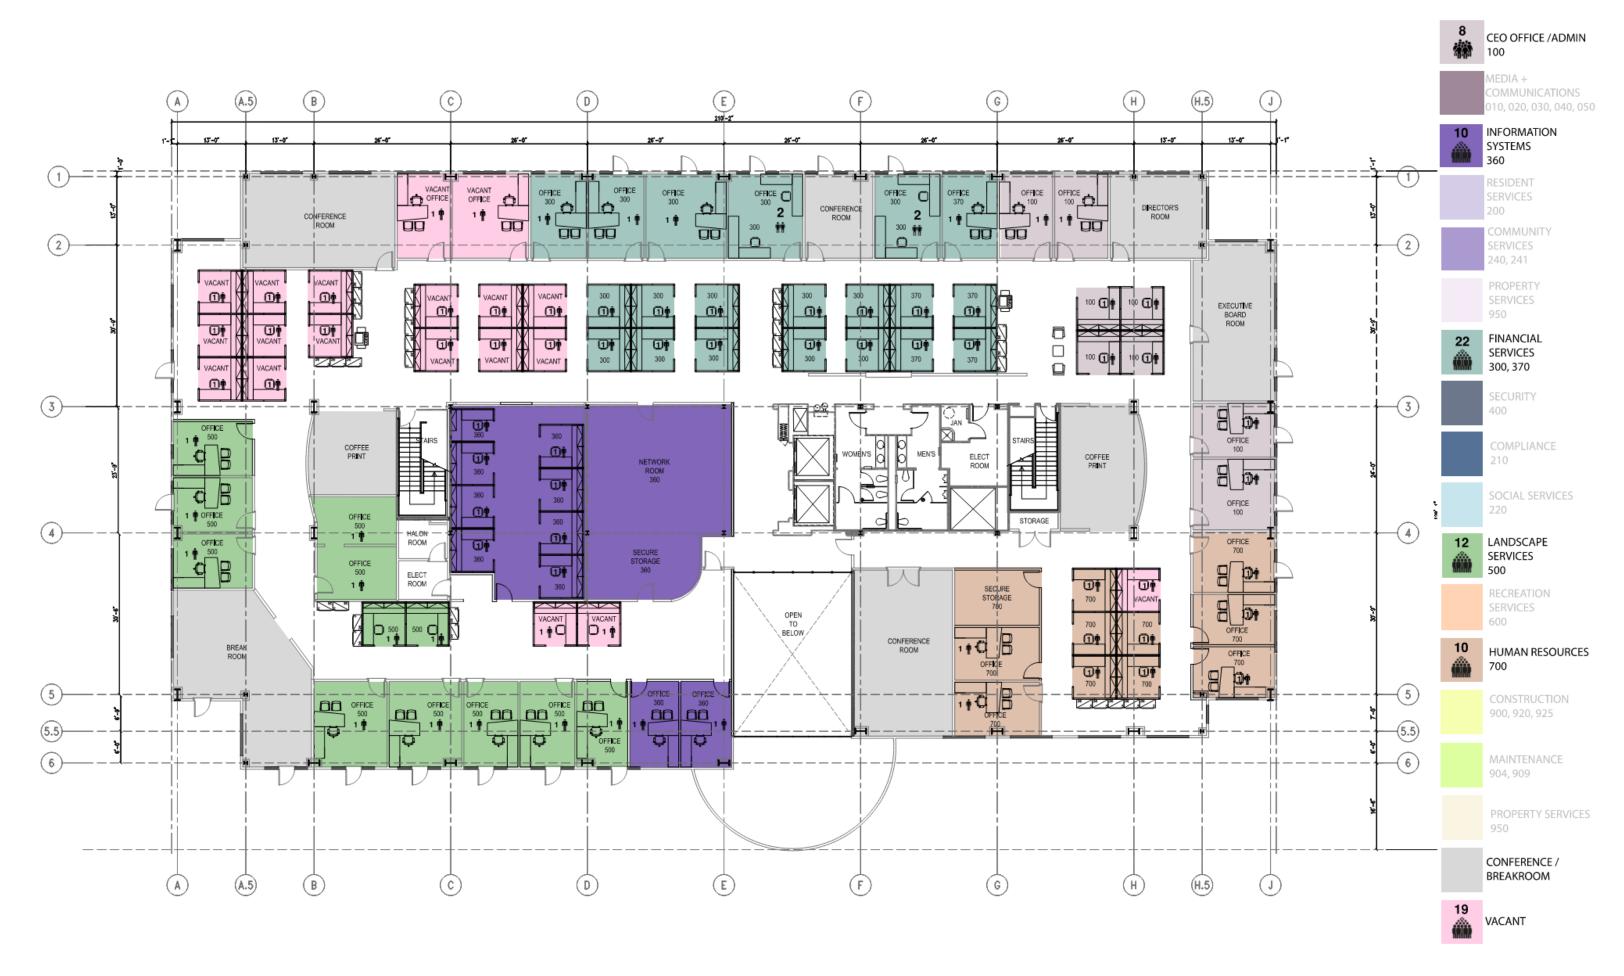
## **Community Center – Third Floor**

With the relocation of Table Tennis, the Computer Classrooms, and the MAC and PC computer Labs, the entire floor is vacant with the exception to the TV Studio and building core elements. This relocation will also reduce the overall required parking count for the building as these high-density assembly type spaces are remodeled to less dense office type spaces. This will help solve the building's parking deficiency with the city's planning department.

Due to the extensive renovation required over a majority of the floor, the renovation scope of work would be treated as a complete tenant improvement project. All the existing walls, ceilings, doors, interior finishes, diffusers, and lighting fixtures would be removed. The HVAC systems would be removed back to the main truck lines and the fire sprinklers removed back to the main piping runs. Existing areas such as the TV studio, restrooms, elevators, and stairs would remain in their current condition.

The areas within the scope of work would receive new walls, ceilings, doors, interior finishes like carpet flooring, diffusers, and LED lighting. New HVAC branch ducts would connect the main lines to new VAV boxes and flex ducts added to the diffuser locations. Fire sprinkler flex lines would connect from the main lines to accommodate the new floor layout. Any work made to the hallways would be patched back with the required fire ratings. It is anticipated that new electrical panels would be required for the relocated Call Center and the Security Services area. New perimeter window blinds would also be included as part of the renovation.

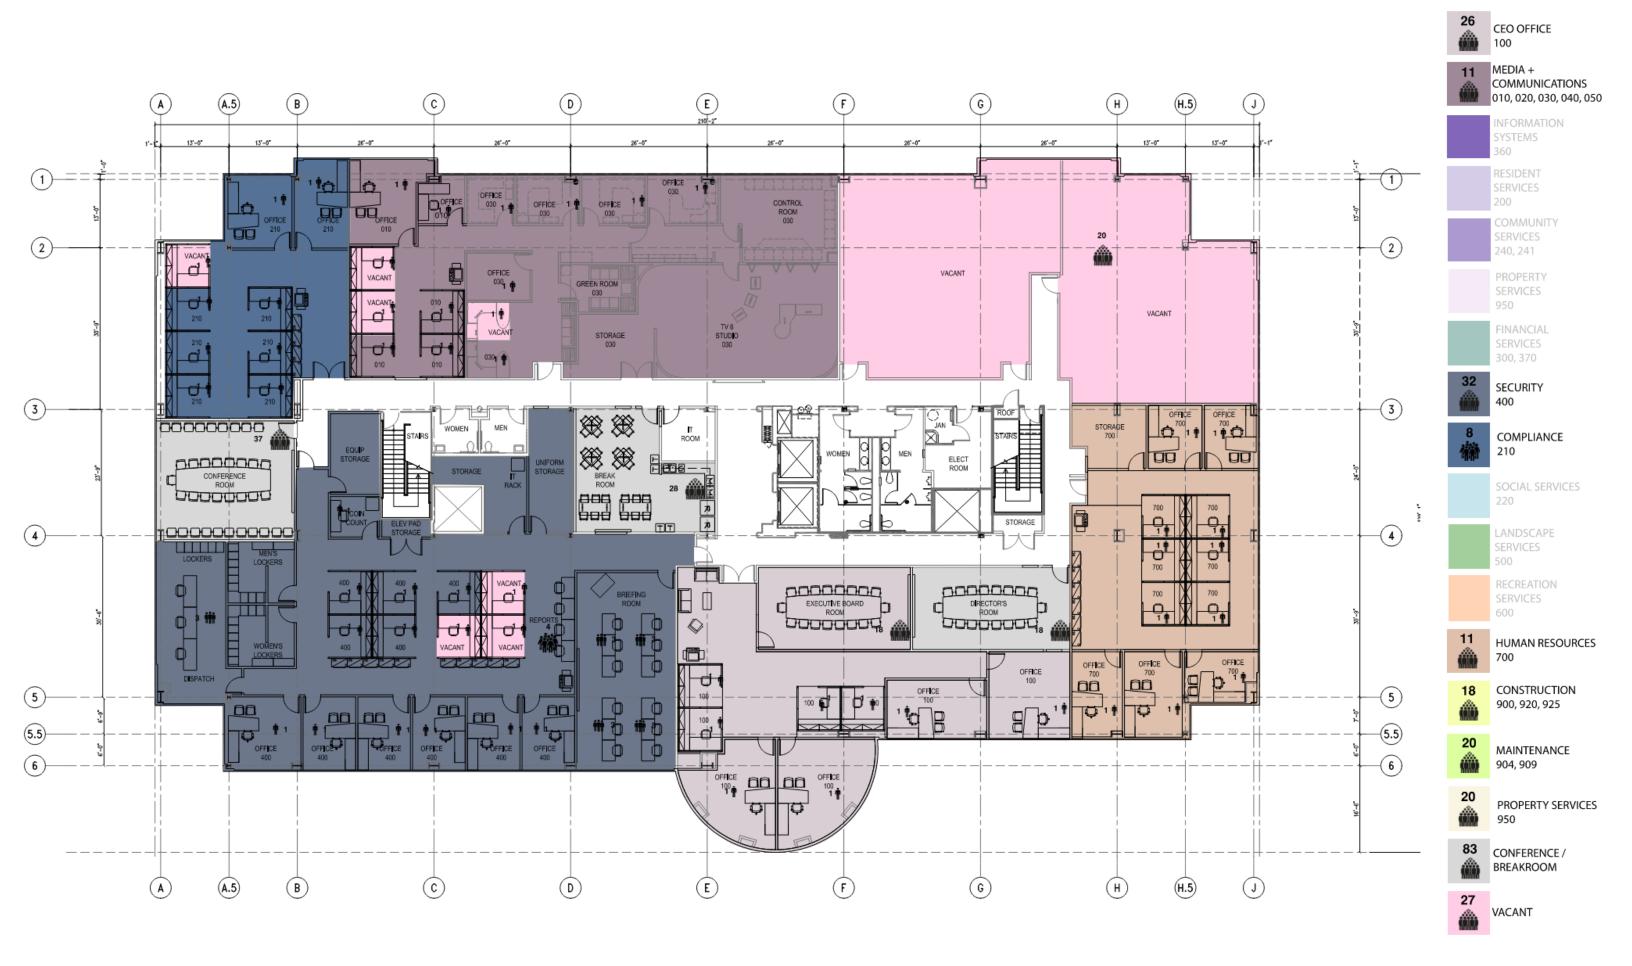
## **Space Use Optimization – Option 2a**

Due to the extensive renovation required over a majority of the floor, the renovation scope of work would be treated as a complete tenant improvement project. All the existing walls, ceilings, doors, interior finishes, diffusers, and lighting fixtures would be removed. The HVAC systems would be removed back to the main truck lines and the fire sprinklers removed back to the main piping runs. Existing areas such as the TV studio, restrooms, elevators, and stairs would remain in their current condition.

The areas within the scope of work would receive new walls, ceilings, doors, interior finishes like carpet flooring, diffusers, and LED lighting. New HVAC branch ducts would connect the main lines to new VAV boxes and flex ducts added to the diffuser locations. Fire sprinkler flex lines would connect from the main lines to accommodate the new floor layout. Any work made to the hallways would be patched back with the required fire ratings. New perimeter window blinds would also be included as part of the renovation.

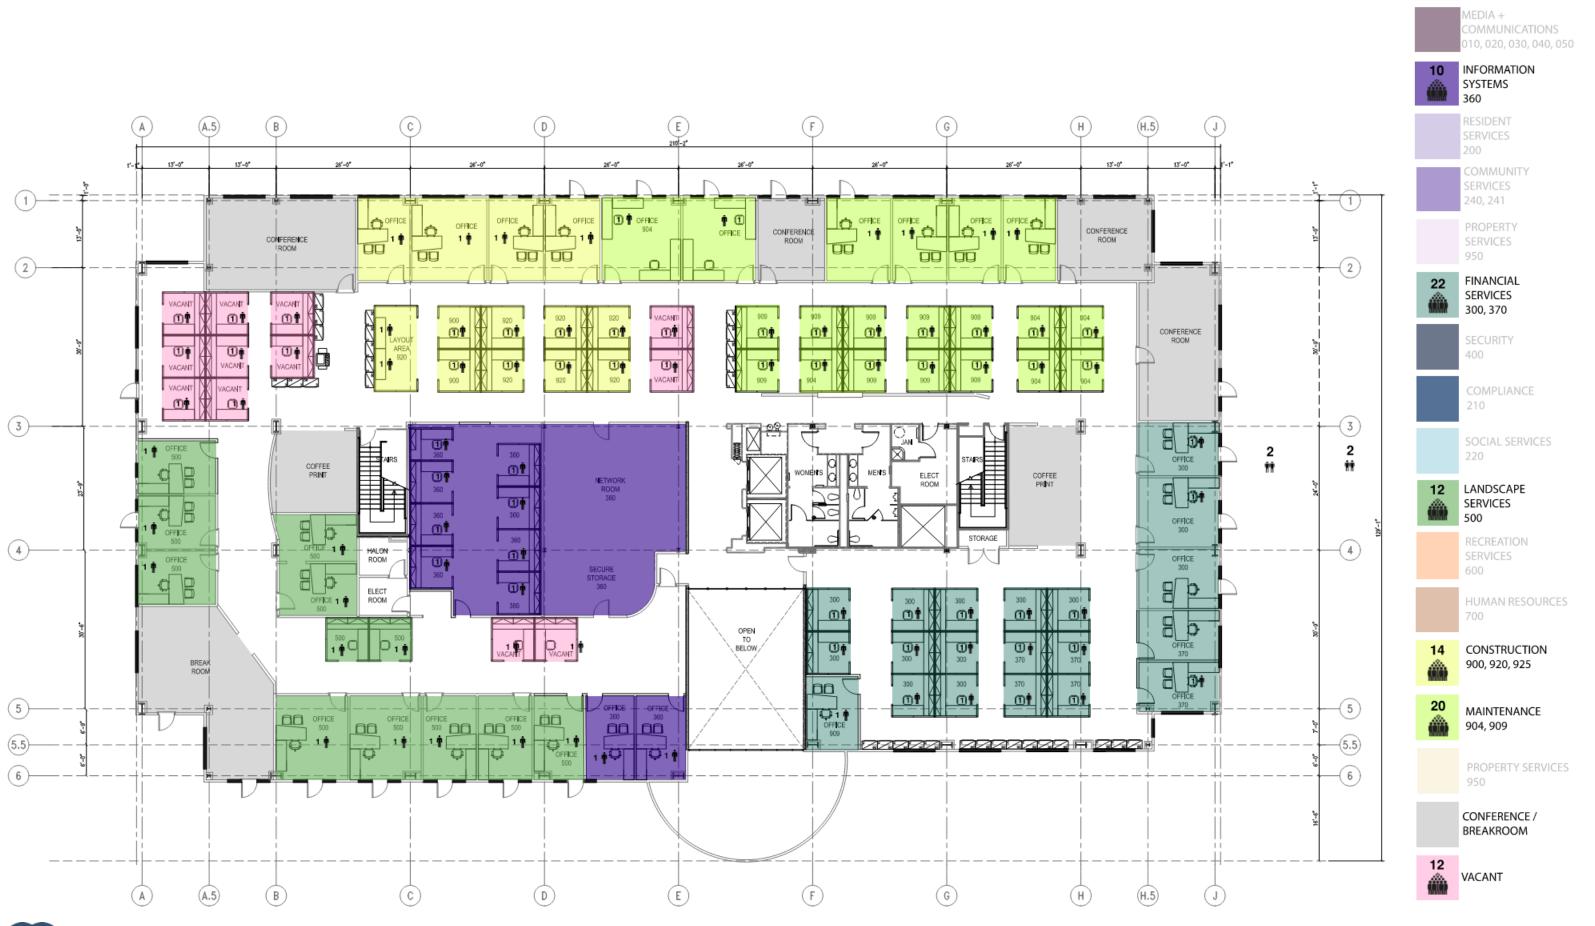
## **Community Center – Third Floor**

With the relocation of Table Tennis, the Computer Classrooms, and the MAC and PC computer Labs, the entire floor is vacant except for the TV Studio and building core elements. This relocation will also reduce the overall required parking count for the building as these high-density assembly type spaces are remodeled to less dense office type spaces. This will help solve the building's parking deficiency with the city's planning department.

Due to the extensive renovation required over a majority of the floor, the renovation scope of work would be treated as a complete tenant improvement project. All the existing walls, ceilings, doors, interior finishes, diffusers, and lighting fixtures would be removed. The HVAC systems would be removed back to the main truck lines and the fire sprinklers removed back to the main piping runs. Existing areas such as the TV studio, restrooms, elevators, and stairs would remain in their current condition.

The areas within the scope of work would receive new walls, ceilings, doors, interior finishes like carpet flooring, diffusers, and LED lighting. New HVAC branch ducts would connect the main lines to new VAV boxes and flex ducts added to the diffuser locations. Fire sprinkler flex lines would connect from the main lines to accommodate the new floor layout. Any work made to the hallways would be patched back with the required fire ratings. New perimeter window blinds would also be included as part of the renovation.
