**REGULAR MEETING  
GOLDEN RAIN FOUNDATION LANDSCAPE COMMITTEE**

**SUBJECT: Aliso Creek Update**

### **2021 ANNUAL PERFORMANCE MONITORING REPORT FOR HABITAT RESTORATION AT THE ALISO CREEK TRAIL REPAIR PROJECT**

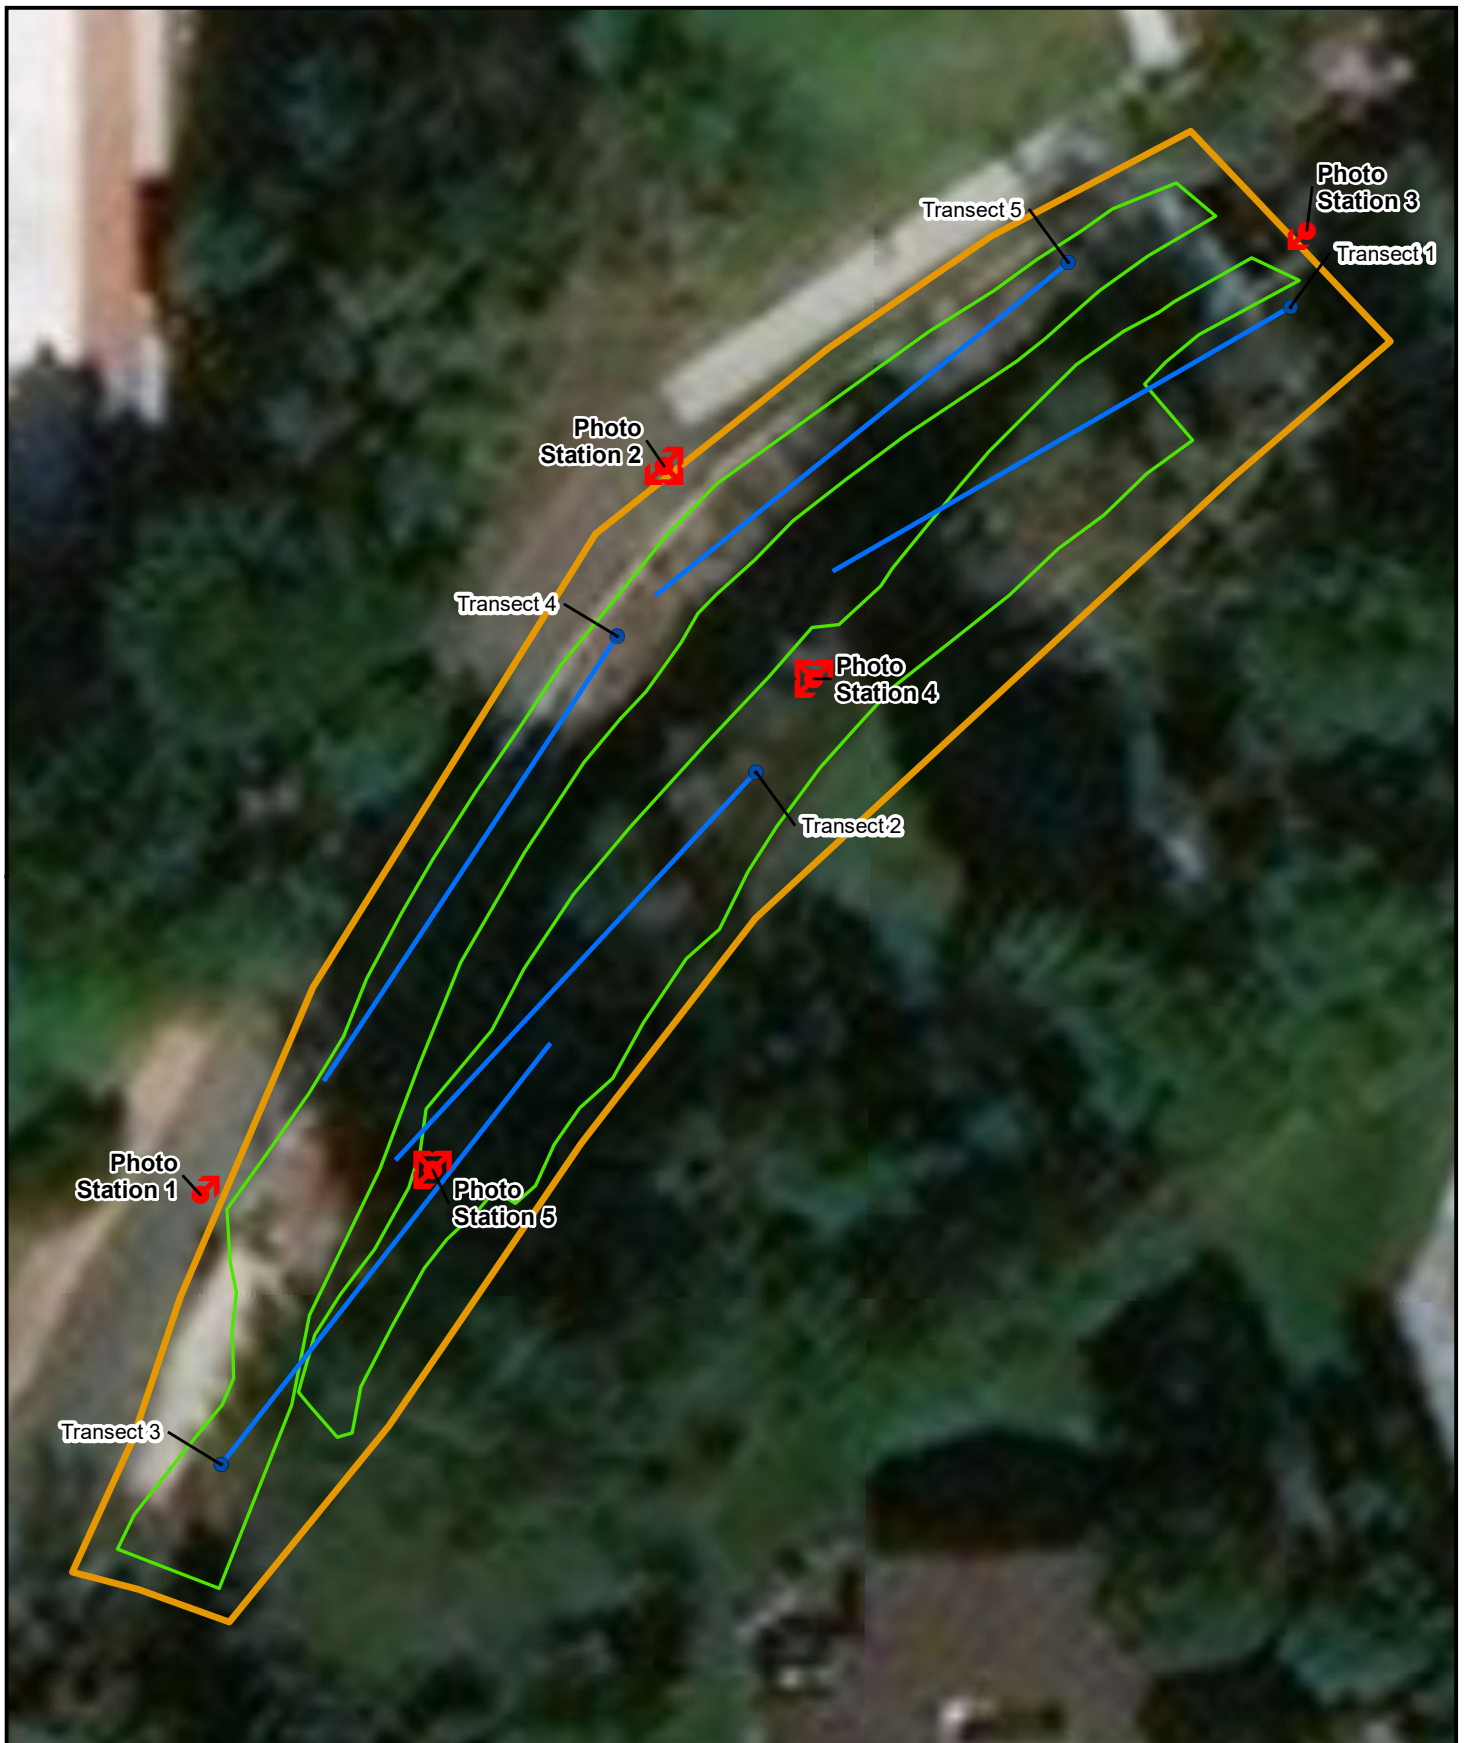
The point-intercept method was used to measure vegetative cover quantitatively (Sawyer and Keeler-Wolf 1995) along a series of five permanent transects. The starting point of each transect was recorded using a hand-held Global Positioning System (GPS) unit, and the direction of each transect was recorded using a compass. The transect locations are depicted in Figure 2.
