SPECIAL OPEN WORK SHOP FOR THE VILLAGE ENERGY TASK FORCE

GOLDEN RAIN FOUNDATION ELECTRICAL INFRASTRUCTURE ASSESSMENT

UNITED LAGUNA HILLS MUTUAL ELECTRICAL INFRASTRUCTURE ASSESSMENT

THIRD LAGUNA HILLS MUTUAL ELECTRICAL INFRASTRUCTURE ASSESSMENT

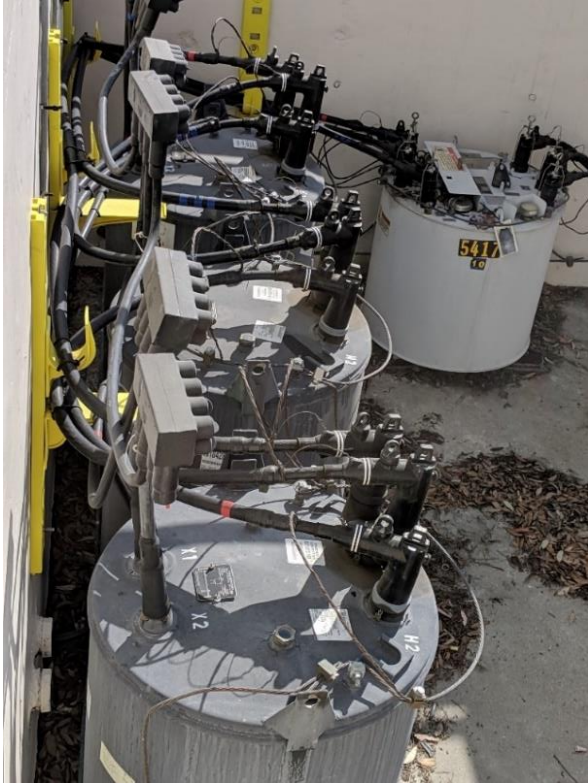
Figure 11: SCE 3-100kVA 120V/208V Overhead Transformer Servicing Clubhouse 2

Clubhouse 2 is served by an older (Mid 1960s) style set of overhead transformers in a secured area as shown on Figure 11. Overall, the external condition of the transformers is 2.33 (Marginal) based on the Asset Condition Measurement referenced in Section 3.4, with newer underground cable serving the switch and the transformers. This equipment is operated and maintained by SCE. The TRC team could not access the secured area to verify transformers sizes since access to this area is restricted with an SCE lock. The transformers are identified as 3-100kVA and the max kW load as shown in Table 3 is 102kW (120kVA @ 85% power factor), so there should not be any overload considerations. There is approximately 150% capacity available on these transformers based on nameplate information. Actual transformer loading analysis is determined by SCE.

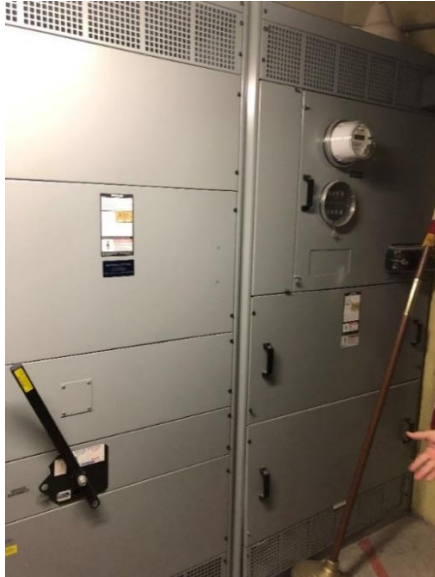
Figure 14: Main Panel 1600A, 120V/208V Servicing Clubhouse 3

14. The equipment was rated at a 4.0 (Good) based on the Asset Condition Measurement referenced in Section 3.4.

Also, it was communicated to the project team that LWV plans to replace the HVAC system in Clubhouse 3. This project is currently in design and LWV should verify that the electrical system be considered to verify it meets codes prior to installation.

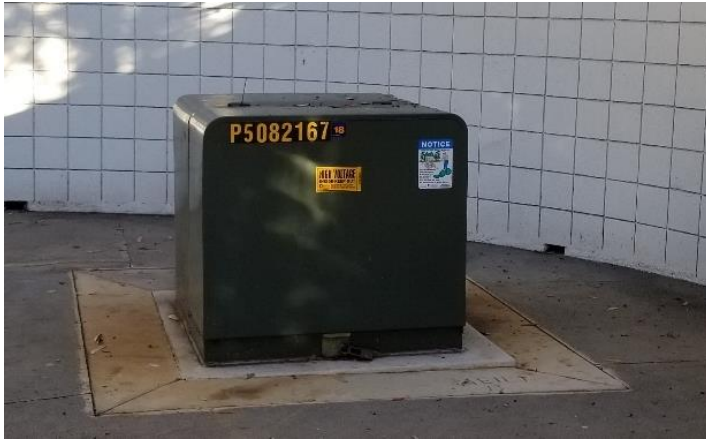
Figure 5: Pad-Mounted Transformer Servicing a United Laguna Hills Mutual Residential Area

The SCE transformers were either single-phase pad-mounted (Figure 5) or sub-surface (Figure 6) and in varying condition depending on replacement dates. Most of the transformers that were found were of newer vintage and in good to excellent condition. The existing panels at the residences were mostly the original installation with an older style. Very few panels were upgraded, except for a directed effort to change out 2,750 Pushmatic panels due to obsolescence by May of 2021.

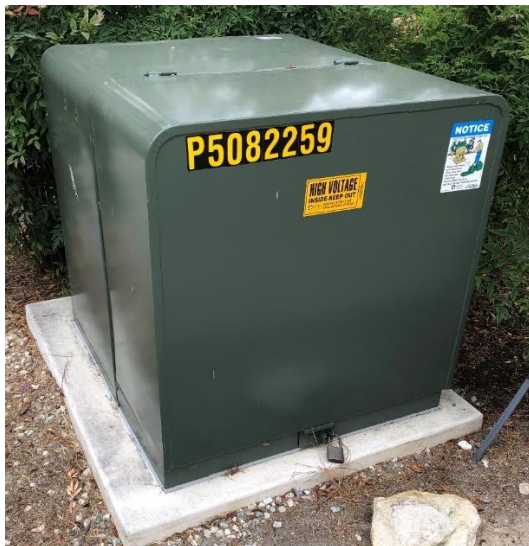
Figure 7: Pad-Mounted Transformer Servicing Laundry Room 90

The SCE transformer (Figure 7) is single-phase 100kVA 120/240V and in excellent condition. It is rated as 5.0 (Excellent) based on the Asset Condition Measurement referenced in Section 3.4. Based on the 17kW (20kVA @ 85% power factor) max demand from SCE metering data, the transformer is sized adequately for the load. There is approximately 400% capacity available on this transformer based on nameplate data. The actual transformer loading analysis is determined by SCE. No action is needed for this equipment.

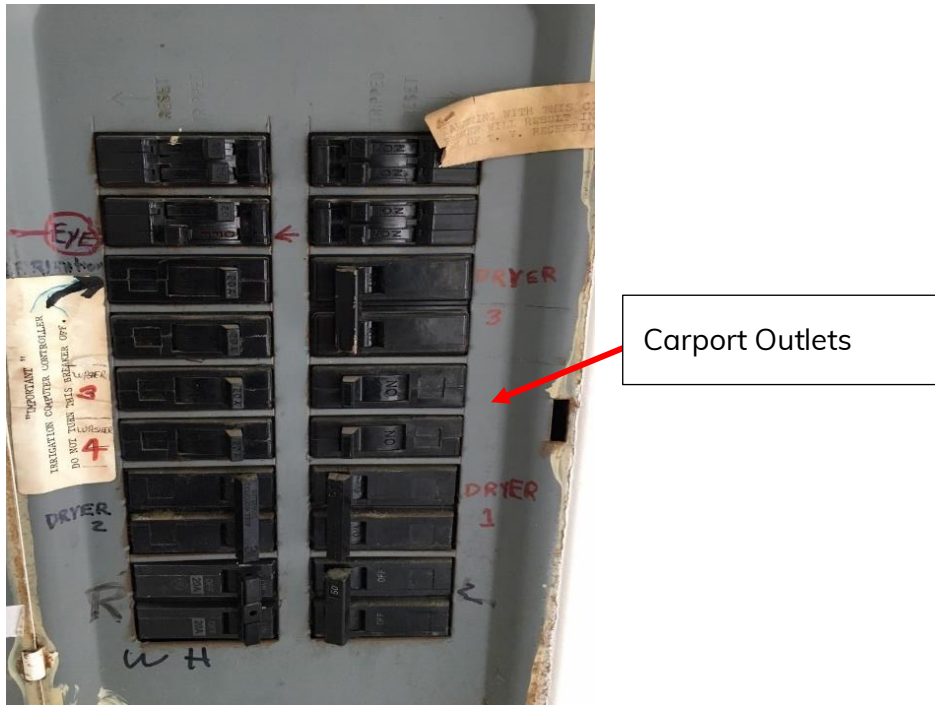
Figure 8: Laundry Room 90 Breaker Panel in United Laguna Hills Mutual Residential Area

The individual circuits feeding the carport outlets for L89 and L90 are 120V, 20A circuits. An example of the L90 panel is provided in Figure 8. These circuits would serve the entire outlet string for each adjacent carport that has outlets numbering one outlet for every two parking spaces in the carport.

The most logical, short-term solution would be to add additional 20A circuits to each of the carports to accommodate the EV charging demand. This would greatly improve the EV charging capabilities for the residences. However, it would still limit one active unit per circuit at any given time. The long-term solution would require the EV charging plan, which will be addressed as part of phase 2.

Another quick but less scalable solution would be to schedule the charging of all EV charging in each carport. Based on conversations with the staff, this method is already occurring. It involves the carport residence to coordinate with each other so that the circuit overloads are limited. However, with the addition of Level 2 EV chargers this will be more difficult due to the time needed to charge larger EVs.

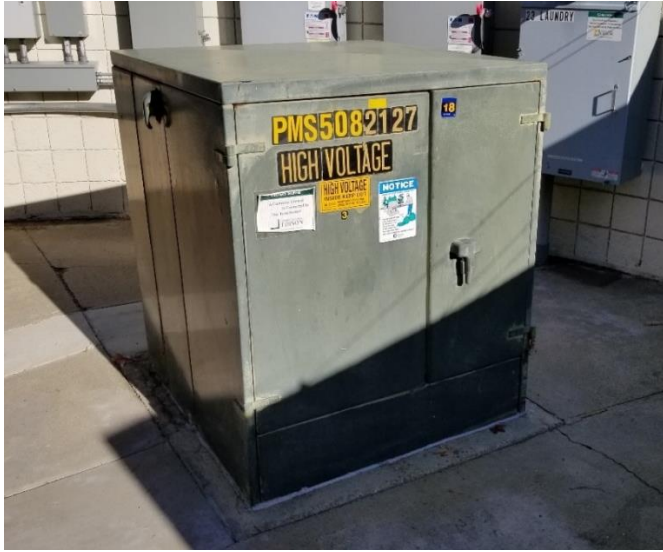
Figure 10: SCE Transformer Servicing Laundry Room 23

The SCE transformer is an older style of unknown size in adequate condition (Figure 10). The size information was not available in the field. The total load for Laundry 23 is 18kW (21kVA @ 85% power factor) max demand from SCE metering data. Since the size is not known, an analysis of the load-carrying capacity cannot be determined. There is solar present at this site and the solar is interconnected and feeding back to the grid when the solar output exceeds the load demand.

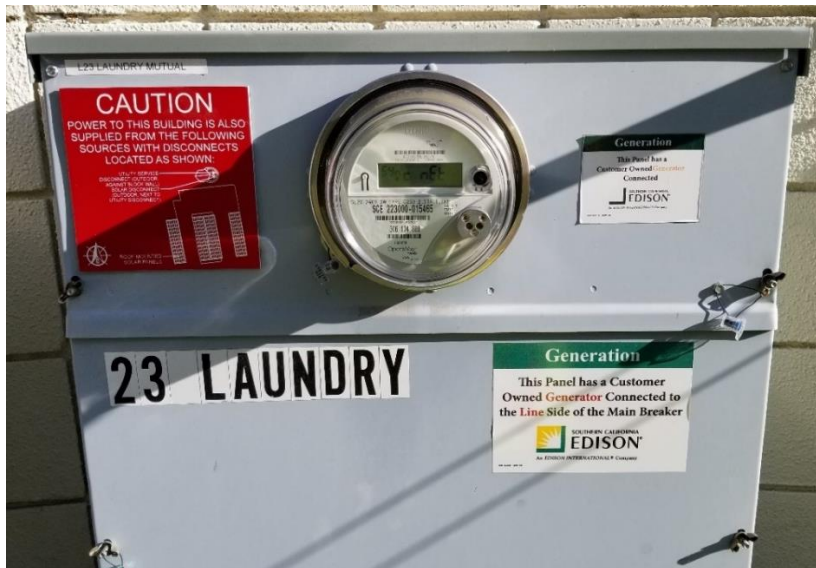
Figure 11: Solar Electric Supply Servicing Laundry Room 23

The panel in the laundry room is a 125A subpanel fed by the new panel (Figure 11) installed to accommodate the solar installation. The laundry panel has been changed to a new style and has some physical spaces for additional load if the NEC calculations support it. The load for this laundry room has been reduced due to replacing the water heaters with efficient heat pump water heaters. The panels are adequate for the current load; however, if any additional load is to be added to these panels it is recommended that the panel be upgraded to accommodate the additional load. The new panel that was installed for the solar equipment was rated 4.5 (Good) based on the Asset Condition Measurement referenced in Section 3.4. There are spare positions available on this panel to serve additional load if the load calculations allow, and the SCE transformer can serve the load.

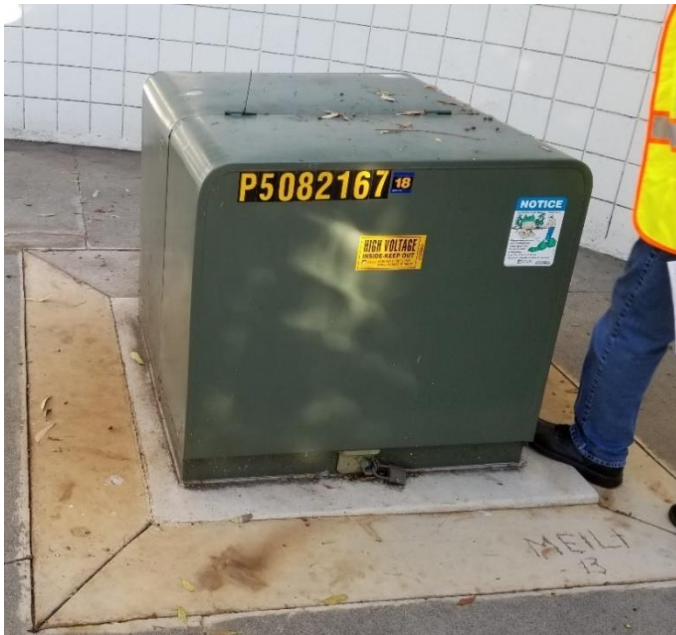
Figure 12: SCE Transformer Servicing Laundry Room 31

The SCE transformer (Figure 12) is a newer style 100kVA 120/240 in excellent condition. It is rated as 5.0 (Excellent) based on the Asset Condition Measurement referenced in Section 3.4. Based on the 18kW (21kVA @ 85% power factor) max demand from SCE metering data, the transformer is sized adequately for the load of Clubhouse 1. There is approximately 372% capacity available on this transformer based on nameplate data. The actual transformer

loading analysis is determined by SCE. No action is needed for this equipment. The transformer is oversized to accommodate the solar capacity.

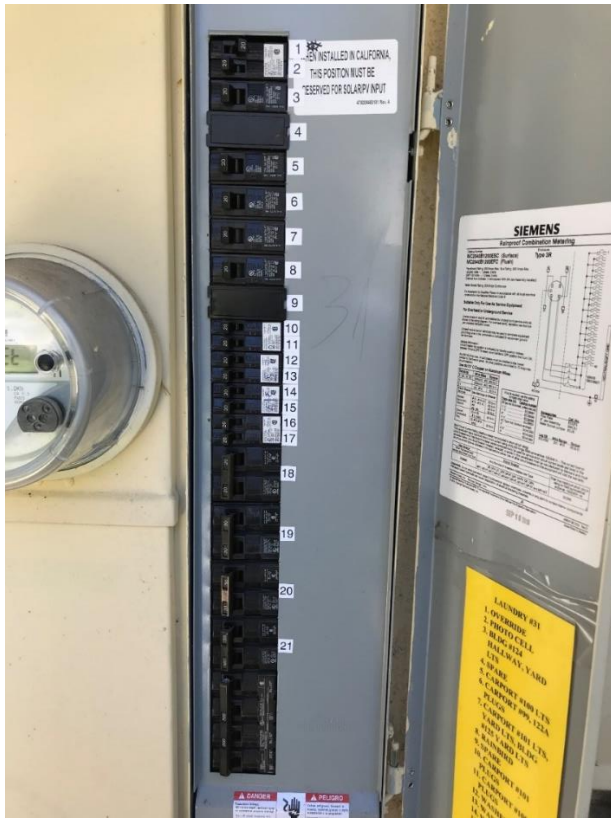
Figure 13: New Subpanel Servicing Laundry Room 31

Based on these conditions, the existing laundry room electrical equipment was rated at 5.0 (Excellent) using the on the Asset Condition Measurement referenced in Section 3.4.

A short-term solution to resolve the circuit overloading would be to add additional 20A circuits to each of the carports to accommodate the EV charging demand. Level 1 and golf cart EV charging would need to be limited to one active unit per circuit at any given time.

Recommendations	Budget Cost
<ul style="list-style-type: none"> Immediate repairs need to occur on the carport circuits that are fed from the laundry room panels. New 20A circuits need to be added. 	\$1,500/Circuit
<ul style="list-style-type: none"> These circuits, and possibly panels, need to be upgraded to accommodate the golf cart and EV charging in the carports. Before adding electrical loads, an electrical load calculation analysis needs to be performed to ensure the equipment is capable of the additional load. 	<p>N/A</p> <p>To be discussed in Task 2</p>

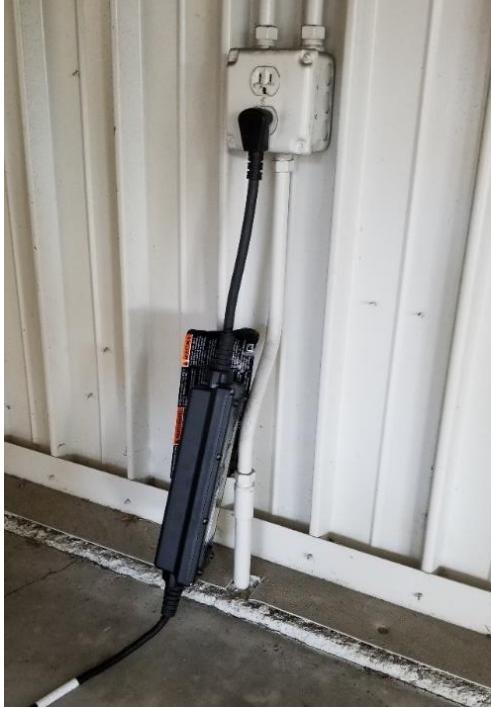
Figure 14: Level 1 EV Charger in United Laguna Hills Mutual Residential Area

The circuit feeding the carports has experienced overloads due to the EV chargers and other load plugged in at the carport outlets. In this carport, there was a Level 1 EV charger plugged into one of the outlets of the adjacent carport (Figure 14) that, on its own, would fully utilize the carport circuit capacity. This needs to be resolved to prevent failure and outages.

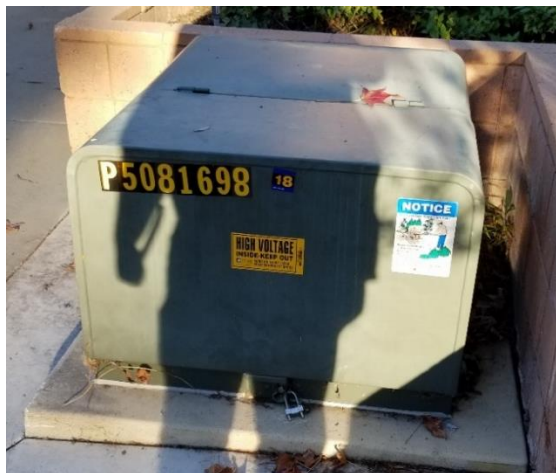
Figure 15: SCE Transformer at L142

In both cases, the SCE transformer is a newer style 75kVA 120/240 in good condition (Figure 15). It is rated as 4.0 (Good) based on the Asset Condition Measurement referenced in Section 3.4. Based on the 15kW (18kVA @ 85% power factor) max demand from SCE metering data, the transformer is sized adequately for the load of Clubhouse 1. There is approximately 325% capacity available on this transformer based on nameplate data. Actual transformer loading analysis is determined by SCE. No action is needed for this equipment.

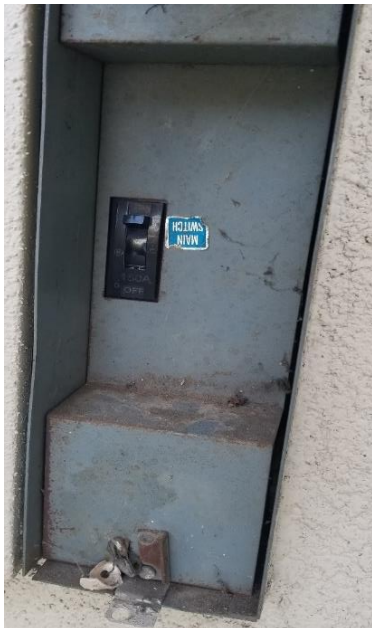
Figure 16: Laundry Room 226 Main Breaker Panel in Laguna Hills Mutual Residential Area

The existing laundry panels are the original 150A panels with the original breakers (Figure 16). The load in this laundry room has been reduced due to replacing the water heaters with efficient heat pump water heaters. The panels are adequate for the current load.

The laundry room also houses the circuit breaker that serves the adjacent carports. The individual circuits feeding the carport outlets are 120V, 20A circuits. These circuits serve the entire outlet string for each adjacent carport that has outlets, numbering anywhere from two to four depending on the number of parking spaces in the carport. The circuit is undersized for the current load, which is evident based on the feedback provided that residents are constantly tripping breakers and the observed golf cart and EV chargers plugged in the carport outlets. The EV chargers plugged into the carports ranged from Level 1 EV chargers (Figure 14) to standalone golf cart/battery chargers (Figure 9). The Level 1 EV chargers are a minimum of 15A and the golf cart/battery chargers range from 5A to 15A, with the majority observed to be at the higher range. If two or more of these chargers are plugged into the same outlet circuit in a carport charging two vehicles (cars or golf carts), they will exceed the capabilities of the breaker and conductors that serve the outlets.

Based on these conditions, the existing laundry room electrical equipment was rated 1.25 (Poor) based on the Asset Condition Measurement referenced in Section 3.4.

The electrical equipment in both Laundry Rooms are original equipment and have some wear and tear due to the multiple circuit trips. In particular, the circuit feeding the carports has experienced overloads due to the EV chargers and other loads plugged in at the carport outlets. This needs to be resolved to prevent failure and outages.

A short-term solution to resolve the circuit overloading would be to add an additional 20A circuit or two to each of the carports to accommodate the EV charging demand. Level 1 and golf cart EV charging would need to be limited to one active unit per circuit at any given time.

Recommendations	Budget Cost
<ul style="list-style-type: none">Immediate repairs need to occur on the carport circuits that are fed from the laundry room panels. New 20A circuits need to be added.Upgrade panel to accommodate new circuits.	\$1,500/Circuit \$4,000/Panel
<ul style="list-style-type: none">These circuits, and possibly panels, need to be upgraded to accommodate the golf cart and EV charging in the carports.Before adding electrical loads, an electrical load calculation analysis needs to be performed to ensure the equipment is capable of the additional load.	NA To be discussed in Task 2

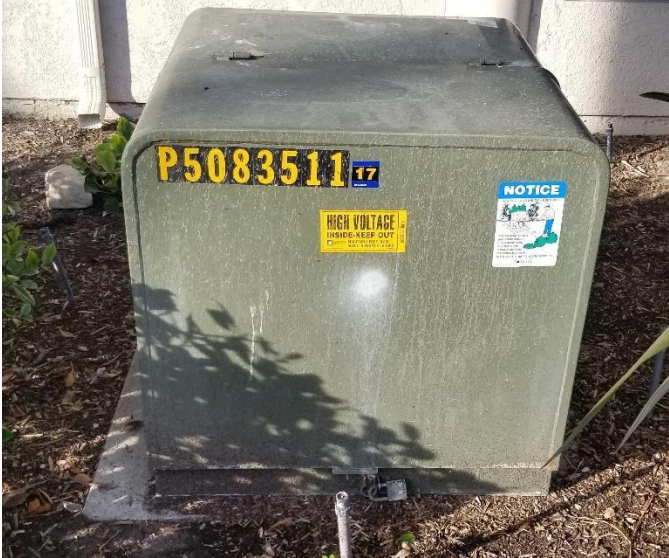
Figure 5: Pad-Mounted Transformer Servicing a Third Laguna Hills Mutual Residential Area (C219)

The SCE transformers were either single-phase pad-mounted (Figure 5) or subsurface (Figure 6) and in varying condition depending on replacement dates. Most of the transformers that were found were of newer vintage and in good to excellent condition. A transformer inventory including transformer ID, location, and total load was requested from SCE for the Third Laguna Hills Mutual boundary, but confidentiality requirements related to the 15/15 Rule prevented them from providing this information. The 15/15 Rule was adopted by the Commission in the Direct Access Proceeding (Commission Decision 97-10-031) to protect customer confidentiality.⁸ The 15/15 rule requires that any aggregated information provided by SCE must be made up of at least 15 customers and a single customer's load must be less than 15% of an assigned category. If the number of customers in the compiled data is below 15, or if a single customer's load is more than 15% of the total data, categories must be combined before the information is released. Without this information, TRC is unable to verify if the transformers are sized adequately for future load. A meeting with SCE was held on the 19th of June 2019 to discuss this request. Based on this meeting, SCE agreed to assess the feasibility of any area identified for additional load and identify if upgrades to their infrastructure is required. While SCE will not provide transformer details, they will assess the capacity of various meters identified as potential electric vehicle charging sites. The details provided by SCE will be applicable to EV charger siting recommendations that will be outlined in Task 2. Additional details regarding the challenges experienced by TEC and TRC to obtain SCE transformer data are outlined in Appendix E. Additional details regarding the challenges experienced by TEC and TRC to obtain SCE transformer data are outlined in Appendix E.

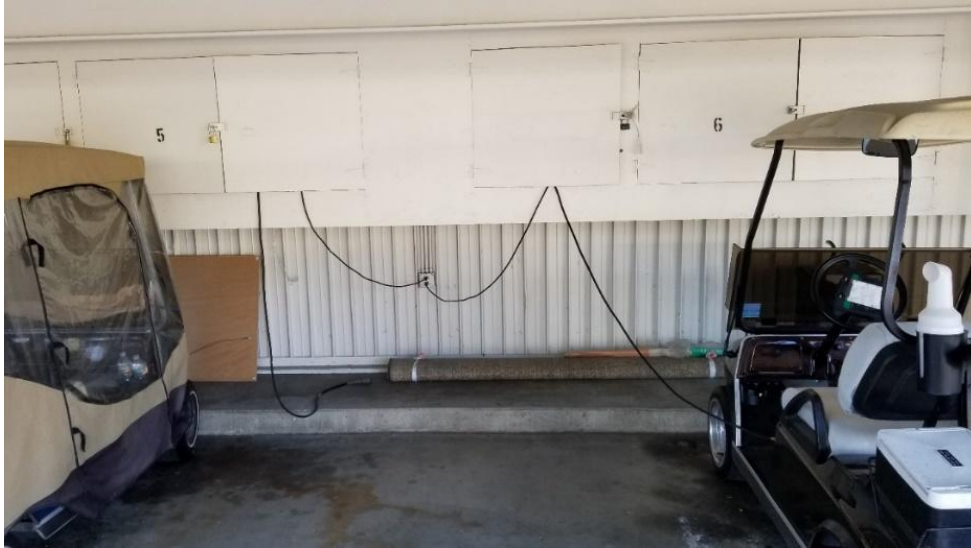
Figure 7: Example of Golf Cart Charging via Battery Charger in Storage Cabinet Plugged into Outlet

All residences in the Third Laguna Hills Mutual, excluding the single-story residences, have either carports, parking garages or detached garages that house cars, golf carts, and other residential belongings. The carports typically have one or more 120V, 20A circuit with a varying number of outlets depending on the number of parking spots. The parking garages have circuits for outlets and lights throughout the parking structure. Golf carts, which are prevalent throughout the Mutual, were charged with a standalone battery charger that either sat on the ground, a concrete block, or in the storage cabinets. Refer to Figure 7 below as an example. There were only a few electric cars observed during the walkthrough. One EV was being charged was using a 120V Class 1 charger.

These residences in the Third Laguna Hills Mutual have carports (Figure 15) or detached garages (Figure 14) that house cars, golf carts, and other residential belongings. The carports typically have one 120V, 20A circuit with a varying number of outlets depending on the number of parking spots. Golf carts were prevalent throughout the Mutual. They are charged with standalone battery chargers that either sat on the ground, a concrete block, or in the storage cabinets (Figure 7).

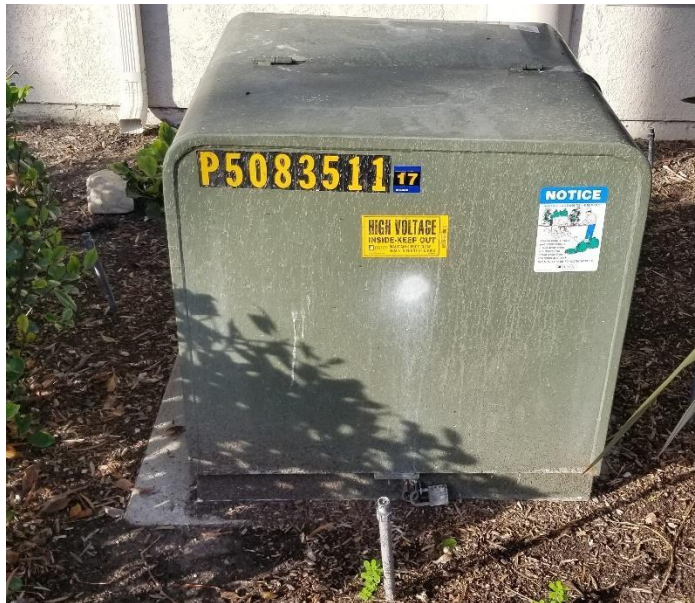
Figure 8: Pad-Mounted Transformer Servicing a Third Laguna Hills Mutual Residences at C219

There are typically four SCE transformers at the parking garages for the multi-story units. Three are single-phase 100kVA 120/240V transformers that service two of the six-meter service entrance sections (Figure 8) each for a total of 12 meters and C219 and the third a separate house panel. They are rated as 4.3 (Good) based on the Asset Condition Measurement referenced in Section 3.4 and installed in approximately 2006. The transformers

Capacity calculations could not be completed because the transformers (except the elevator transformer) feed residential customers and meter data could not be obtained from SCE due to the 15/15 Rule.

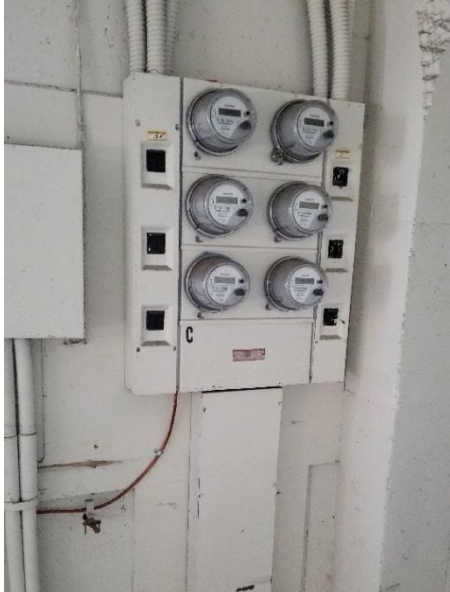
Figure 9: One of the Six-Meter Residential Panels at C219

The electrical system servicing the parking garages are similar to one another. Therefore, the unit at C219 and 5370 Punta Alta will be used as examples. The electrical panels servicing the residences at C219 appear to be 600A panels (Figure 9) from the original installation. The equipment labels were illegible and thus assumed to be 600A since they contained 6-100A breakers. The panels are in marginal condition and rated 2.25 (Marginal) based on the Asset Condition Measurement referenced in Section 3.4 above. The panels are showing signs of their age with some rusting (Figure 10).

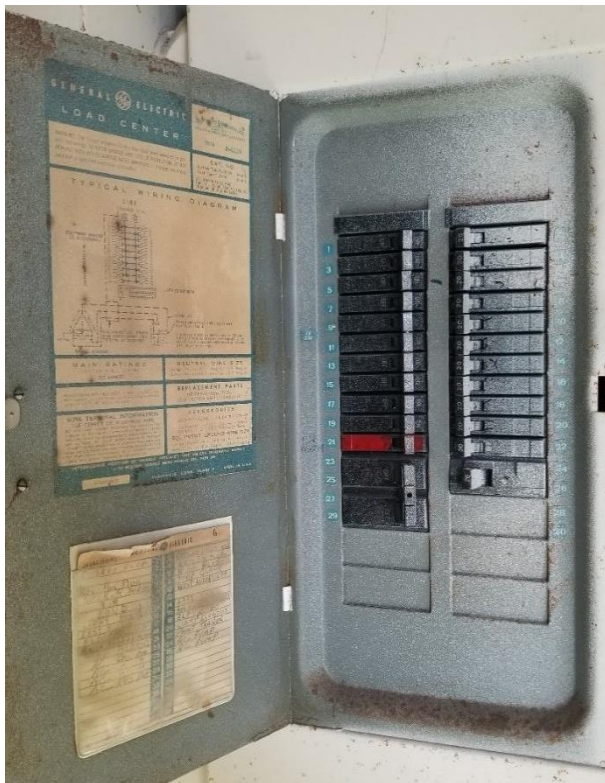
Figure 11: House Panel 1 at C219

The house panel (Figure 11) serves the garage lighting, the recreation room, the fire alarm, and the garage outlets. This is a 400A 120/240V panel. The outlets are served from a 120V, 20A circuit that have multiple receptacles throughout the garage. There are 15 outlets on the one circuit in the garage at 5370 Punta Alta. As with the carports, if two or more EV chargers are plugged in at the same time, the circuit can become overloaded and trip the breaker. Based on the comments about frequent breaker trips from the LWV Energy Task Force and the observed golf cart and EV chargers plugged in the carport outlets, the circuit is undersized

Another quick, but less scalable solution, would be to schedule the charging of all EV charging in each parking garage areas. Based on conversations with the staff, this method is already occurring. It involves the residence to coordinate with each other so that the circuit overloads are limited. With the addition of Level 2 EV chargers, this will be more difficult due to the time needed to charge larger EVs.

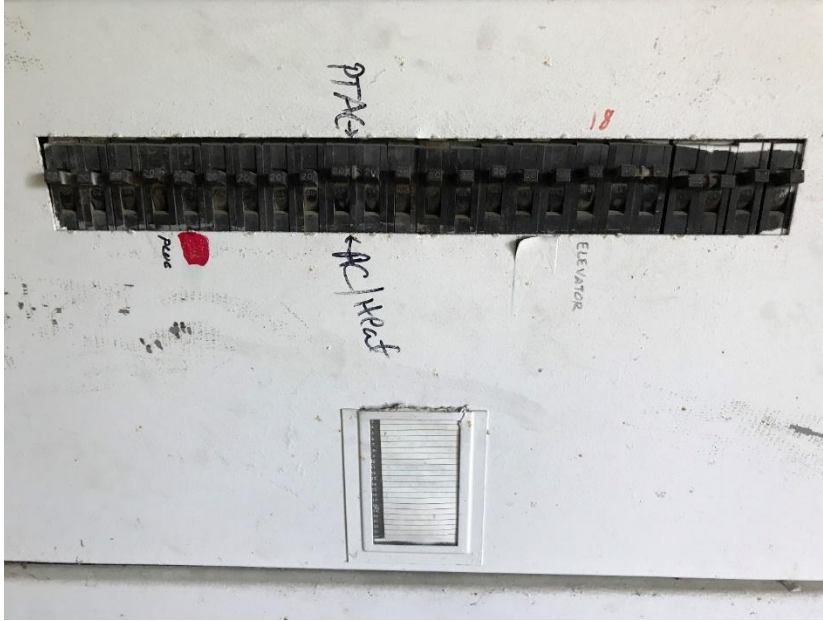
Figure 12: Breakers in Main Panel Servicing 5370 Punta Alta

The parking garage underneath the 5370 Punta Alta had an additional challenge in that the house breakers were incorporated into the main panel as shown on Figure 12 in section 4.2 below. Adding circuits to that panel will require a new subpanel to service the load.

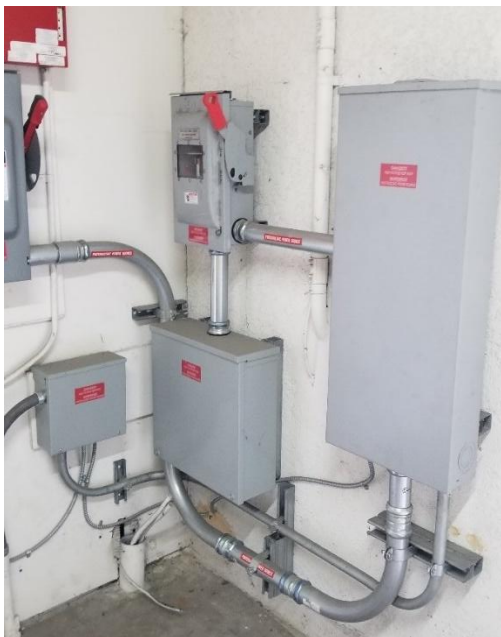
Figure 13: Accompanying Solar Equipment within Parking Garage at C219

Solar panels were recently installed throughout the community. The accompanying equipment (transformer, inverters, switches, and meters) were located within the residing parking garage at C219 as shown in Figure 13.

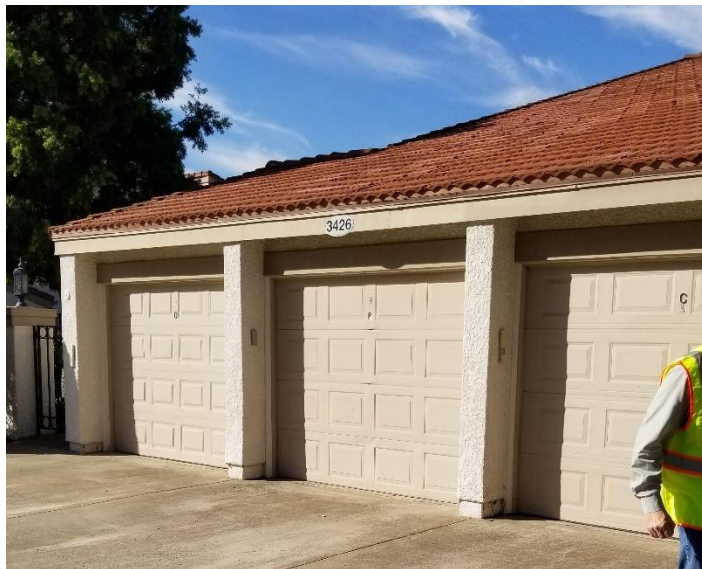
Figure 14: Detached Garages at C344

Electrical equipment at carports within cul-de-sacs 307 and 327 were readily available while fielding. The carports at C327 were located under the building and fed from the house panels, and the carports at C307 were similar to the facilities addressed in the United Mutual report. The detached garage electrical equipment at 344 was not observed as access to the private garages was not available.

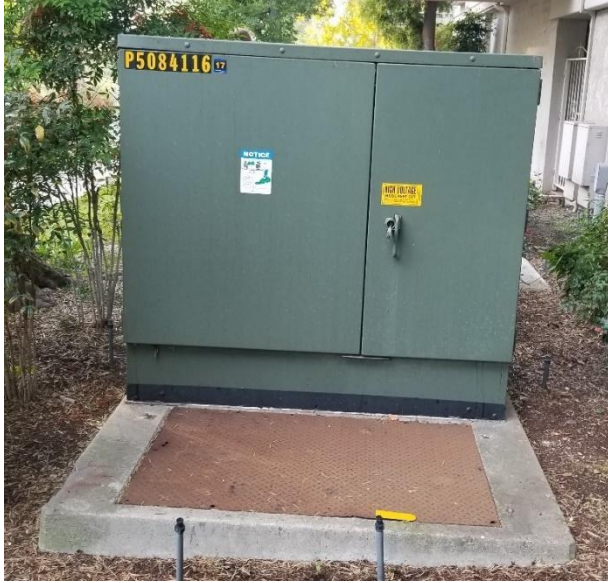
Figure 16: Pad-mounted transformer servicing a Third Laguna Hills Mutual Elevator at C219

All multi-story residences have elevators that are serviced by circuits from either residential panels or their own dedicated service. Elevators are serviced by a three-phase transformer sized to the lift motor size. All elevator facilities appeared to be in good condition. Figure 16 provides an example of a pad-mounted transformer servicing an elevator.

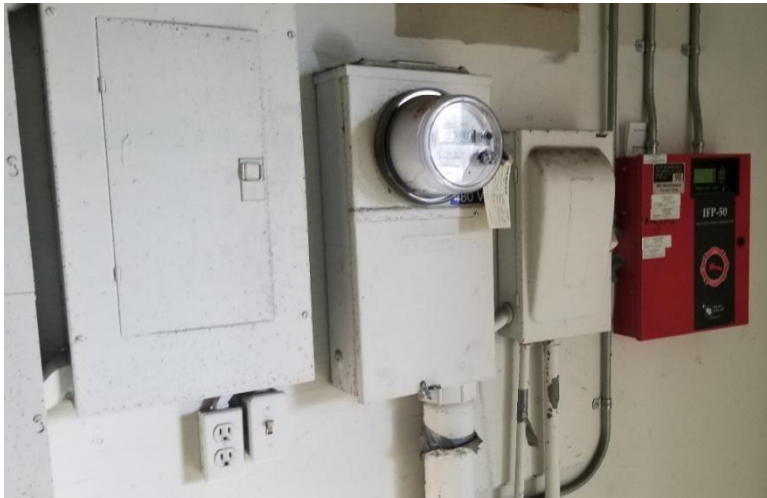
Figure 17: 480V Panel Servicing a Third Laguna Hills Mutual Elevator at C219

The electrical panels are dedicated 480V circuits that service only the elevator load (Figure 17). The circuits were in adequate condition based on Table 2 provided in Section 3.4 above with a rating of 3.25 (Adequate) based on the Asset Condition Measurement referenced in Section 3.4 above. If the panels are not compromised and the elevator load or any other load on the panel does not increase, the equipment should continue to operate as is for a number of years.
