REGULAR MEETING OF THE GOLDEN RAIN FOUNDATION BUILDING E SPACE PLANNING AD HOC ADVISORY COMMITTEE*

Wednesday, January 31, 2024 – 1:30 p.m. 24351 El Toro Road, Laguna Woods, CA 92637

Prepared for GOLDEN RAIN FOUNDATION c/o PCM, Inc. Mr. Alberto Garcia P. O. Box 2220 Laguna Hills, CA 92654 GRF Contract No. P90003326 Project SA20436643

Project K11.062.05

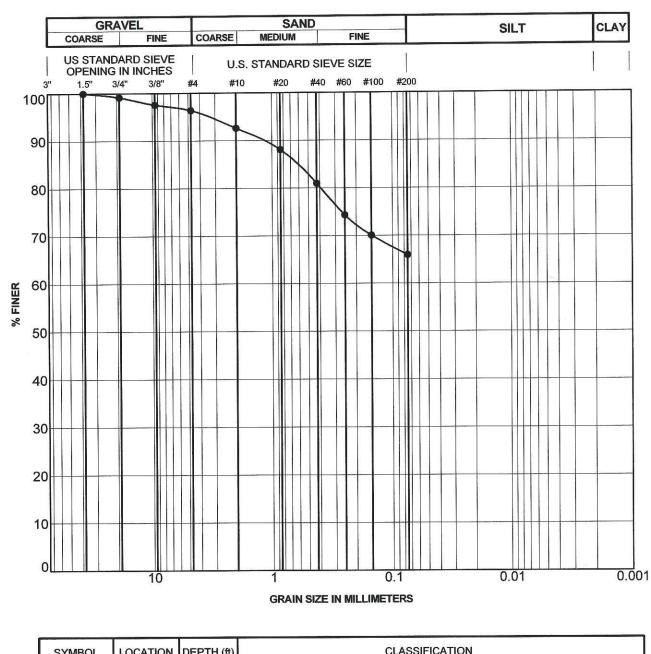
A-5

SYMBOL	LOCATION	DEPTH (ft)	CLASSIFICATION	
۲	BH-1	1.0	SANDY FAT CLAY (CH)	
100.00	-			
	-

ASTM Method D422-63 (REAPPROVED 1998)

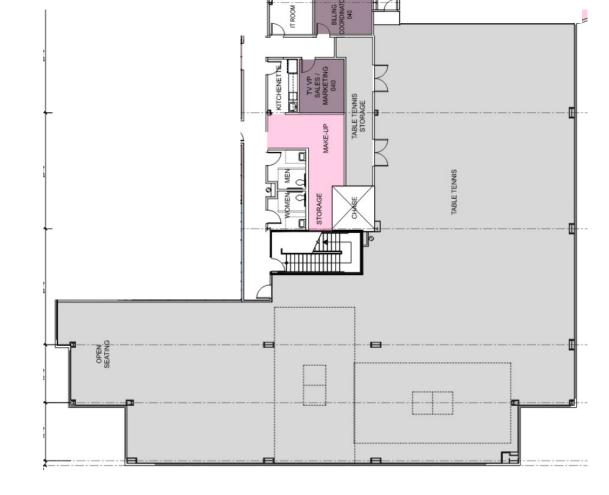
Community Center – 3rd Table Tennis

6,640 s.f.

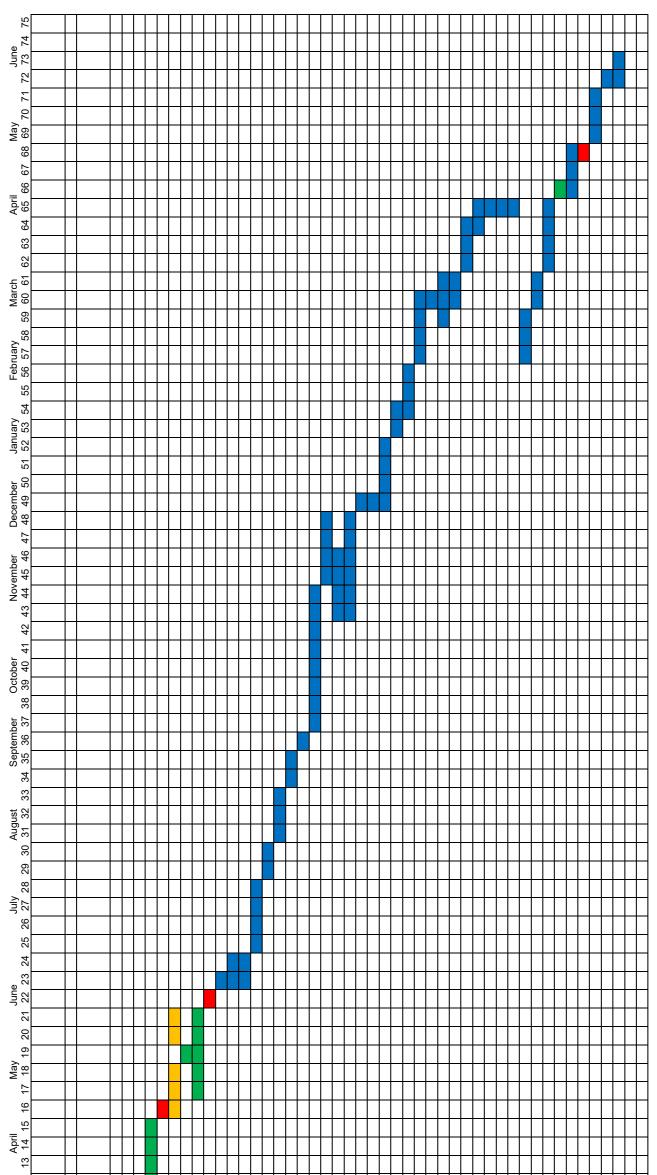
Laguna Woods Village Building E Proposed Project Schedule 25-May-22

The graphic schedule is as follows:

25-May-22 Month: Week:	h: January k: 1 2	ი ი	4	February 5 6		7 8	Marc 9	~	Ę	12
A&E RFP process of Design is provided in Feasiblity Study	sis									
Review A&E RFP and Award								\square		
SCHEMATIC DESIGN Assume floor/site plan in Feasibility, minor revisions	te									
60% Owner Keview, A&E revisions Des Dev Cost estimate update					_					
Construction Documents										
95% Owner Review, revise					_					
Plan Check Corrections								-		
Contractor Bidding/Negotiate					$\left \right $			+		
Contract for Construction Notice to Proceed Dre construction coordination/stacing	sed									
Fire Sprinkler design										
Erosion Control										
Site demolition, grading, utilities										
Site grading/recompaction Foundation excavation/rrading										
Foundation rough U/G, vapor barrier										
Foundation pour/finish/cure										
Structural steel/Framing/ ext glass										
Stucco/exterior finish

- 1. LWV request for proposal from design firm, evaluation and contract
- 2. Design process
- 3. City Review and Processing
- 4. Bidding and Negotiation with general contractors
- 5. Construction of new building
- 6. Relocation of staff to the new building
- 7. Demolition of old building, sitework and repaving.

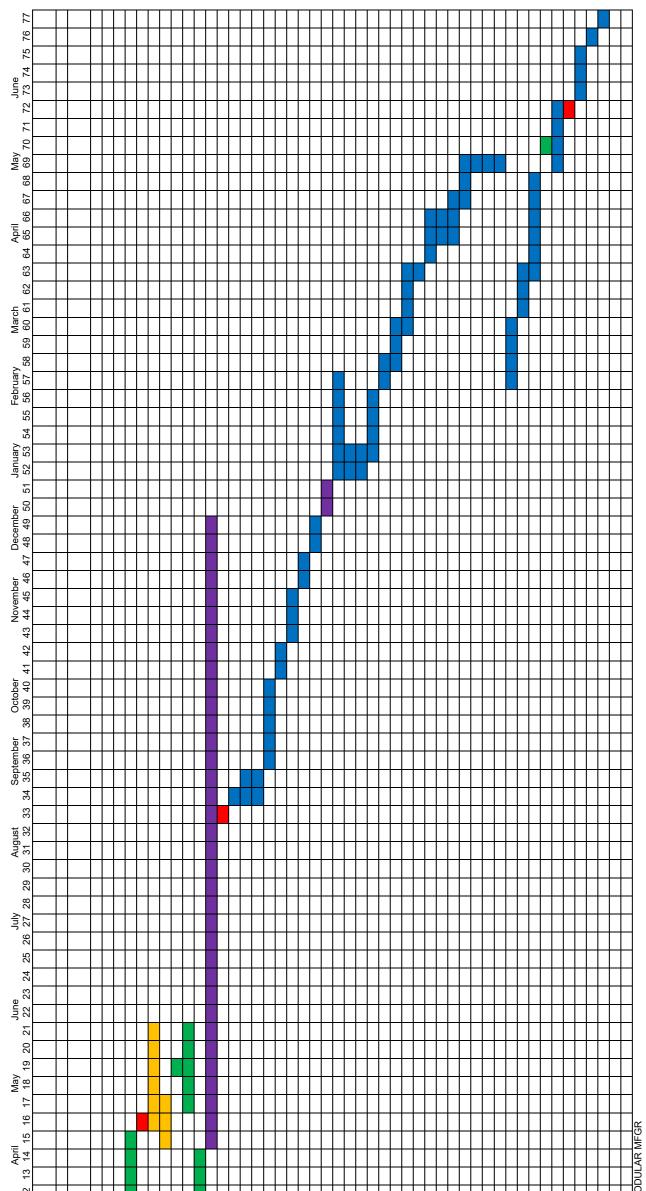
The graphic schedule is as follows:

Rough MEP						
Set HVAC units, roof penetrations						
Rough voice/data						
Insulation/Drywall						
Urywalli IInisri Suspended Ceiling grid/lighting						
Finish MEP and Fire Sprinklers						
Set acoustical ceiling tiles						
Doors/Windows/finish carpentry						
Set millwork						
Painting/vvalicovering/base Flooring						
Toilet accessories/Partitions						
Interior signage						1
vvindow treatments Derimeter neving hese/recompation						T
Concrete curbs/gutters/flatwork						
Asphalt paving/striping/signage						
Project punch list						
Punch list completion						
Occupancy and Move-In Demolish old Building F						
Paving base and recompation						
Asphalt paving/striping						
NOTES:	OWNER		CH/EN	ARCH/ENG		MOD
*no allowance for weather delays	AHJ	S	NSTRU	JCTION		
*no allowance for material aqusistion delays	/s

- 1. LWV request for proposal from design firm, evaluation and contract
- 2. Design process
- 3. City Review and Processing
- 4. Bidding and Negotiation with modular building suppliers
- 5. Order modular building (assumes 8-month lead time)
- 6. Bidding and Negotiation with general contractors for sitework and tenant improvements
- 7. Start sitework and foundation construction
- 8. Install modular building
- 9. Start tenant improvements, set HVAC, complete sitework
- 10. Relocation of staff to the new building
- 11. Demolition of old building, sitework and repaving.
